# Quality Assurance for the Manufacturing of Oxide Fiber Reinforced Ceramic Composites for Aerospace Applications

**Abstract.** The processing route of a CMC material comprises several very complex manufacturing procedures which have to be optimized down to the last detail and, if necessary, monitored and controlled continuously. Consequently, non-destructive inspection techniques are important tools to provide the necessary information that is needed to understand the microstructure and to identify the failure-relevant defects that may occur during manufacturing. The examples discussed here are focusing the manufacturing and material properties of the wound highly porous oxide ceramic matrix composite (WHIPOX<sup>TM</sup>) developed by DLR. It is reported about inspection results with air-coupled ultrasound, optically excited lock-in thermography, 3D terahertz imaging and computed tomography ( $\mu$ -CT, nano-CT). Furthermore, mechanical properties of WHIPOX samples which are obtained from tensile and Iosipescu shear tests are correlated with non-destructive inspection results from lock-in thermography and high resolution CT analysis.

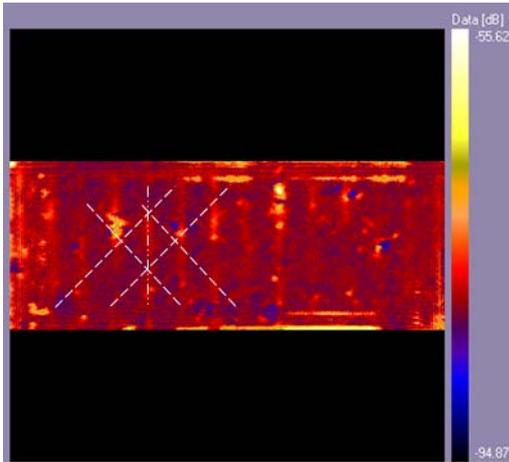
All three plates were inspected by using air-coupled ultrasound (ACU). The C-mode image of plate W1233 shown in Figure 6 was obtained with a through transmission mode technique. The transducer's frequency was about 180 kHz. As the dashed lines indicate, the rhombic fiber bundle structure is slightly visible in the ultrasound image. As the very view dark blue tinted areas confirm, there are no significant defects in this WHIPOX plate. For comparison, Figure 7 shows a photographic image of a part of the plate's surface structure.

**Fig. 6.** Air-coupled ultrasound scan of plate W1233 (C-mode)

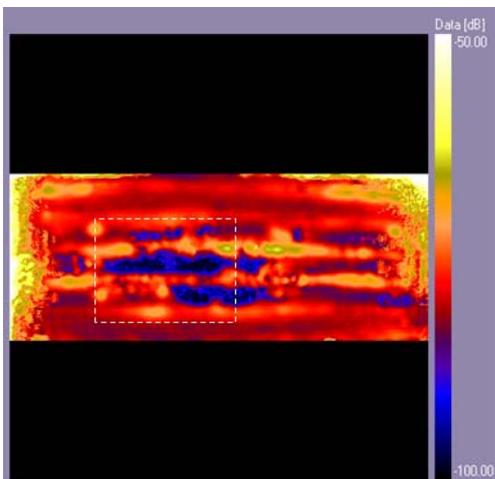
Figure 8 shows an ultrasound image of WHIPOX plate W1289 which is rather thick (approx. 10 mm). The dark blue tinted areas in this scan indicate that there is high ultrasound signal attenuation in these areas. Locally increased porosity or delamination is the most likely explanation for this phenomenon. However, the blue areas are localized along horizontal lines. Regarding the number of lines as well as the distances observed in the C-mode ultrasound scan, it seems that the defective blue areas are in good correlation with the interspaces of the horizontal lines that are visible on the material's surface (cf. Fig. 9). These lines on the photographic image are showing the so called cross-over points of the wound fiber rovings (cf. Fig. 4 & 5). Thus, the defects found by ultrasound inspection are obviously located in between these rows of cross-over points.

**Fig. 8.** Air-coupled ultrasound scan of plate W1289 (C-mode)

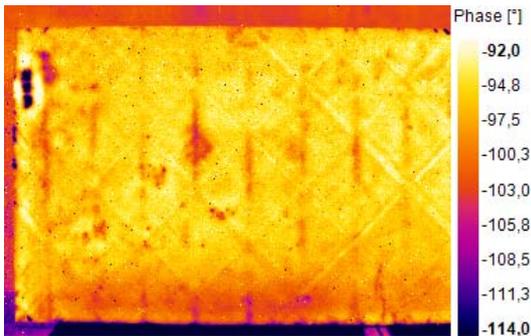
Figure 10 and 11 are showing phase images of optically excited lock-in thermography (OLT) inspections from parts of plate W1233. The lower the excitation frequency  $f$ , the higher is the thermal diffusion length  $\mu$  [6]. As a consequence, the phase image of Figure 10 shows more surface features than that of Figure 11. The penetration depth of the thermal waves in WHIPOX material is approximately 14 mm for  $f = 0.06$  Hz and 34 mm for  $f = 0.01$  Hz. Thus, in the phase images there is also information included which is from thermal waves reflected by the plate's back side (see Table 1). The rhombic fiber filament structure is clearly identifiable in both OLT images and the vertical lines are marking cross-over points of the filament bundles (cf. Fig. 6). In this plate there are no details visible that could be identified as signals from significant material flaws.

Fig. 10. Phase image of plate W1233 ( $f = 0.06$  Hz)

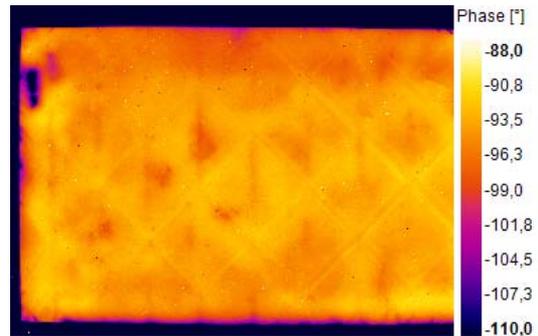
Fig. 11. Phase image of plate W1233 ( $f = 0.01$  Hz)

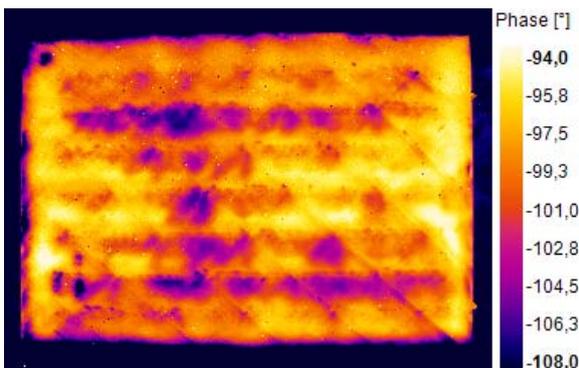
Figure 12 shows the OLT phase image of plate W1262 at  $f = 0.01$  Hz. This plate is 5 mm thick and shows the rhombic structure as well. Here the material is interspersed with defects which are indicated by the dark blue and purple tinted areas. The corresponding ultrasound scan is shown on the right (Fig. 13). The locations of material defects are obviously aligned in horizontal and vertical orientation which is certainly connected with the rhombic fiber filament structure and the resulting cross-over points. Local areas of delaminated material or aggregations of porosity are the most likely interpretation.

Fig. 12. Phase image of plate W1262 ( $f = 0.01$  Hz)

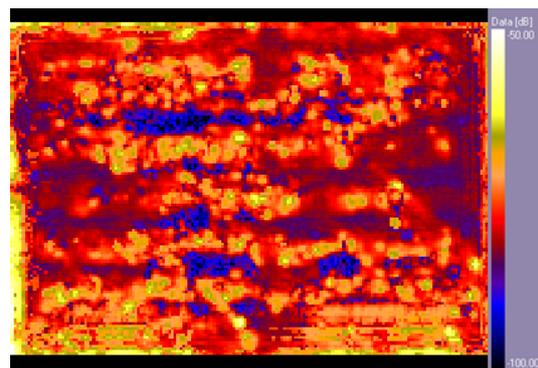
Fig. 13. Corresponding ACU scan of plate W1262

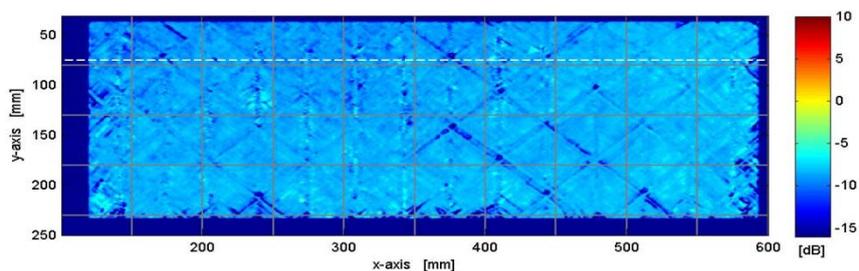
It is the very first time that the WHIPOX material is inspected with terahertz technology (THZ). The details about the measurement conditions are reported by Becker [7]. Figure 14 shows the total reflection signal image mapping of the surface region from plate W1233. It is the corresponding image to the ultrasound C-scan shown in Figure 6 and the OLT phase image in Figure 10. At the first sight the filament's rhombic structure comes out very clear. There are no single fibers visible but the gaps and interspaces along the lines of roving structures. The locations of the cross-over points of the oxide fibers are clearly detectable as they are aligned in vertical rows. However, this is changing fundamentally as soon as the focused XY-layer is located beneath the plate's surface region [7]. With deeper penetration along the Z-axis only surfaces and boundaries of increased reflectivity within this layer are visible while the filament structures are not directly visible anymore. On the other hand single defects within the focused XY-layer are coming out very clear.

Fig. 14. C-scan image of WHIPOX plate W1233 at 0.3 THz

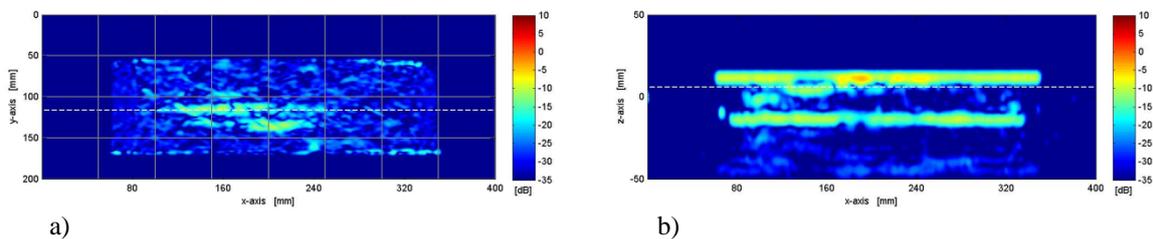
Figure 15a shows a C-scan image of the inside structure of plate W1289. The Z-position is located approximately 2.5 mm below the plate's surface. The reflectivity image scan reveals some defect signals at certain positions. Judging from the size, location and extension, the signals are quite similar to that of the corresponding ultrasound image (cf. Fig. 8). The dashed horizontal line in Figure 15a goes right through and marks the location of the B-scan image on the right (Fig. 15b). The B-scan is like a cross-section through the plate's thickness (XZ-plane). Beside the plate's front and back side surface echoes, it shows the depth locations of any defect in this plane. The defect's signal addressed here is located approximately 2-3 mm underneath the material's surface. By contrast to the lock-in thermography imaging, the location in depth can be displayed in a B-scan mode.

Fig. 15. a) C-scan of WHIPOX plate W1289 at 0.1 THz. b) the B-scan is representing a cross-section view with a front and a back side surface echo of the plate

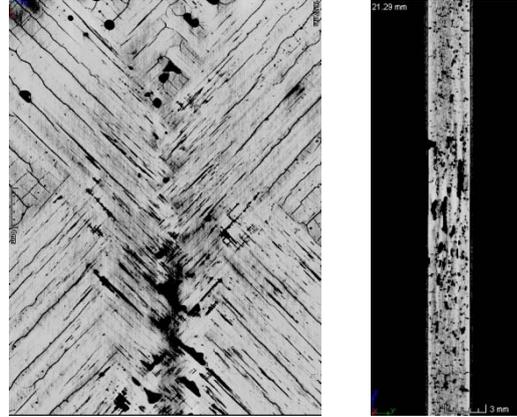
cross-over region, the real microstructure of such a section is depicted in Figure 17, viewing along Y-axis (left image) and along X-axis (right image). The microstructure is a small ROI of plate W1233 (voxel size: 28.2  $\mu\text{m}$ ). Beside the cross-over structure of the filament bundles, there are also a view very small cracks and shrinkage pores visible which are all part of the matrix (Fig. 17, left image).

**Fig. 17.** CT-images of a fiber roving cross-section in plate W1233 (voxel size: 28.2  $\mu\text{m}$ )

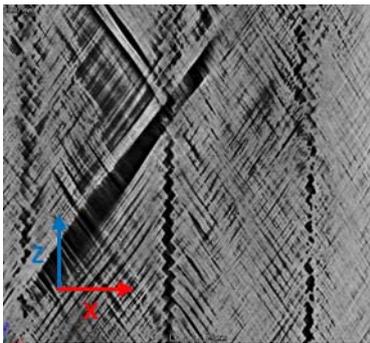
Figure 18 to 20 show CT images of a ROI scan of plate W1289 (voxel size: 42.2  $\mu\text{m}$ ). A typical filament displacement is depicted in Figure 18. The distribution of these kind of defects is statistical and can be found almost everywhere in the WHIPOX microstructure. However, Figure 19 shows a local delamination which is outlined with an arrow in the cross-section views beside (Fig. 20). It is exactly the delaminated area which caused the defect signal in the Terahertz scan (Fig. 15a & 15b) and the ultrasound scan (Fig. 8) and was located in a depth about 2-3 mm beneath the material's surface. Furthermore, the upper two cross-section views (Fig. 20) both show the horizontal shift of small pores across the laminate's thickness. These are the gaps which are caused by the cross-over fiber regions.

**Fig. 18.** Filament displacement in plate W1289 (CT image)

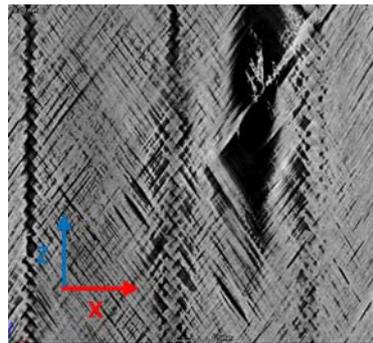
**Fig. 19.** Delamination in plate W1289 (CT image)

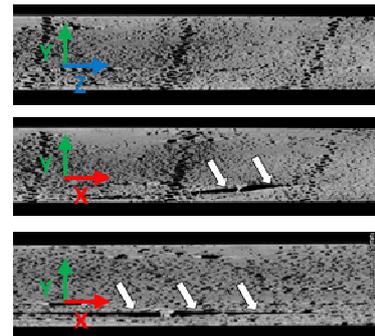
**Fig. 20.** Cross-section views of delaminated areas (CT images)

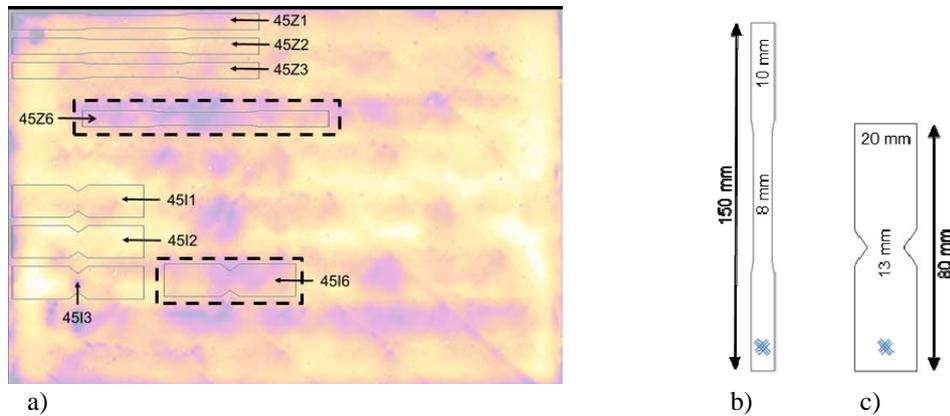
In order to determine differing mechanical properties of samples from one single oxide CMC plate, the OLT phase image of plate W1262 was used as a reference for porosity distribution (cf. Fig. 12, 21a). As previously reported, there are several regions of different porosity that were clearly identified within the plate. The mechanical properties were determined from tensile and shear tests. Regarding the load direction of the test samples, the fiber orientation was  $\pm 45^\circ$  (Fig. 21b, 21c). The tensile test samples measured 150 mm in length with a waist line cross-section of 8 x 5 mm<sup>2</sup> and 50 mm in length (Fig 21b). The Iosipescu shear samples were notched on both sides with the angle of 110° (Fig 21c).

**Fig. 21.** a) Correlation of OLT image information and test specimen selection for tensile and Iosipescu shear testing. Specimens 45Z6 and 45I6 were prepared from areas of increased porosity (outlined by dark purple color); b) tensile test sample dimensions (150 x 10(8) x 5 mm<sup>3</sup>) and fiber orientation ( $\pm 45^\circ$ ); c) Iosipescu shear test sample dimensions (80 x 20(13) x 5 mm<sup>3</sup>) and fiber orientation ( $\pm 45^\circ$ )

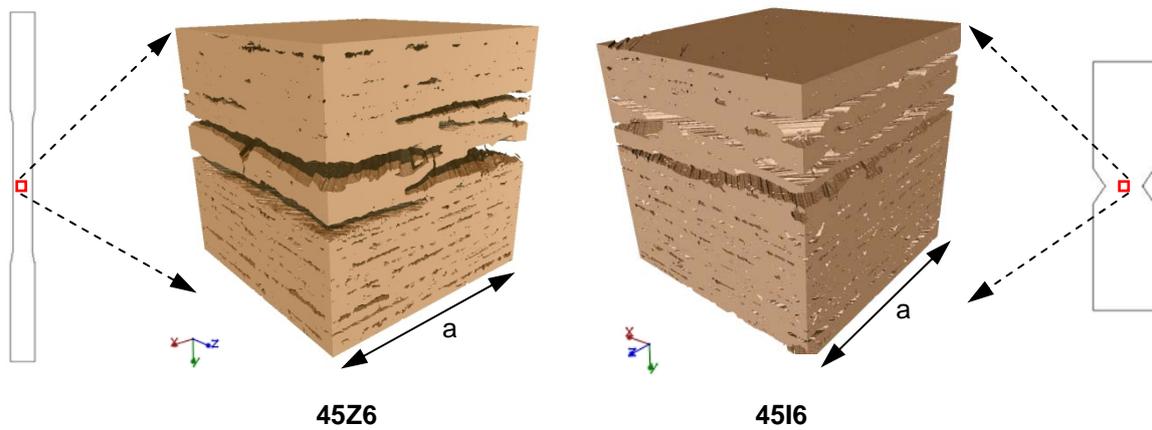
**Fig. 22.** CT based analysis of local porosity distribution in the center area of tensile test specimen 45Z6 and shear test specimen 45I6 ( $a = 3.6 \text{ mm}$ )

While the brown phase of these images depicts the 3-dimensional distribution of oxide fibers with the surrounding oxide matrix, the interlaminar pores and gaps between the fiber bundles are visible as elongated, almost even tubular-like cavities in between the laminate microstructure. Of course, the geometry of these cavities is strongly influenced by the oxide fiber's orientation. As the two 3-dimensional CT images indicate for both samples, there is a cumulation of larger pores in some layers of the CMC's laminate. These are the defects that were detected with OLT and ultrasound inspection (compare to Fig. 12 & 13, 21).

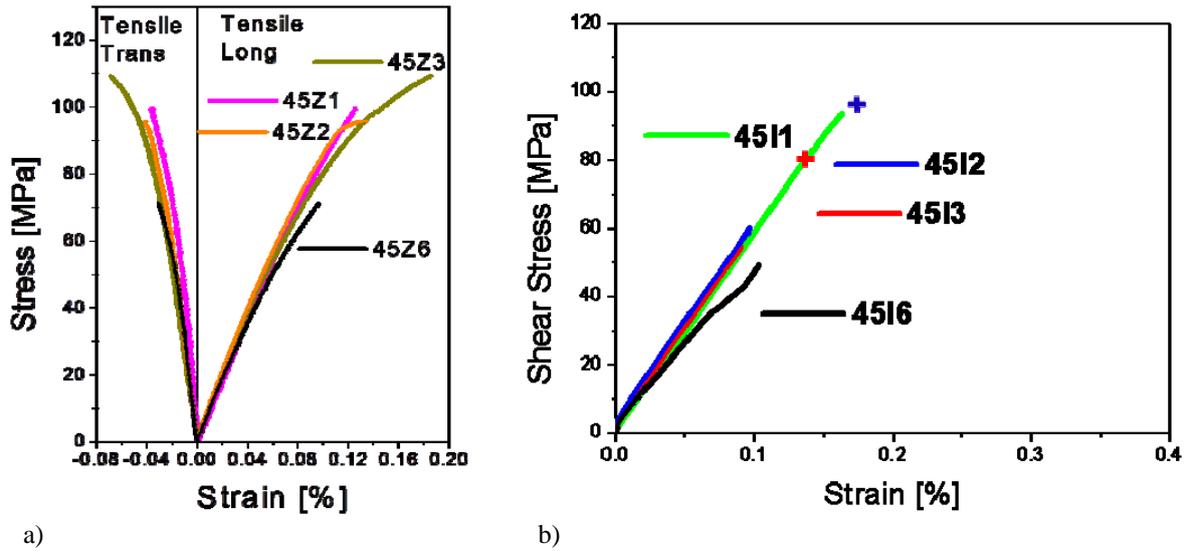
As shown in Figure 23, there is considerable different mechanical behavior between the specimens from porous locations (45Z6 & 45I6) and those of other locations with more dense material (45Z1-3 & 45I1-3). In the case of sample 45Z6, the material fails already at a relatively low stress level of 70 MPa which is approximately only 70% compared to the load levels of the other samples (Fig. 23a). Regarding the shear test samples, the porous material (45I6) also shows a relatively low strength and shear modulus compared to the other samples (45I1-3) (Fig. 23b). It should be noted that some strain gauges broke earlier than the shear samples (45I2 & 45I3). However, it is obvious that there is a correlation between the detected porosity and the mechanical properties of the test specimens.

**Fig. 23.** Stress-strain curves of WHIPOX composite: a) tensile testing with longitudinal and transverse strain gauges; b) Iosipescu shear testing with strain gauges in  $\pm 45^\circ$  orientation
