# Caveats and pitfalls of high energy UV laser operation on ground

**Abstract**—During the Aeolus laser and instrument transmitter development it was shown that atmosphere quality was one major limiting factor for high energy UV laser operation at ambient pressure. As already proven in literature operation can only be safely obtained in the presence of oxygen ([1] to [6]).

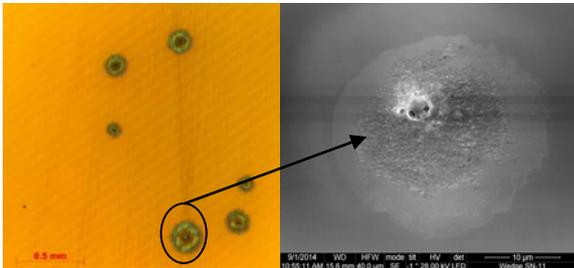
LIC is not, however, an effect purely limited to hard vacuum conditions. LIC deposits can and will form at ambient pressure. The presence of O<sub>2</sub> is a deterrent to the LIC formation in these conditions too. As such operation with normal dry air is to be preferred to operation in nitrogen (or any other mixture not containing reactive oxidants), as evidenced in *Figure II-1*.

*Figure II-1* LIC induced damage event after irradiation in N<sub>2</sub> ambient (microscope image (left) and detail with Atomic Force Microscope (right))

Oxygen is therefore as already demonstrated in literature a necessary ingredient in the safe operation of high energy laser, especially in the UV domain.

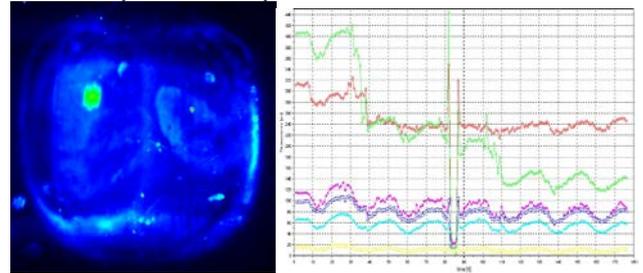
*Figure III-1* Fluorescence image FM-A TV test campaign and different areas of interest evolution over test campaign.

On the other hand, as shown in *Figure III-1*, fluorescence based setup can be used as a good indicator of the air quality and alerts raised as needed. Fluorescence verification remains an efficient check during testing but cannot be used to demarcate the usable gas supplies a priori.

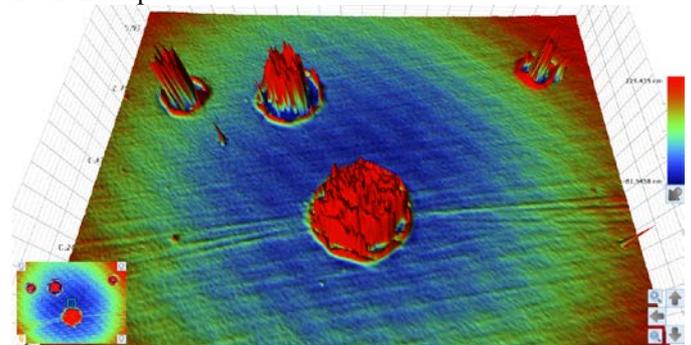
*Figure III-2* white light interferometry measurement for LIC induced event presented in *Figure II-1*.

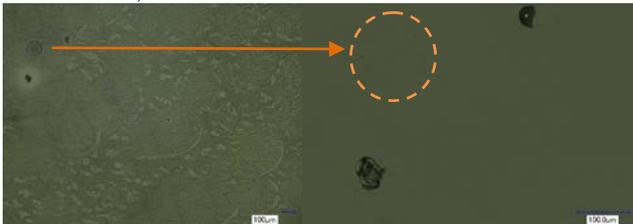
Figure III-3 Beam footprint visualized using huffing (left). Visible droplets on surface in beam footprint after huffing (right). Successful test no WLIM detectable growth.

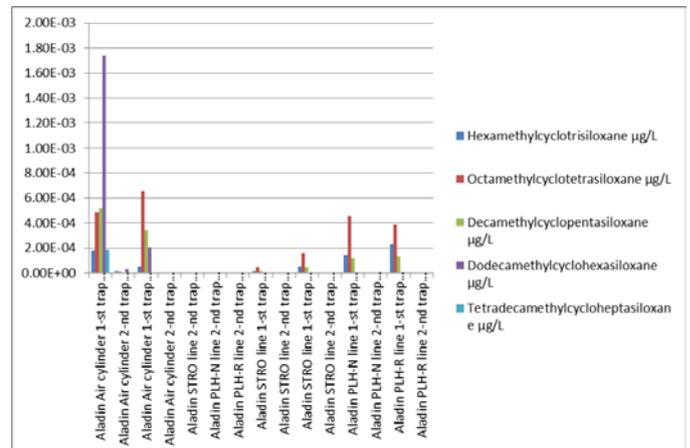
In series usage of two such traps allows to reach much lower silicones concentration than those seen on the given purge line as can be shown in Figure III-4.

Figure III-4 Reduced concentration [µg/L] of silicone contaminants after two in series traps.

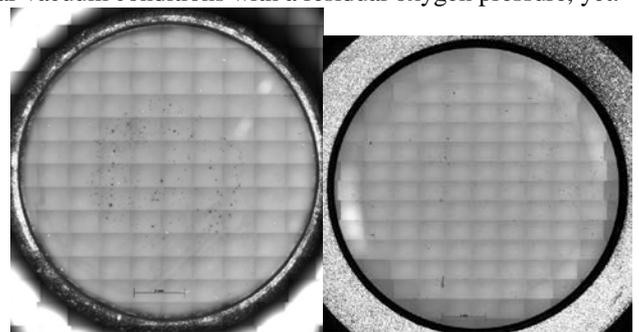
Figure IV-1 Left: input side of laser window, Right: output side. Same environment on both sides.

Analogously features are more abundant on the laser input surface of a transmissive optic. This is well evidenced by the instrument input window sample in *Figure IV-1*. The left-hand (laser input side) shows a high concentration of features in the beam foot-print, the concentration is random and not fluence dependent. The output surface shows dust and a few isolated absorbing features in the central laser irradiated area.

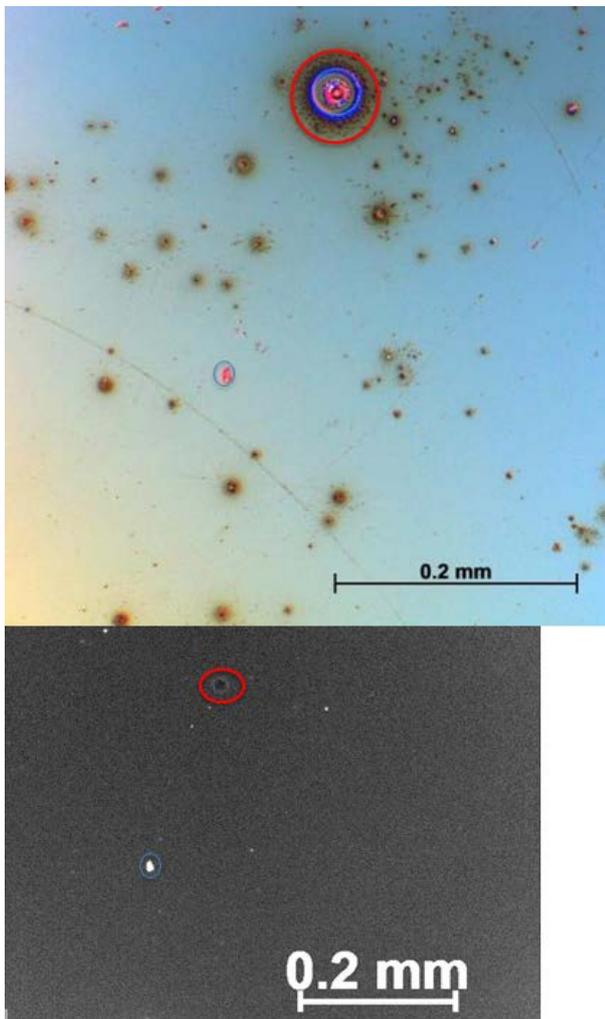
On the laser input side, at higher magnification, the features have a dot-like appearance, and are commingled with rare, small compared to beam size ( $\approx 100\mu\text{m}$  vs.  $5\times 6\text{mm}$ ) laser damages, *Figure IV-2*. Same morphology is evidenced in *Figure IV-4* for output surface.

*Figure IV-2* Input surface: absorbing features, organic particle and small damage. Bright field, fluorescence.

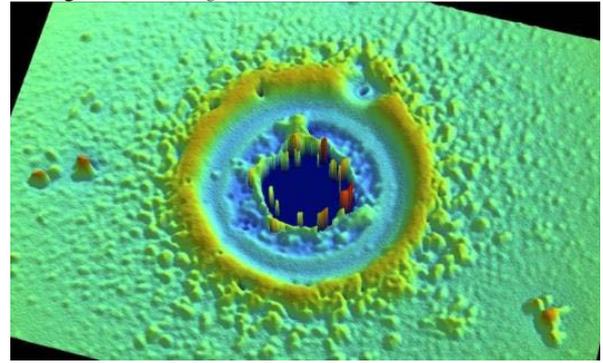
The features are located on the surface of the optic; the damage structure position with respect to the same is less easily monitored, due to lack of reflectivity in the central area (*Figure*

*Figure IV-3* WLIM of damage area presenting a few of the absorbing features.

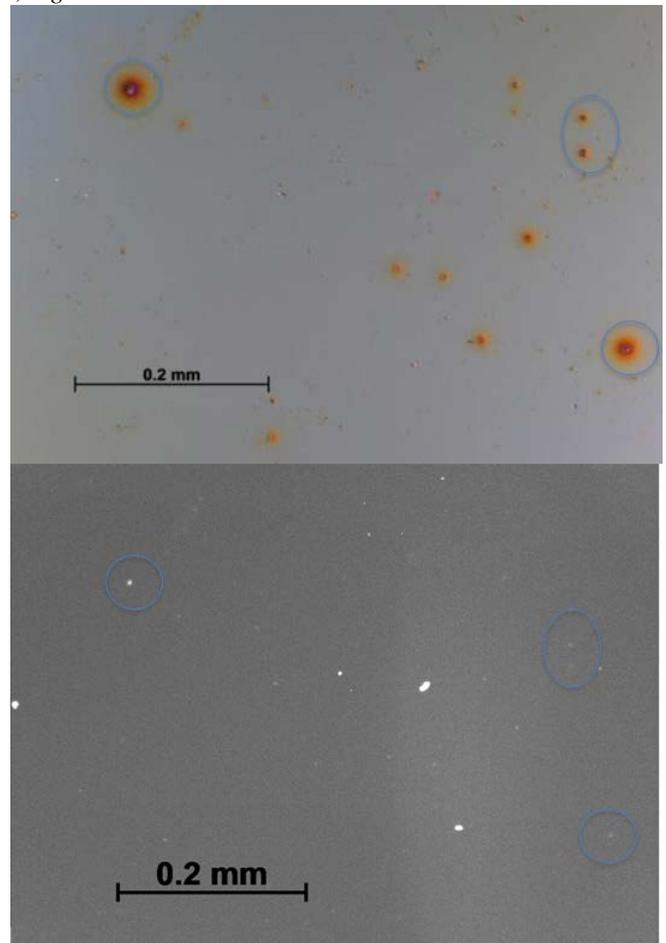
The absorbing features are very faintly emissive at best as it pertains to fluorescence. Not fluorescing, but for the annulus of the damage area as can be seen on the input surface, *Figure IV-2* or only faintly fluorescing, as can be seen on the output side, *Figure IV-4*.

*Figure IV-4* Output surface detail bright field and fluorescence.

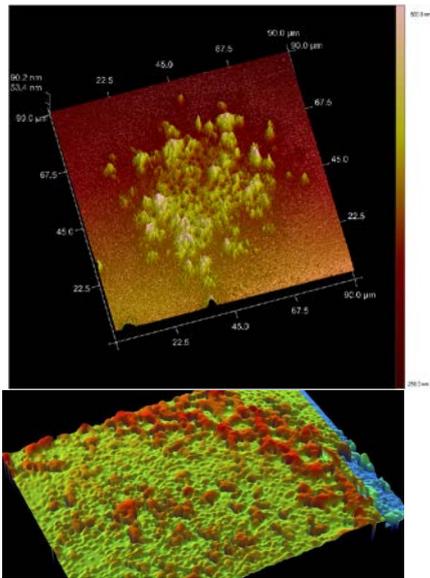
*Figure IV-5 AFM (top) and WLM (bottom) micrographs of instrument output window.*

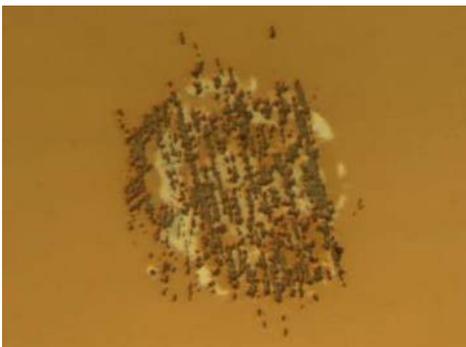
contamination a higher local concentration of Si and O ( $\text{SiO}_2$ ) would be expected. The shape of a silicone deposit is shown in *Figure IV-6* and is not unequivocally germane to the one observed for the dot like features, the features being much less sparse.

*Figure IV-6 Power Laser Head samples 01 from DLR showing silicone based contamination covering whole beam area.*

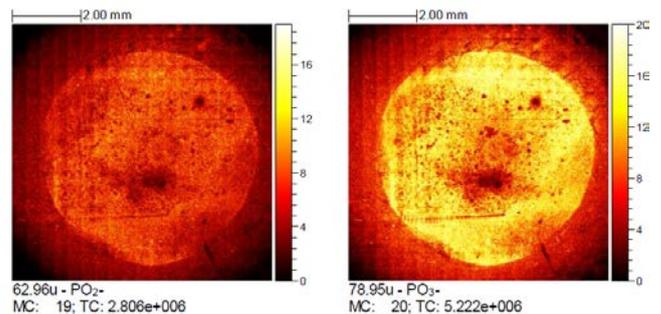
Consistently the presence of Phosphates ( $\text{PO}_2^-$  and  $\text{PO}_3^-$ ) on the optical surface in conjunction with the laser foot-print is evidenced, *Figure IV-7*.

*Figure IV-7 Aladin Laser FM-A output window: SIMS map for negative phosphate ions. Beam footprint evident, depletion co-located with damage structures.*

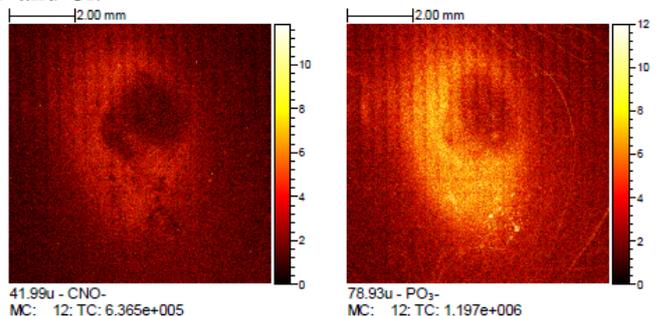
*Figure IV-8 Long Term Sample A, halo at extrema of beam.*

The phosphate/ amine deposit is not always covering the whole beam footprint as seen in *Figure IV-8*, but is occasionally present as a halo surrounding the beam.

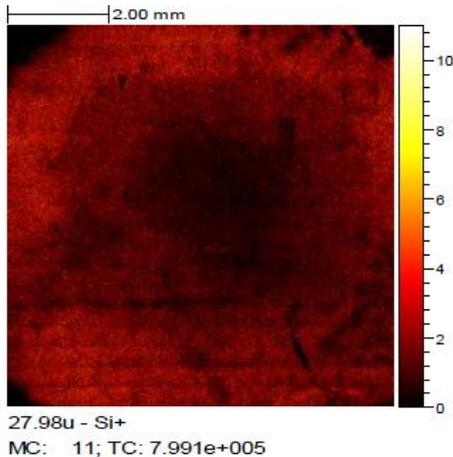
The corresponding depletion of Si in the SIMS map of the positive ions corresponding to the laser footprint shows that a deposit is covering the optical surface (Figure IV-9). This is also a generic observation which holds for all samples investigated so far.

Figure IV-9 Aladin Laser FM-A output window SIMS map of positive ions. Si depletion is evident in the beam footprint.

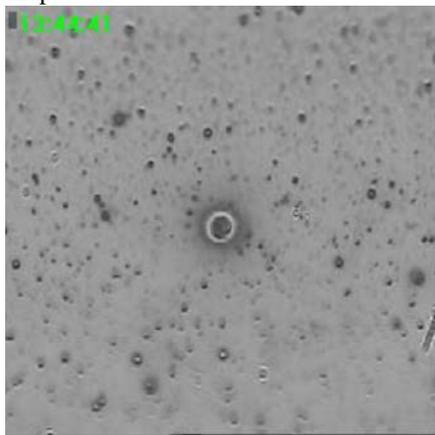
If we now concentrate on an area around a damage feature such as the one observed on the Aladin FM-A output window the optical image (Figure IV-10) shows a clear correlation with the chemical maps.

Figure IV-10 Aladin Laser FM-A output window: optical microscope image of detailed area of analysis taken from ToF-SIMS set-up.

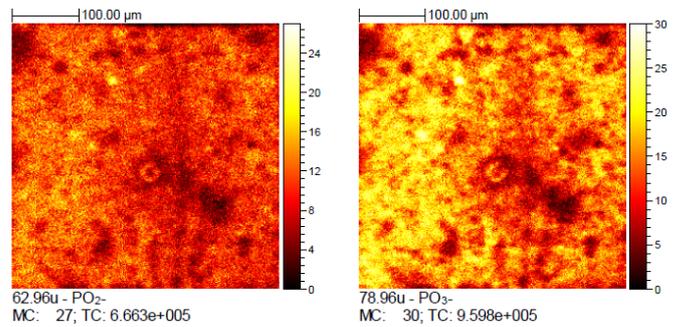
Correlation is obvious with the phosphates which show a significant depletion in the center of the damage structure, a bright ring and a second darker annulus.

Figure IV-11 Aladin Laser FM-A output window: SIMS map of negative ions before Ar sputter cleaning.

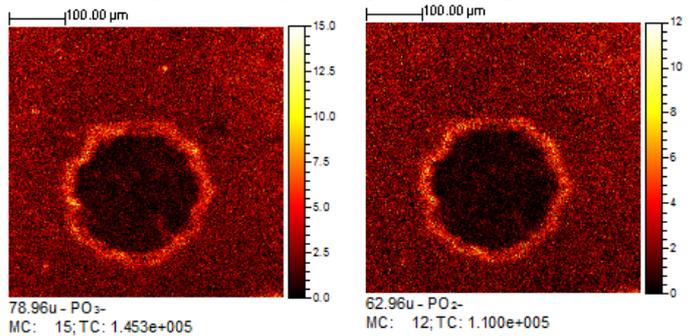
Figure IV-12 LIC induced damage after laser irradiation in N2 ambient ToF-SIMS detail of circled area.

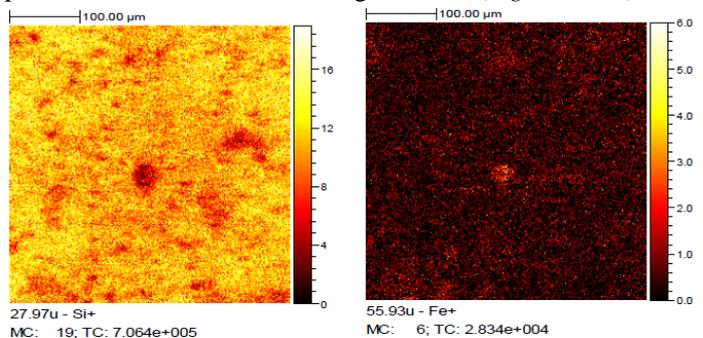
After sputter cleaning the majority of the remaining organics, PDMS, Cl and F have been removed. In the positive SIMS maps the presence of metals (iron) at the centre of the damage structure becomes evident. Also notable is the corresponding depletion of silicon which correspond to the presence of a metallic particle (i.e Fe) in or on the coating as a potential root-cause for the damage creation (Figure IV-13).

Figure IV-13 Aladin Laser FM-A output window: SIMS maps of Si+ and Fe+ after sputter cleaning.

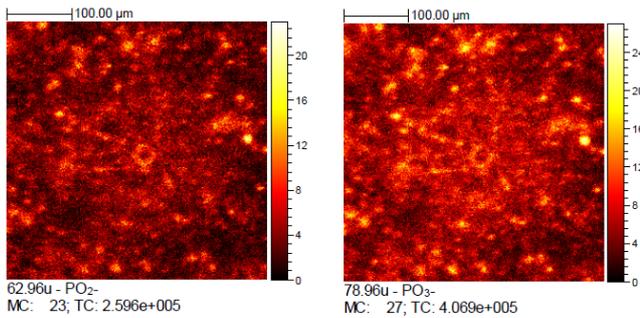
Analysis of negative ions maps shows (Figure IV-14) significant residual of the phosphate deposits still present after Ar cluster sputter cleaning.

Figure IV-14 Aladin Laser FM-A output window: SIMS maps of  $PO_2^-$  and  $PO_3^-$  after sputter cleaning.

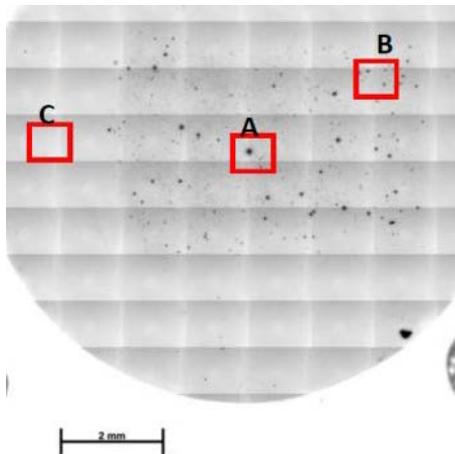
The absorbing features themselves show a consistent chemical make-up with the damage structures. The best sample to visualize the dot like features without any damages (which have a potential to relocate contaminants) is a flight hard-ware grade Half Wave Plate coming from a test set-up (Figure IV-15).

Figure IV-15 HWP from Airbus Toulouse laser test set-up.

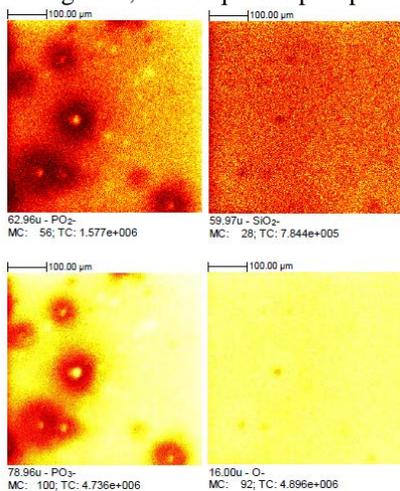
Figure IV-16 Area B negative maps:  $PO_2^-$ ,  $SiO_2^-$ ,  $PO_3^-$ ,  $O^-$ .

In area B where only dot like features are present, the negative ion maps show the usual good correlation between phosphates and surface structures. The centers of the dot like features show higher phosphate content than the borders. This may be due to view factors, and may also hold for the damage features.

Significantly no accretion (in fact a faint depletion can be surmised) of  $SiO_2$ , Si or O is visible in correspondence with the dot like features. This tentatively rejects the hypothesis of an origin linked with silicones (PDMS are present on the surface but their localization is also not germane).

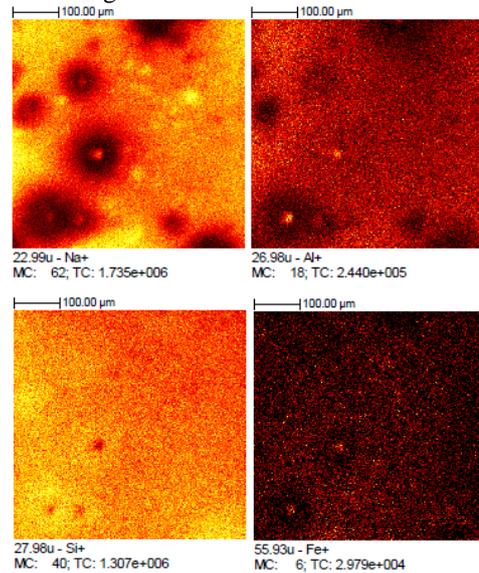
As far as the positive ion maps are concerned it is important to recognize the presence of metals associated with some (but not all) of the features.

Figure IV-17 Area B positive maps:  $Na^+$ ,  $Al^+$ ,  $Si^+$ ,  $Fe^+$ .

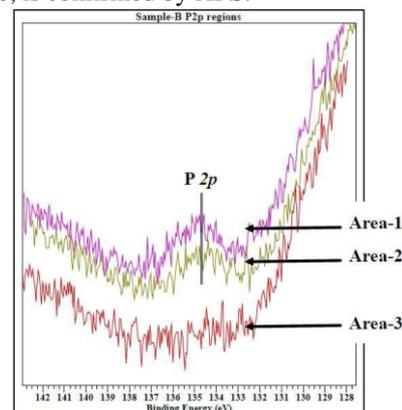
The presence of a phosphorous content in irradiated area, but not outside, is confirmed by XPS.

Figure IV-18 Phosphorous  $2p_{1/2+3/2}$  peak, coming from phosphates. Concentration in Area-1 beam footprint, centre, Area-2 beam footprint periphery, Area-3 control area outside of beam.
