# Study and Comparison of Naturally-Aged and As-Received Silvered-Glass Reflectors

**Understanding the cause of rapid corrosion observed in  
back-silvered glass mirrors exposed for 7 years at the MISIP, Abu Dhabi**

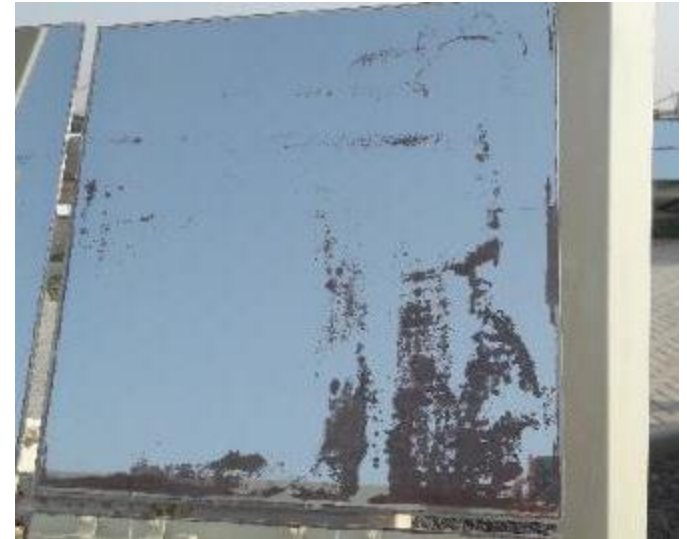
Corroded facet selected for analysis

> 10 pp specular reflectance drop  
after 7 years exposure

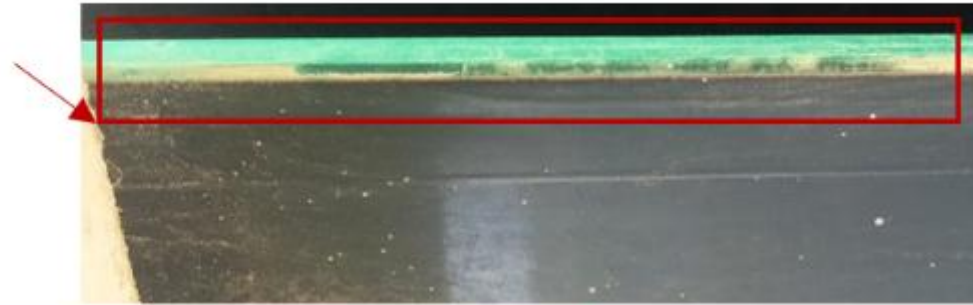
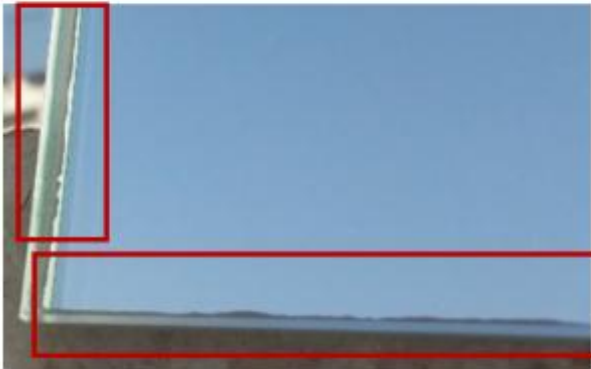
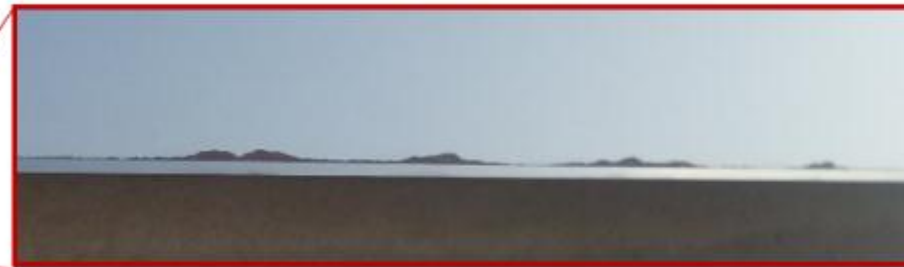
Backside protective resin detachment at the edges

Edge corrosion of the silver layer

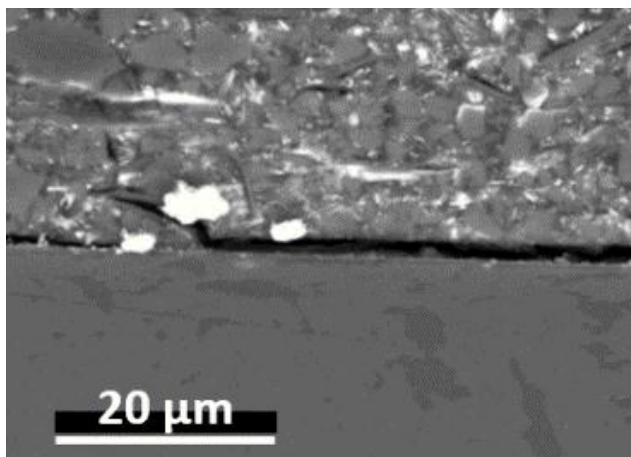
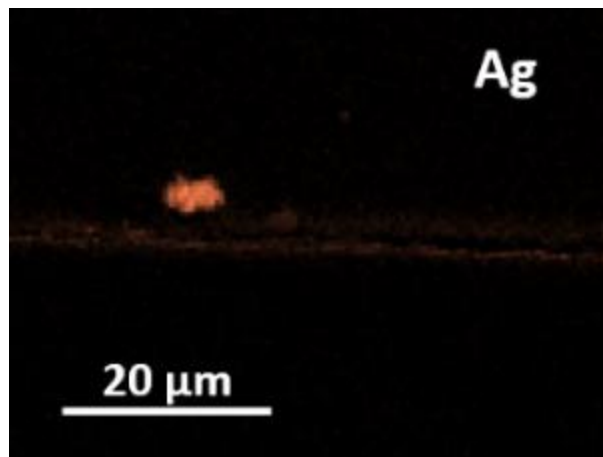
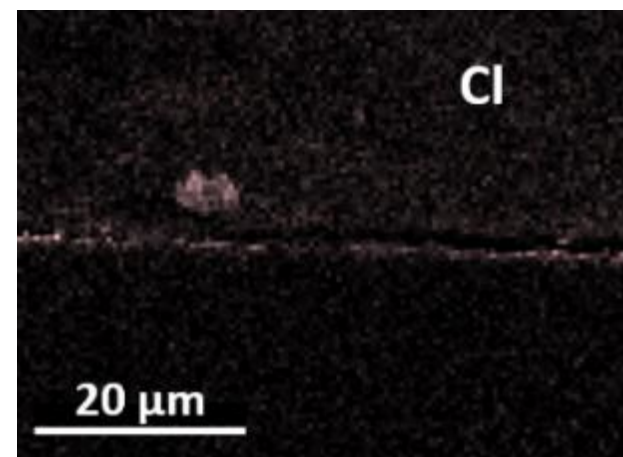
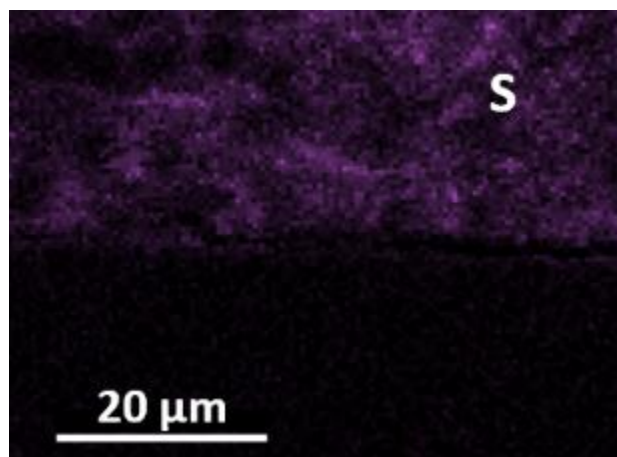
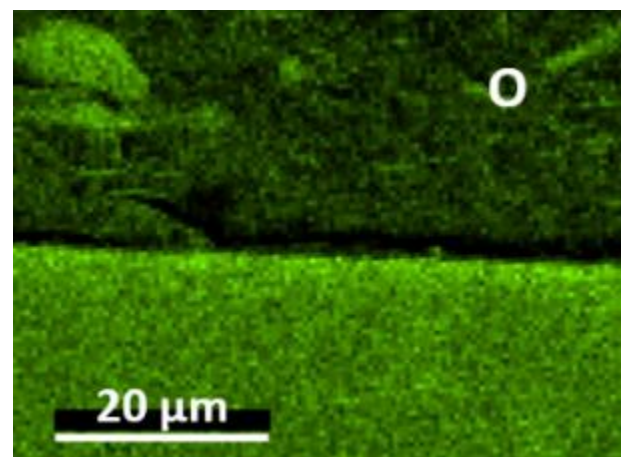
## Analysis of Nishio\_Exp – EDS mapping

- 1) weak adhesion and manufacturing defects in reflecting layers
- 2) weak protective top coating, especially against UV
- 3) absence of copper layer
- 4) high initial presence of corrosive contaminant, chlorine, remaining from the manufacturing process
- 5) low mechanical stability of top coating especially at the edges.
