REXUS 24 FAILURE INVESTIGATION

On Monday, March 12 at 14:30 UTC, 2018, the sounding rocket REXUS 24 was launched from Esrange Space Center. After T+8.9 s, the payload separated unintentionally from the motor. The payload impacted 2 km north east of the launcher. The thrusting motor continued to fly down range. All objects were contained within safe areas, causing no damage on human beings or property.

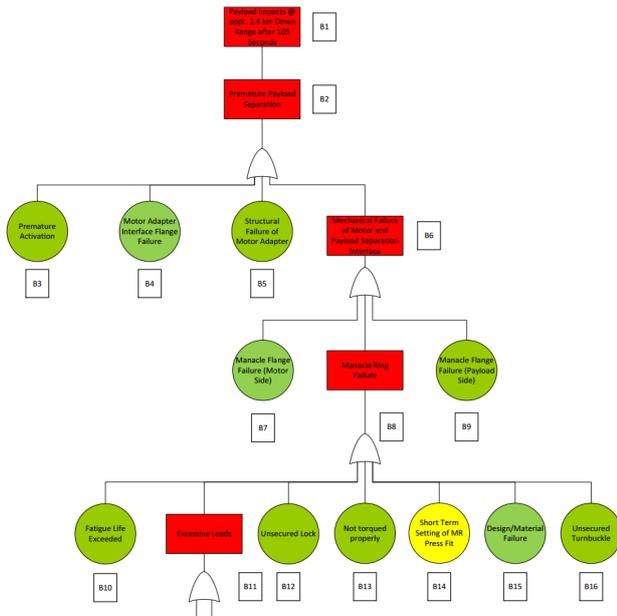
Figure 2: Upper part of the developed failure tree for REXUS 24. Circles denote nodes which cannot be broken down any further. Rectangles denote nodes with sub-branches which are linked to the parent element with a logical OR. The colors have the following meanings:

- Green: Did NOT occur
- Red: Occurred
- Yellow: Cannot be excluded

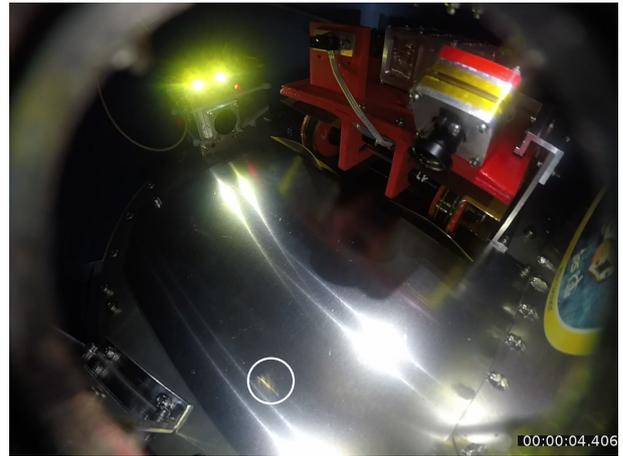
The media footage taken from inside the rocket payload as well as from outside during launch have been analyzed. The two video cameras of experiment ROACH detected a noticeable “bang” sound and a visible mechanical shock around T+3.56 s (CTL). From this time onwards, the sound changed to a whistling noise and repeating light reflections were visible in the compartment as shown in Fig. 3. At T+6.20 s, a second small “bang” and mechanical shock was detected by these cameras and from T+6.741 s onwards, a repeating red light reflection was seen in the compartment. Around T+8.8 s, a large shock and “bang” occurred. Subsequently, the amount of light flooding the module increased significantly, debris and damages were visible in the ROACH compartment.

Figure 3: ROACH payload video. T+4.406 s. Frame showing bright light reflection pattern indicated by the white circle.

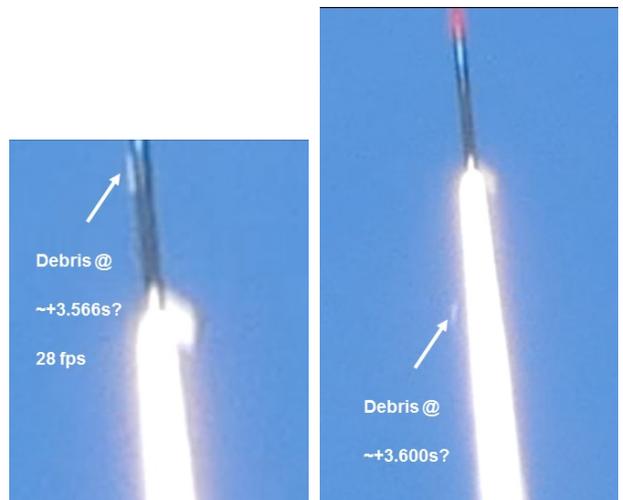
Figure 4: Magnified video frames taken from Radar hill (Team ROACH). Arrows indicate observed debris. The accuracy of the given times is limited by the video frame rate (30 FPS).

– revealed an object falling next to the rocket vehicle around T+3.6 s (see Fig. 4). This event occurred at that time when the first “bang” and mechanical shock in the experiment module ROACH were recorded.

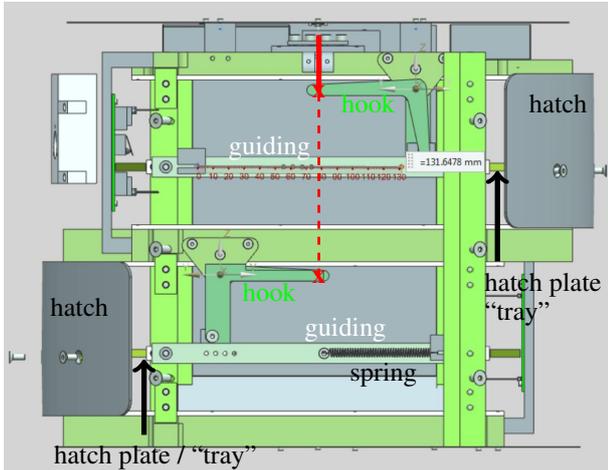
Part of the ejection mechanism displayed in Fig. 6 are the pairs of hooks which prevent the hatches to move. The hooks are restrained by 1 mm thick steel cables that are cut for ejection by a pyrotechnical cable cutter triggered by the REXUS SM. The cables are fed through small holes at the lever arms of the hooks (marked by red crosses in Fig. 6). The cable ends at the hooks are prepared as loops around a nut in order to provide a stop in case of slipping. The loops are crimped according to a procedure [3, 4]. Moreover, the cable ends are attached to the hooks with zip ties through the nuts as depicted in Fig. 8. The cables are bent 90 deg between the hook and the crimp. The other ends of the cables are fed through the cable cutter and are clamped on a plate in the upper part of the module.

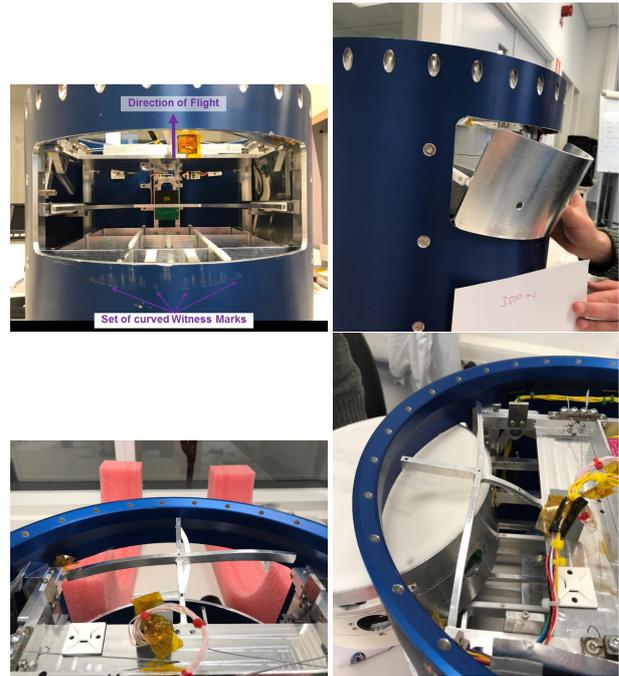
Upon recovery of the payload, the two hatches and FFUs of the WOLF module were seen to be missing. Marks, scratches and damages around the openings and inside the module suggested a non-nominal ejection with

Figure 7: Post-flight investigation of WOLF experiment module. Witness marks and reconstructed positions of hatch and FFU.

an external force pressing the upper hatch against the lower rim of the FFU bay. The possible positions of the hatch and of the FFU before their detachments could be reproduced with the recovered module and spare hardware of hatch and FFU as shown in Fig. 7.

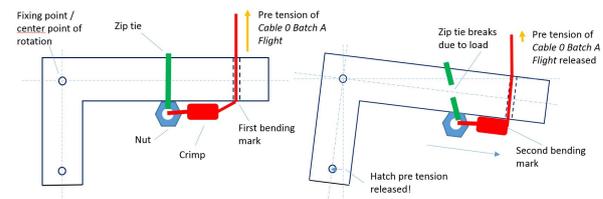
Figure 8: Sketch of possible slipping scenario of crimp on hook.

The failure investigation found that one of the cable crimps of the upper hatch was missing. It was determined that this probably led to the release of the hatch tray assembly. It was also demonstrated that a slipping of the

cable end compromises the pre-tension of the hook as depicted in Fig. 8. After the payload was recovered, one zip tie (lower hatch), which was intended to hold the cable end in place, was found broken in the module.

In case of future experiment modules with in flight-actuated hatches or FFUs, further guidelines have been elaborated. These guidelines involve technical recommendations and restrictions applied to the design of hatches and frames, the retention system including retention cables and cable ends, pyrotechnics as well as the verification process. In addition, management aspects and procedures have been revised in order to regulate late design changes and flight preparation. The updated guidelines can be found in the latest version of the REXUS User Manual [7].

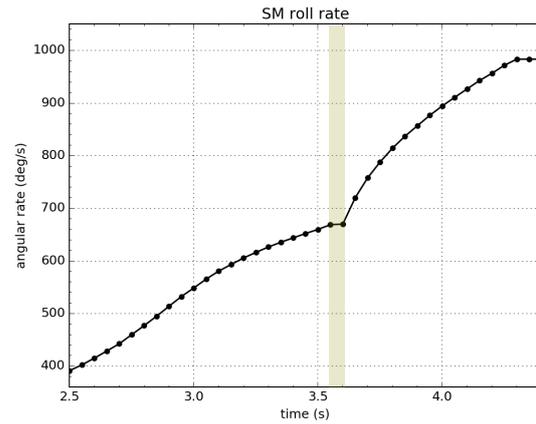
The most noticeable anomalies seen in the flight data were a discontinuity and steep increase of the roll rate at T+3.6 s as shown in Fig. 9. At the same time, pronounced spikes in the lateral rates have been detected. The time resolution of the SM data is limited to 50 ms.

Figure 9: Roll rate measured by SM. Within the highlighted time interval (T+3.55 s - T+3.60 s) which cannot further resolved by SM data, the slope of the roll rate changes significantly.

of the steep increase in the roll rate (Fig. 9) and the changes in the lateral rates. The measured roll rate could be reproduced in a simulation by assuming that the net fin incidence angle of all fins is increased by 0.1 deg from T+3.6 s onwards. A mechanism was reproduced that appears to be able to cause such change: the impact of a hatch on one of the Improved Orion fins.

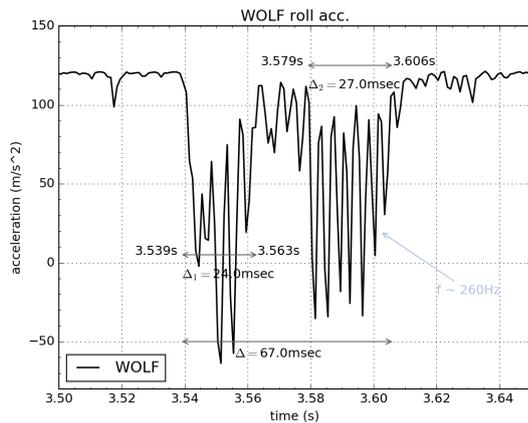
The assumption of an impact is supported by the two impulses recorded by the WOLF IMU. The first impulse around T+3.55 s is possibly associated to the detachment

Figure 10: Acceleration along roll axis measured by WOLF IMU.

of one of the hatches whereas the second impulse at $T+3.59$ s is possibly caused by an impact of the hatch on one of the fins. The derived event times are in line with the evaluated times of the video analysis presented in Fig. 4. Furthermore, a graphical analysis of the roll rate slopes before $T+3.55$ s and after $T+3.60$ s independently led to an event time which coincides with the second impulse measured by the WOLF IMU and which is interpreted as the impact of the hatch on one of the fins. Furthermore, these times are in agreement with the computed duration for a hatch transit between payload compartment and fin leading edge.
