FOREIGN OBJECT DAMAGE IMPACT TESTS ON SOUNDING ROCKET FIN STRUCTURES

15 years after Space Shuttle Columbia's disastrous foam strike accident, DLR's Mobile Rocket Base (MORABA) performed high velocity impact tests on two Improved Orion (IO) fin structures thus supporting the failure investigation of the REXUS-24 flight anomaly.

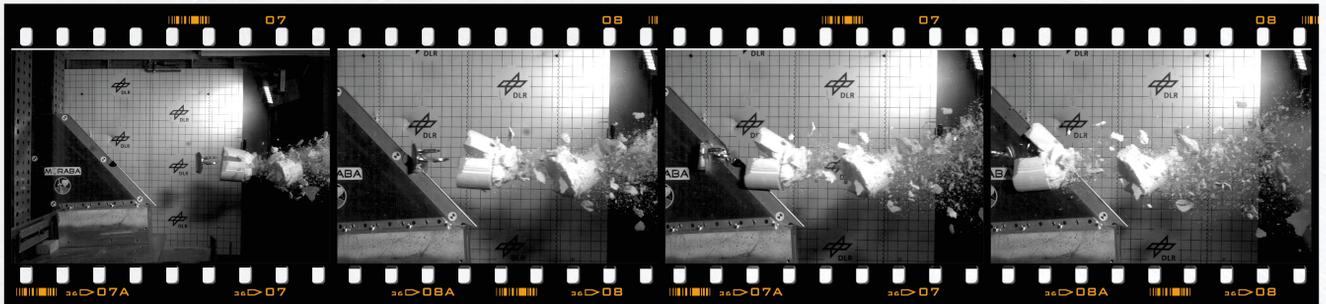
- Both fin assemblies were impacted at two leading edge positions each, one with a 0° and the other with a 2° angle of attack setting. For all shots the fin sweep angles were set to the original 45° .
- The impactor geometry was copied from a specific REXUS-24 experiment hatch design. Its previously calculated impact velocity was set to 260m/s.
- Depending on the impactor's predefined orientation the shot has been performed in original or downscaled configuration with comparable mass (320g) and inertia properties.
- All seven shots have been recorded by two high speed cameras, type Photron Ltd. Sa-Z Modell 2100K-M-16GB (30000fps, 1/40000 shutter, resolution 1024x688).

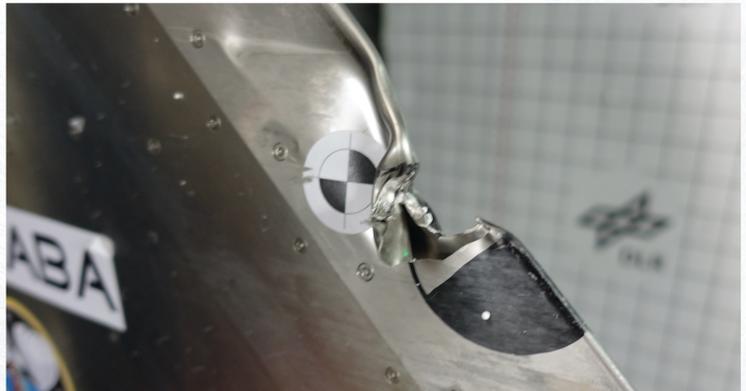
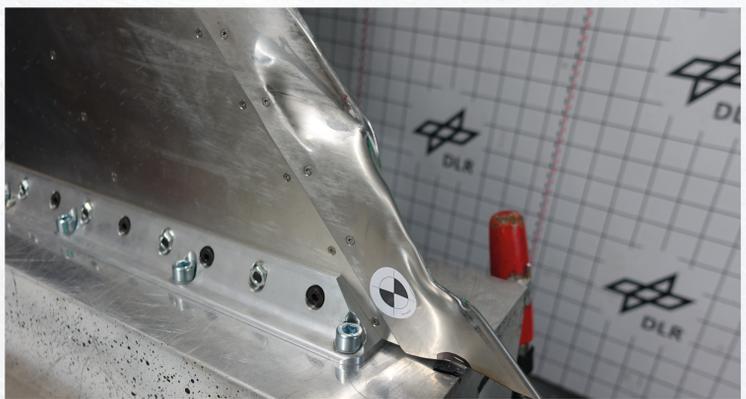
- All impactors showed a stable flight behaviour with an average measured impact velocity of 257m/s.
- After impact all damage patterns showed strong but local destruction from cuts, bents, buckles, scratches and dents. Grazing shots with only marginal damage are possible for some impactor orientations.
- Right after the point of impact none of the impactors showed noticeable deflection or deceleration. All impactors disintegrated in several large pieces which stayed together in close formation on their predefined flight path.

Effective failure can be induced however its failure mode is strongly dependent on the impact scenario. A complete disintegration of the fin structure seems rather unlikely by the given boundary conditions.
