International Conference on Concentrating Solar Power and Chemical Energy Systems,
SolarPACES 2014

Durability testing of silvered-glass mirrors

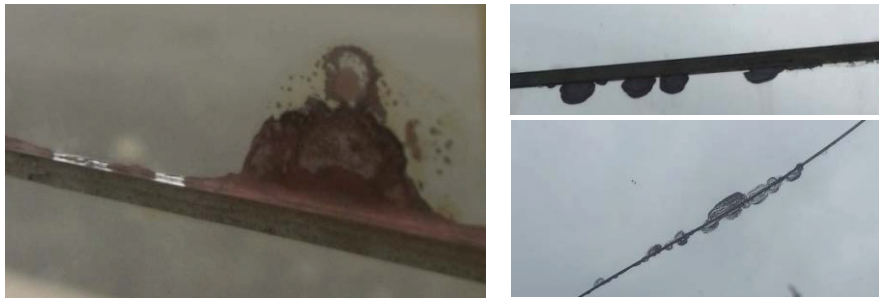
The samples exposed outdoors showed degradation in the field after only two to three years of service. Sample 'C 1' is a silvered-glass mirror of 1 mm glass thickness which is glued to a backing structure. The mirror is installed in a parabolic-trough collector at the PSA in Tabernas, Spain and shows edge corrosion up to 12 mm after approximately two years of outdoor operation (see Fig. 2). The conducted SEM analysis of a cross section of the edge corrosion revealed that the silver layer close to the edge is completely dissolved. EDX mapping showed that further along the edge round silver chloride particles were found as corrosion product (see Fig. 3 d). Delamination occurs in the glass-silver interface. Accelerated testing was performed without the collector backing structure and adhesive.

Fig. 2: Photographs of edge corrosion of material 'C 1' during outdoor operation of approximately 2 years at PSA, Tabernas, Spain.

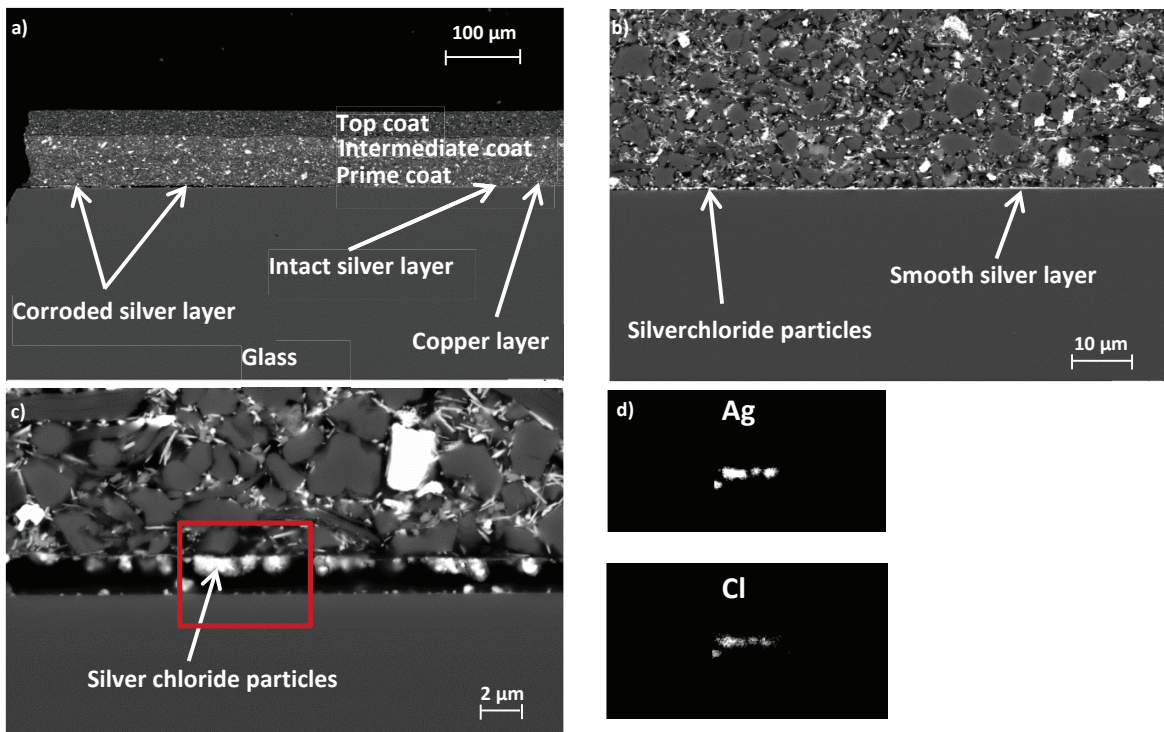
Fig. 3: SEM analysis of material 'C 1' after outdoor operation of approximately 2 years at PSA, Tabernas, Spain. a) cross section of edge corrosion, edge is shown left; b) silver corrosion at end of edge corrosion; c) detail of silver corrosion showing silver chloride particles as corrosion product, d) EDX mapping showing that Ag and Cl are found in identical locations.

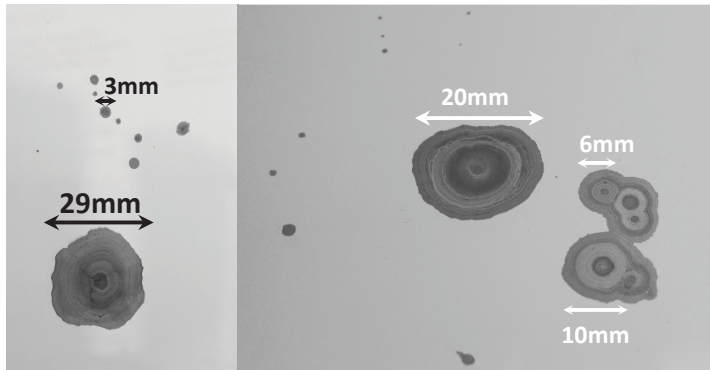
Sample 'C 2' is a silvered-glass mirror of 4 mm glass thickness which was approximately three years in operation in the heliostat field of CSIRO in Newcastle, Australia. It consists of a reflective silver layer which is protected by only two paint layers (see Fig 5 top left). An EDX line scan revealed that the mirror lacks the usually employed copper layer which acts as UV protection and bonding layer between the silver and the paint layers. The mirror showed several pitting corrosion spots of diameters up to 29 mm, with an average diameter in the range 6 – 8 mm (see Fig. 4). EDX mapping of the cross section revealed the presence of chlorides and sulfates within the corroded area. Pinholes in the top coat have been found by SEM inspection from the back side (see Fig.5 lower right). The

Fig. 4: Photographs of material 'C 2' during outdoor operation of approximately 3 years at CSIRO, Newcastle, Australia.

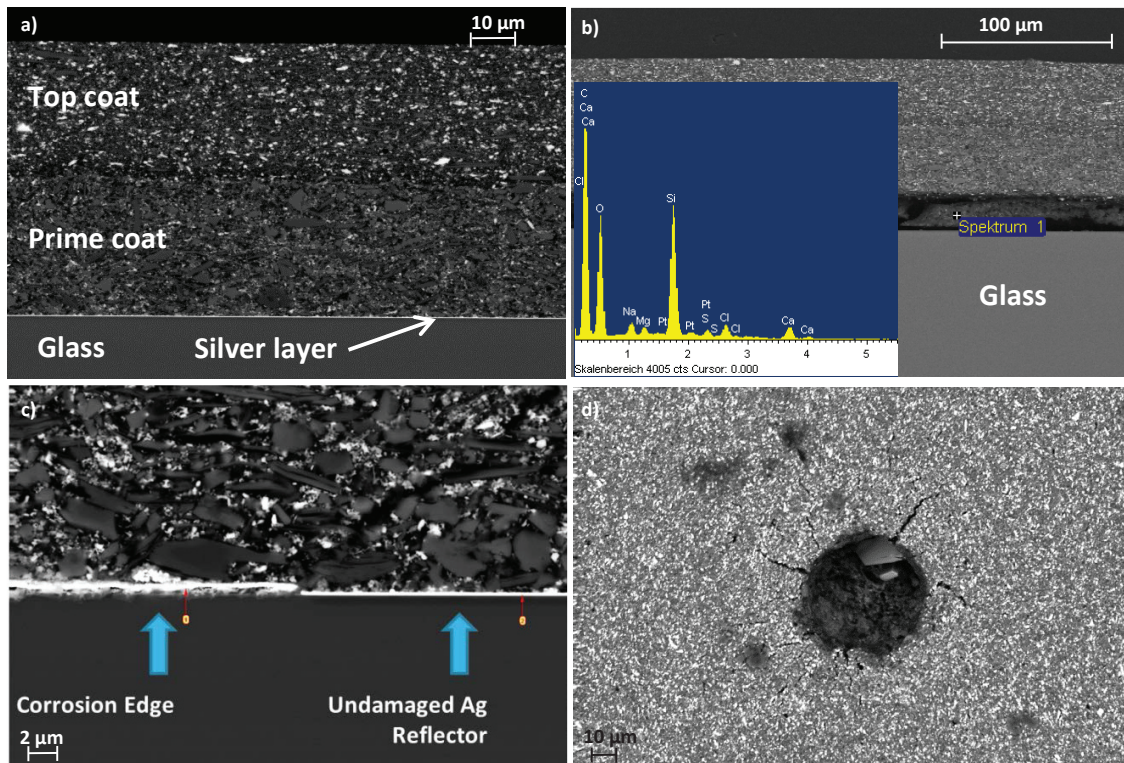
Fig. 5: SEM analysis of material 'C 2' after outdoor operation of approximately 3 years at CSIRO, Newcastle, Australia. a) layer structure of non-degraded mirror area; b) cross section through local corrosion spot, the EDX analysis shows presence of chloride in the delamination gap; c) detail of silver corrosion at edge of spot; d) top view of pinhole in top coat.

pinholes from the back side could be associated to the silver corrosion from the front side. The cross section analysis through the corrosion spot revealed that delamination occurred in the silver-paint interface, which is probably due to the lack of the copper layer or due to localized defects in the paint layer.

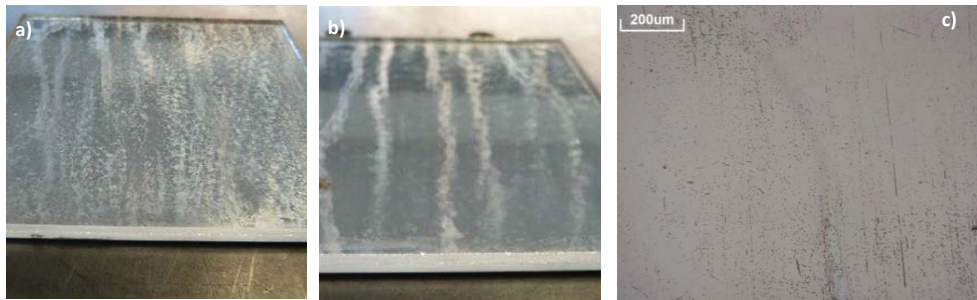
After 500 hours of damp heat and NSS testing and after 1500 hours of UV+Humidity testing first signs of glass corrosion can be appreciated on samples from different manufacturers. The glass corrosion increments severely with time for some samples, especially for 'A 1' in the NSS test (see Fig. 7), where specular reflectance decay is mainly due to scattering and absorption effects at the corroded glass rather than a degradation of the silver layer.

Fig. 7: a and b) Glass corrosion on 'A 1' samples after 3000 hours of NSS testing; c) Microscopic view of glass surface

Specular reflectance measurements as a performance indicator of the mirror quality during accelerated testing is problematic because of severe glass corrosion at elevated testing times. Glass corrosion reduces specularly significantly and it has not been observed during outdoor exposure. As a consequence, glass corrosion should be suppressed in accelerated testing, for example by protecting the glass front side with sealing films.

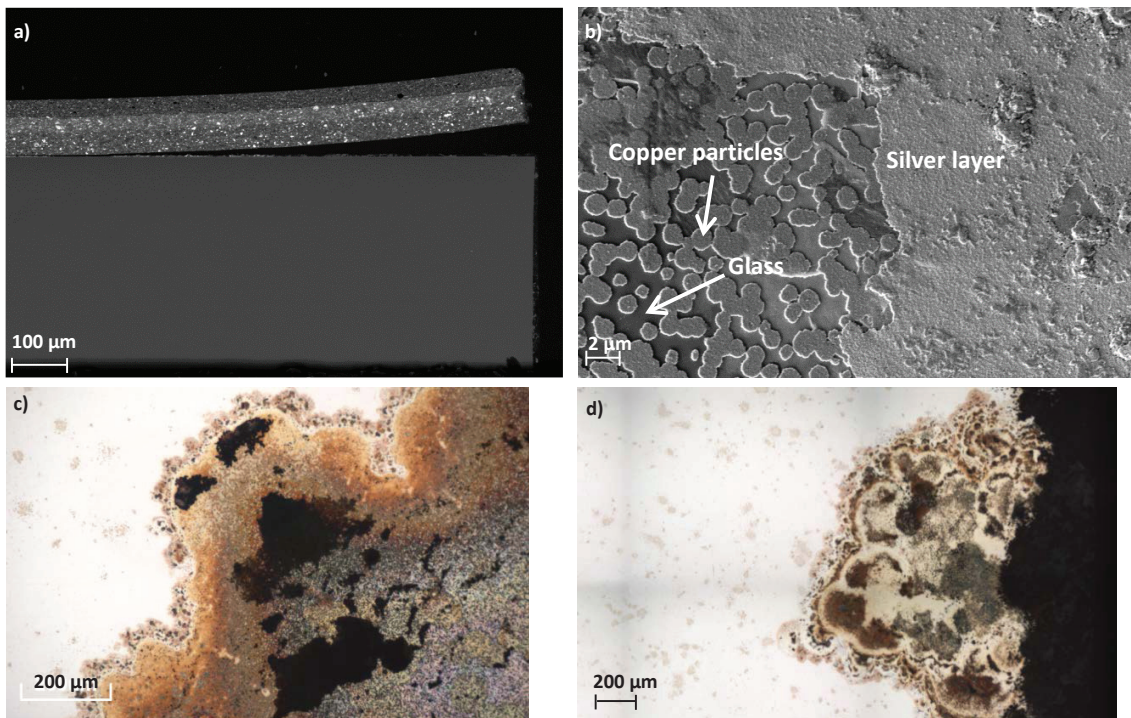
The detected edge corrosion observed outdoors of samples 'C 1' was reproduced by thermal cycling testing in combination with 2000 hours of damp heat (compare Fig 8 to Fig 3). A top view on the glass surface from which the paint layers delaminated revealed the presence of round shaped copper containing particles and remaining rests of silver by EDX analysis. The copper particles seem to deposit directly on the glass surface where the silver is corroded. The diffusion process of copper into the silver layer indicates that the testing temperature of 65°C might be inappropriate to reproduce the silver corrosion mechanism realistically. Copper diffusion into the paint layer has also been reported during NSS testing in [11].

Fig. 8: a) Cross section of edge corrosion of sample 'C 1' after 2000 hours of Damp Heat testing; b) Top view of glass surface after delamination of paint layers in corroded area close to edge; c and d) light microscopic view of edge corrosion

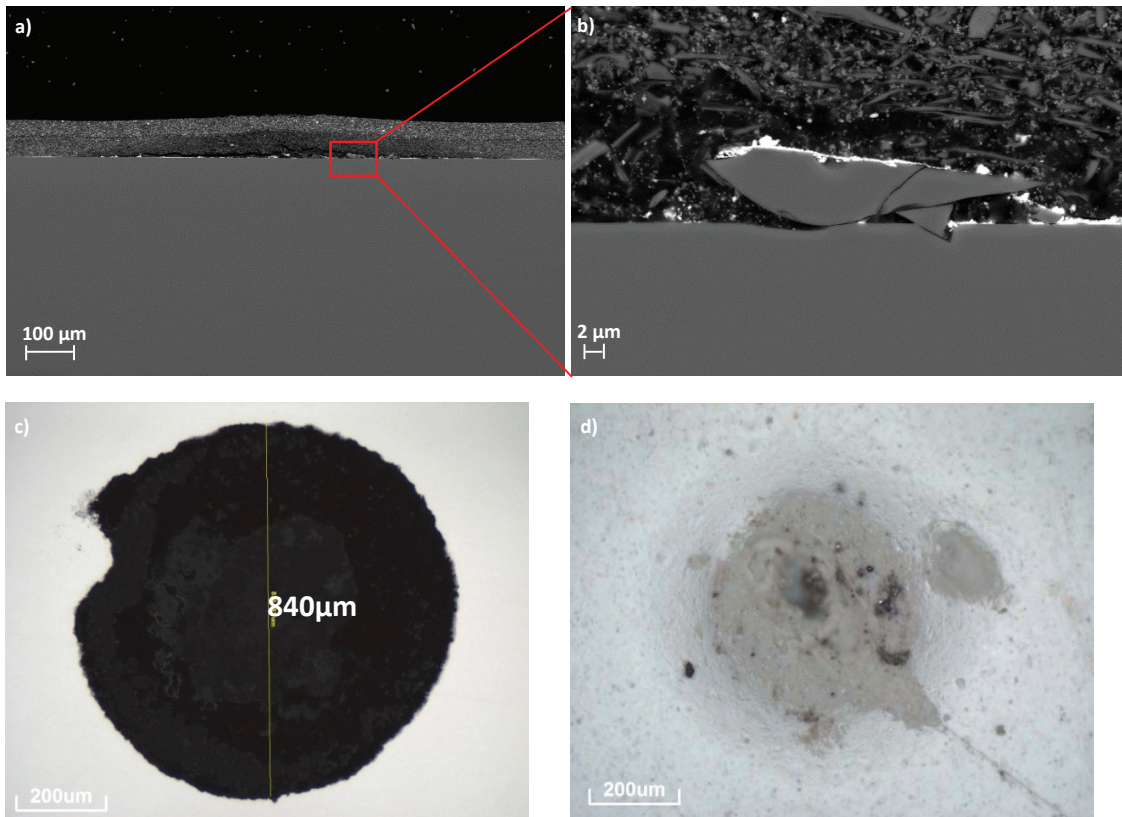
The detected pitting corrosion spots outdoors of ‘C 2’ samples were best reproduced in the CASS test. Fig. 10 shows a SEM cross section analysis after 480 hours of CASS testing (compare to Fig. 5). Only two pitting corrosion

spots were found on the two samples tested. The size of the pitting corrosion spots was measured with the light microscope to be 840 and 300 μm . Thus, 480 hours of CASS testing does not seem to be enough to reproduce the 3 years outdoor exposure as spot sizes and spot density are smaller than in outdoor exposure. Fig 10 shows a glass splint close to the center of the corrosion spot. The glass splint seems to be a manufacturing defect (it is coated with silver from the top, see Fig 10 b) and might be the starting point of the localized corrosion spot. On the other hand, a sample preparation artefact is unlikely but cannot be completely excluded.

Fig. 10: a) Cross section of corrosion spot of 'C 2' sample after 480 hours of CASS testing; b) glass splint in the glass-silver interface; c) light microscopic view of corrosion spot from glass side; d) corresponding pinhole in top paint layer viewed in the light microscope.
