Standardizing Accelerated Aging Testing Conditions for Silvered-Glass Reflectors

Johannes Wette, Florian Sutter, Arantxa Fernandez,
Radia Lahlou and Peter Armstrong

SolarPACES 2017 Santiago de Chile

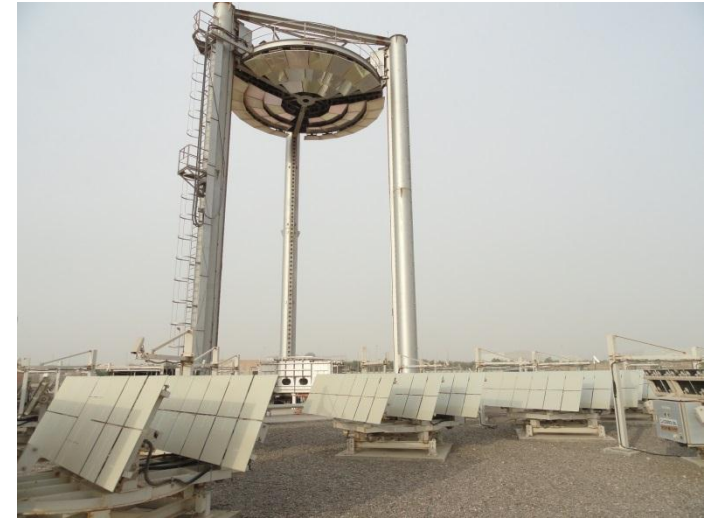
Outdoor facet

- Degradation on all of the 1419 installed facets
- Ranging from little to very severe degradation
- Microscopic analysis shows similar patterns known from other mirrors where silver layers gets attacked
- For details on the material composition and degradation:
“Study and Comparison of Naturally-Aged and As-Received Silvered-Glass Reflectors”

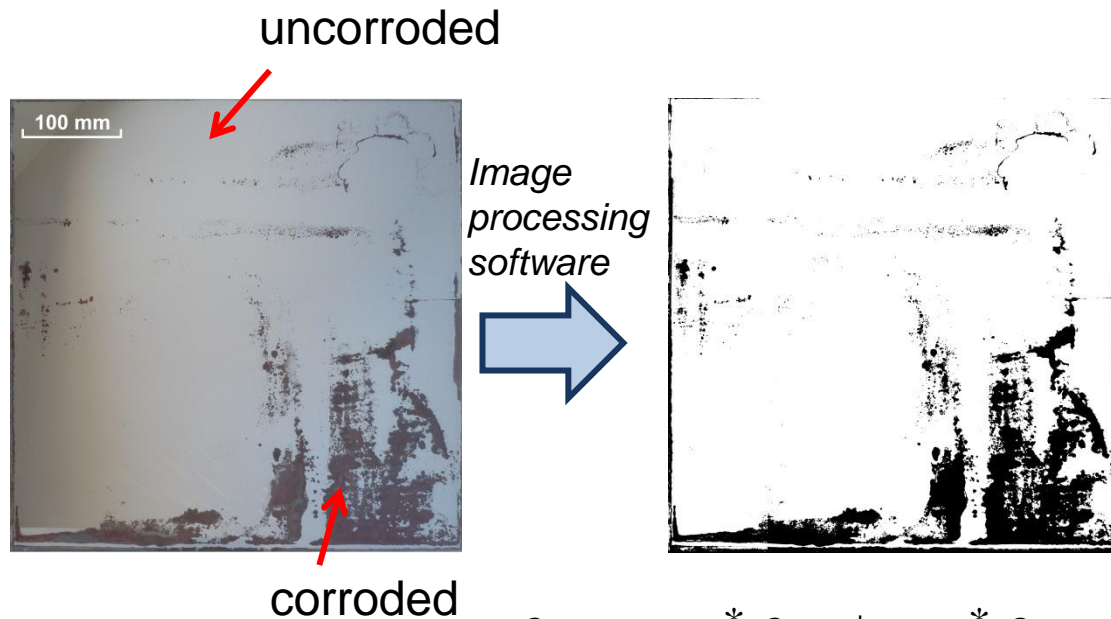
- 14.1% of facet corroded

- $\rho_{\text{non}} = 0.838 \pm 0.003$

- $\rho_{\text{deg}} = 0.103 \pm 0.049$

$$\rho_{\text{tot}} = a_{\text{non}} * \rho_{\text{non}} + a_{\text{deg}} * \rho_{\text{deg}} = 0.859 * 0.838 + 0.141 * 0.103 = 0.734$$

Total specular reflectance
loss of 0.112

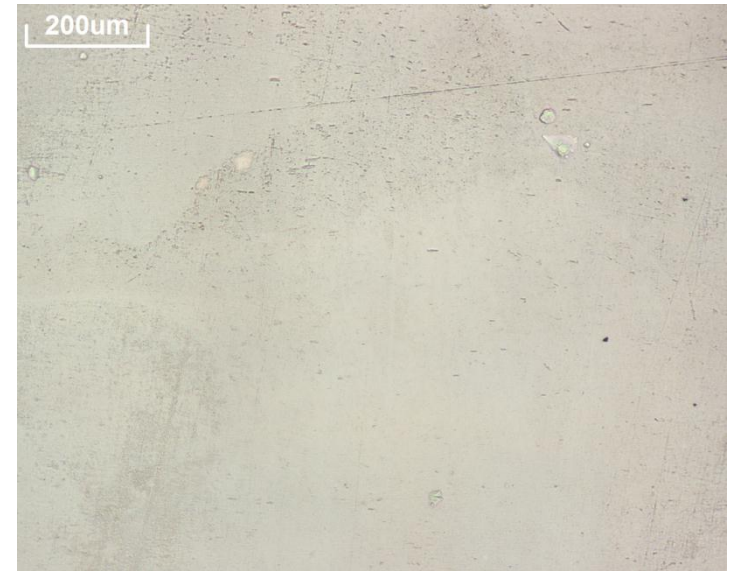
- Strongest reflectance drop of all tests (hemispherical and specular)
- Glass corrosion
 - Known degradation of glass surfaces in high humidity environments
 - Usually not detected outdoors
- Minimal edge corrosion
- Total testing time more than 4x AENOR

Glass surface corrosion

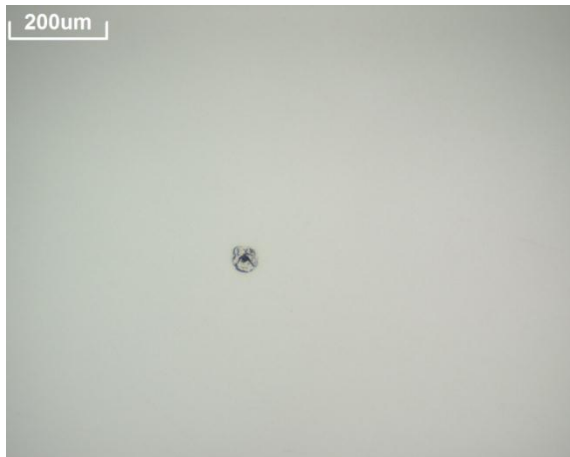
- Very aggressive corrosion test
- Only very minor degradation after testing
- Total test duration 4x AENOR

Appearance of microscopic, stable spots

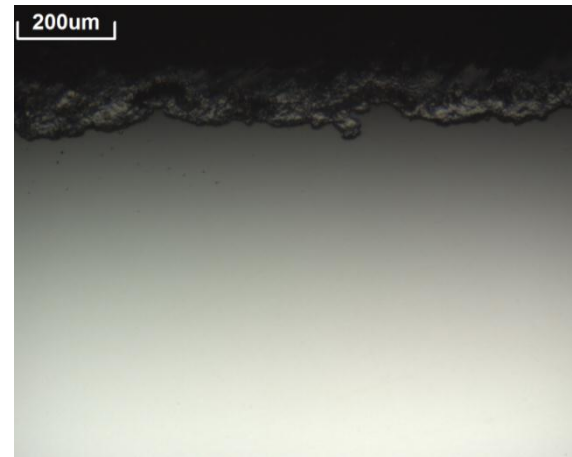
Beginning edge corrosion on micrometer scale

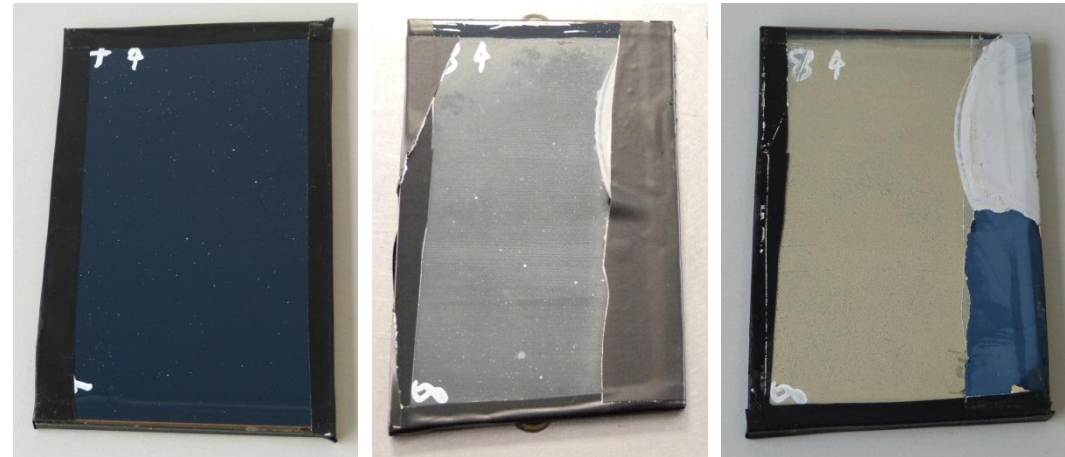
- Severe attack of the backside coating exposed to chamber
- No considerable degradation of the silver layer on both samples
- Minimal edge corrosion

initial

350h

3000h

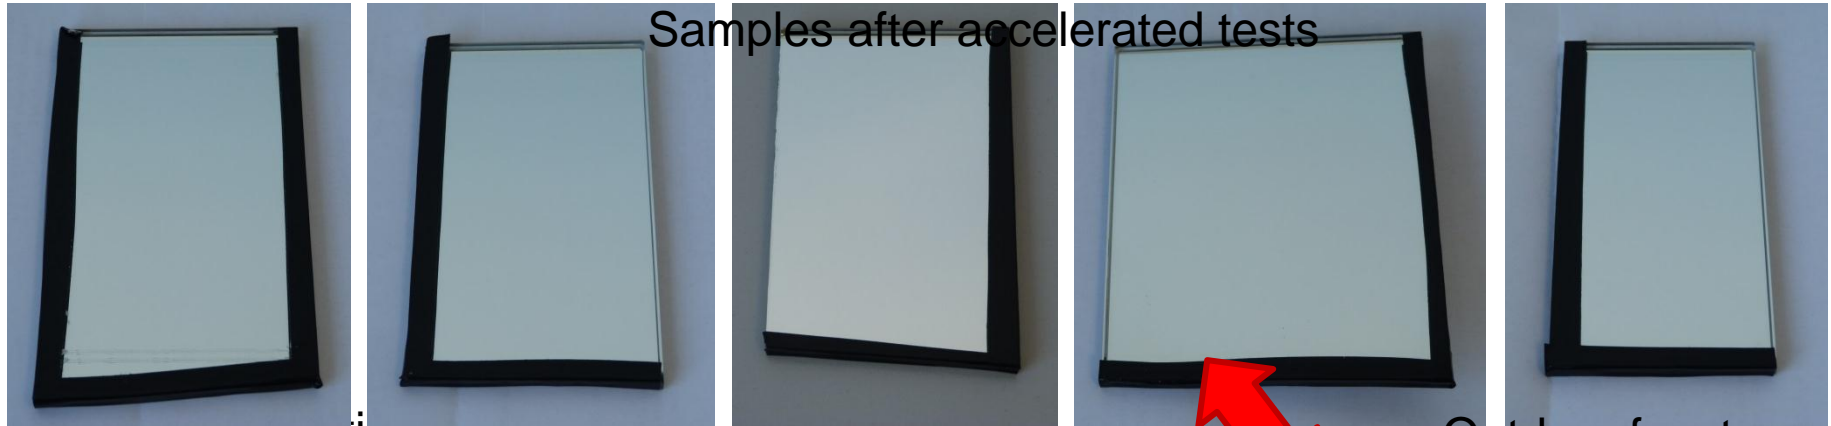
- Standardization of testing is a good progress
- Degradation found during exposure is not reproduced by accelerated tests
- Test procedure is unable to identify weak material
- Samples from all 5 accelerated tests
- No macroscopic degradation for AENOR

Testing and parameters have to be optimized
