COMPUTED TOMOGRAPHY FOR NON-DESTRUCTIVE INSPECTION OF HOT STRUCTURES AND TPS COMPONENTS

Thomas Ullmann, Raouf Jemmali, Severin Hofmann, Thomas Reimer,
Christian Zuber, Kornelia Stubicar and Hendrik Weihs

*German Aerospace Center (DLR)
Institute of Structures and Design, Pfaffenwaldring 38-40, 70569 Stuttgart (Germany)
For correspondence: Thomas.Ullmann@dlr.de*

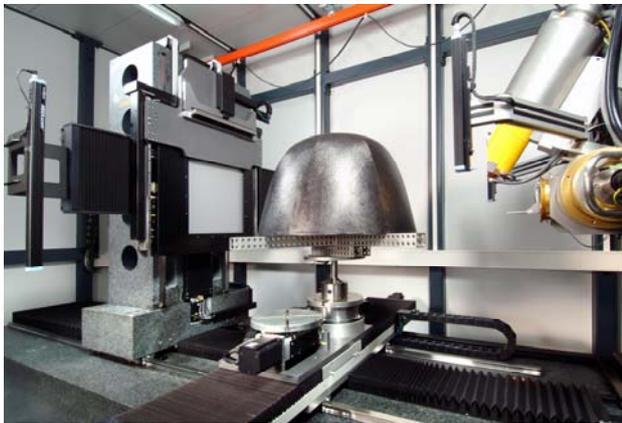
Fig. 1. Large CT test facility with the C/C-SiC nose cap structure of EXPERT mounted inside (DLR Stuttgart)

Since January 2008, DLR is operating two CT test facilities at the research centre in Stuttgart. With the v|tome|x L450 facility (Fig. 1), it is possible to scan large structure components. The maximum scanning range is up to 800 mm in width and 1100 mm in height. The CT facility is provided with two X-ray sources: the 240 kV microfocus and the 450 kV high power minifocus tube which are basically differing in the size of the focal spot diameter. The pixel size of the flat panel detector array is 200 μm . Like a digital image is composed of a two-dimensional matrix of numerous small dots (pixels), a CT scan is consisting of a three-dimensional cloud of numerous dots (with up to ≥ 65000 different grey values) that are so to say volume pixels or just “voxels”. With a focal spot diameter of $3 \times 5 \mu\text{m}$ (microfocus), it is possible to attain a minimum voxel size of approximately 5 μm . The voxel size V is given by:

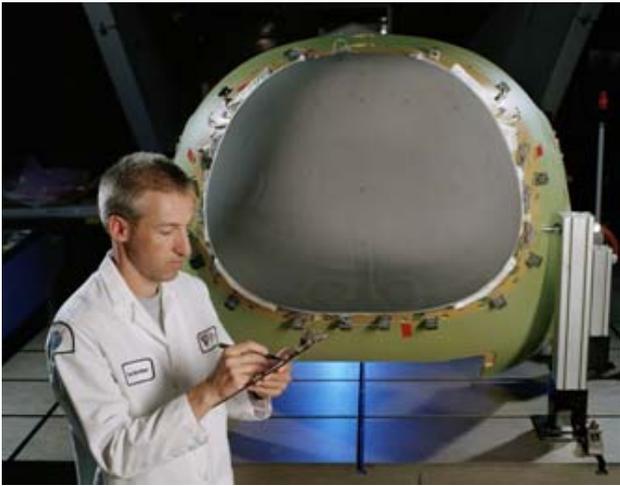
Fig. 3. DLR's C/C-SiC structure mounted on the nose tip of the X-38 vehicle (Johnson Space Center, Houston, TX)

About ten years ago, the CMC nose cap structure of the X-38 reentry vehicle was designed and manufactured at DLR. The whole nose assembly – including the chin panel, the CMC nose skirts and a full set of US made insulation tiles – was fully integrated, tested and qualified as flight hardware according to NASA standards (Fig. 3) [1,2]. The C/C-SiC nose cap structure was manufactured by using the liquid silicon infiltration process (LSI) which was developed and established at DLR’s Institute of Structures and Design before [3]. The C/C-SiC shell was provided with eight anchorage points at the interior side (Fig. 4) for mounting the load introductions which were connecting the nose cap with the vehicle’s aluminium substructure. The C/C-SiC anchor attachments and pressure port plugs were joined to the nose cap shell by using a special in-situ technique which is an integrated step in the manufacturing process. The thin interface layer which connects both CMC parts is consisting of SiC and no carbon fibres are passing through. During the flight, the mechanical loads would be transferred through these interfaces and so one of the pivotal questions was: is the bonding quality of the interface layer sufficient? For this specific task the nose cap structure with its potentially

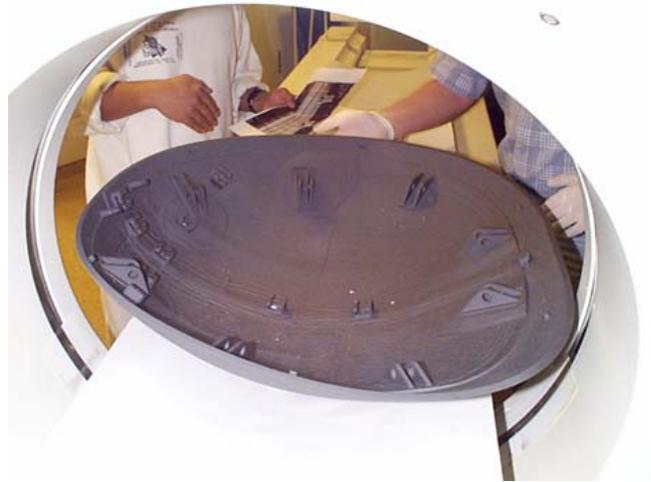
Fig. 4. C/C-SiC nose cap structure during inspection in a medical CT facility (Klinikum Heilbronn, Germany)

failure critical joining interfaces was inspected within a medical CT facility at a hospital near the city of Heilbronn (Fig. 4). Figure 5 shows one of several hundred two-dimensional CT cross sections of the nose cap structure with two of the CMC load introduction clamps. The dashed section marks the region which is shown in a close up view beside (Fig. 6).

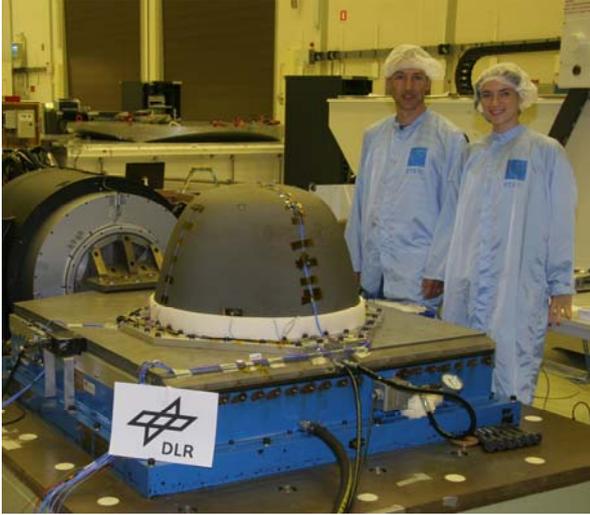
Fig. 7. EXPERT's C/C-SiC nose cap structure during a shaker test at ESTEC (Noordwijk, NL)

With the development of EXPERT's CMC nose cap structure another design for the load introduction was favoured. The C/C-SiC nose cap is approximately 700 mm in diameter (Fig. 7). It is attached to the substructure with 16 load introductions and the so called C/C-SiC hat profiles are the anchorage points that are joined to the interior side of the

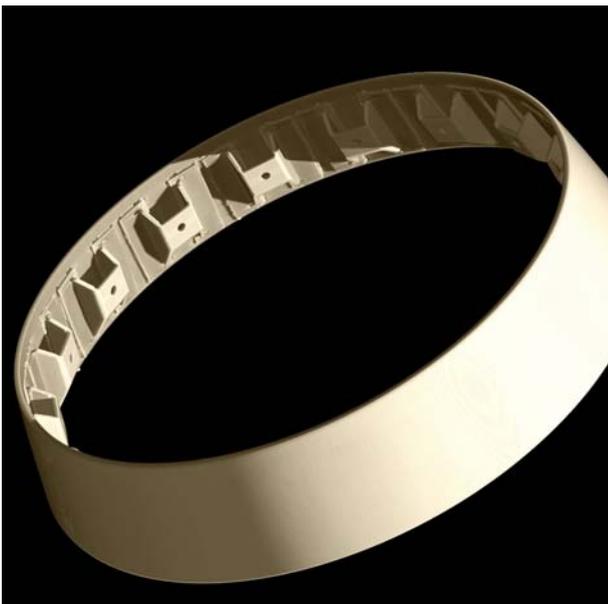
Fig. 9. 3-dimensional CT image, showing a part of the EXPERT nose cap structure with the CMC hat profiles

With respect to the structure component's size, it has to be considered that the non-destructive inspection technique which will be used for qualifying flight hardware must allow detailed investigation of relatively confined regions which are located at almost inaccessible areas. As shown in Figure 9 and 10, the CT inspection facilities of DLR are fulfilling this demand. Figure 9 shows a three-dimensional false colour view of the complete nose cap's load introduction rim. This image is a calculated three-dimensional reconstruction of more than 4000 two-dimensional X-ray projections. Each of the visible C/C-SiC hat profiles was inspected separately with much higher resolution. In contrast to the very first CT investigations with the nose cap structure of X-38 some years before (Fig. 5 and 6), it is now possible to obtain detailed insight in the laminate's microstructure and the in-plane porosity distribution of the SiC joining interface. Previous work with the nanotome CT facility has shown that it is even possible to inspect the microstructure of cracks and to pay attention to single carbon fibre filaments [4]. Figure 12 shows the porosity within a hat profile's joining interface.

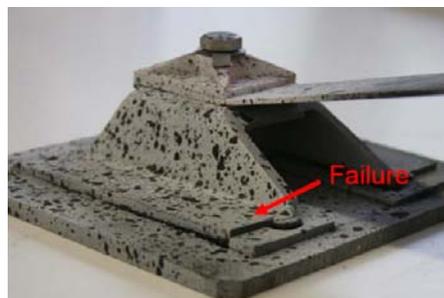
Fig. 17. Mechanical failure by debonding within the joining interface

From a first comparison between the CT image analysis of the interface layers (Fig. 19-21) and the failure type (Fig. 17 and 18) that was observed as a result of the mechanical test of each specimen, it becomes obvious that the mechanical failure must be in connection with the degree of porosity and the porosity distribution within the bonding respectively. A high quality of the interface layer – which means that there is no porosity detectable at all – leads to a failure type of

Figure 16 shows that the orientation of the load introduction (axial force vector \vec{F}) is not exactly parallel to the bonding layer. That is why the first separation of most debonded specimens appears at the upper region of the interface bonding layer (Fig. 17). From this point it seems quite clear that in terms of structural stability of the load introduction in general and the bonding quality in particular, is not only a question of the amount of porosity and the statistical pore size

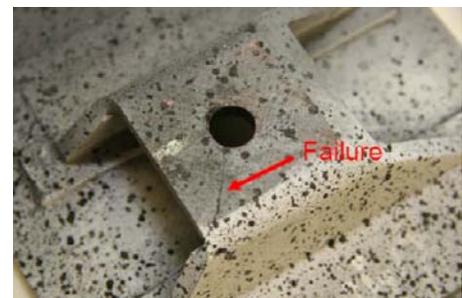
Fig. 18. Mechanical failure within the CMC material (cracking)
