Testing of DLR C/C-SiC for HIFiRE 8 Scramjet Combustor

7th European Workshop on Thermal Protection Systems and Hot Structures
8-10 April 2013
ESA/ESTEC, Noordwijk, The Netherlands

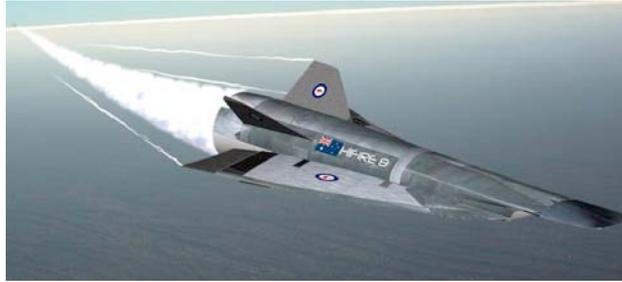
Figure 1: Schematic of the HIFiRE 8 flight vehicle

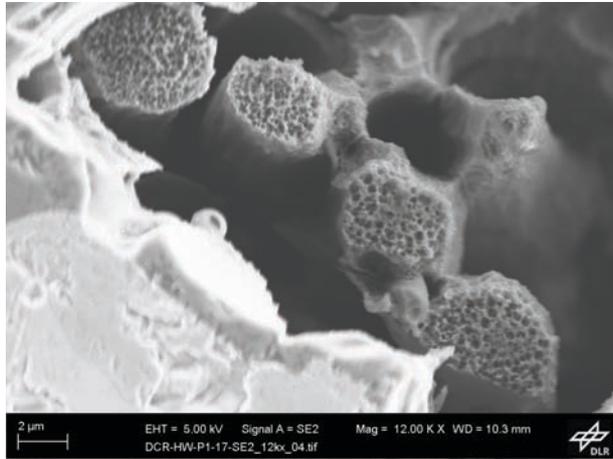
Figure 10: SEM image of fiber ends that have a rough cross-section which is interpreted as the effect of oxidation.

The conclusion is that there was some oxidation on the surface of the panel, but limited to only the topmost one or two layers, with no significant degradation of the panel.
