Master Thesis

Laser-induced contamination on high- reflective optics

University of Applied Science Darmstadt
DLR - German Aerospace Center
(Deutsches Zentrum für Luft- und Raumfahrt)

February 2014

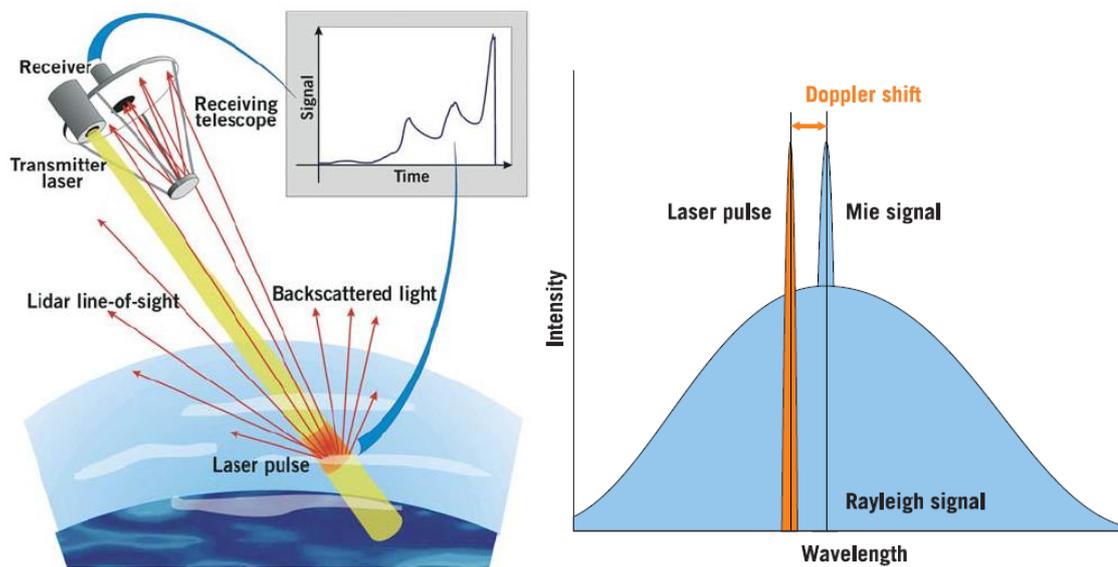
Figure 1.1: (Left): Schematic view of a space-borne LIDAR. A short laser pulse is emitted towards the atmosphere where air molecules and particles reflect a small portion of the light pulse back to the LIDAR. A telescope collects the light and directs it to the receiver. The signal is recorded as a function of time to determine the altitude of the scattering layers. (Right): The relative motion of air leads to two effects - the center frequency of the backscattered light is shifted proportional with the wind velocity in the measurement direction, and the random motion of the air molecules leads to a broadening of the frequency width for the backscattered Rayleigh signal. Images taken from ADM-Aeolus Science Report [3].

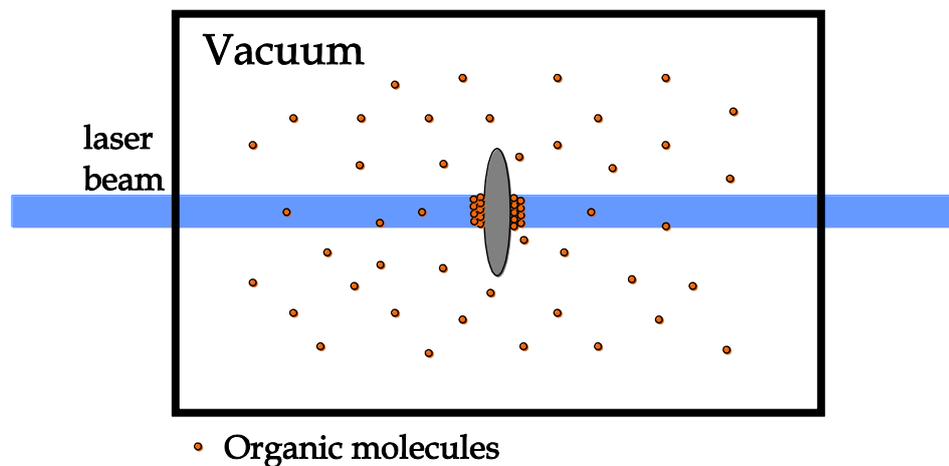
Figure 2.1: During the contamination process in vacuum organic molecules deposit on the optical surfaces irradiated by the laser beam.

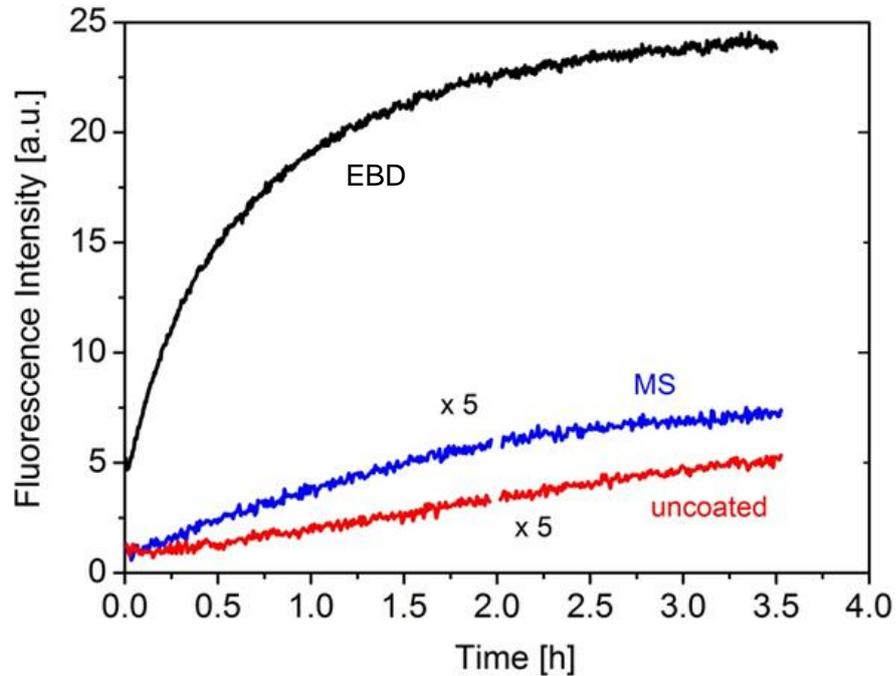
Figure 2.2: Samples with anti-reflective coating (EBD and MS) show stronger laser induced fluorescence from the deposit, and therefore more contamination, than uncoated fused silica samples. EBD samples show more contamination than MS samples. Tested under 0° angle of incident with fluence of $7\text{mJ}/\text{cm}^2$ and under 3.5×10^{-4} mbar naphthalene contamination pressure. AR coatings made for 355nm wavelength. Taken from Schröder et al. [16].

Magnetron Sputtered (MS) samples, see **Figure 2.2**. Uncoated samples showed lower contamination compared to MS or EBD samples.

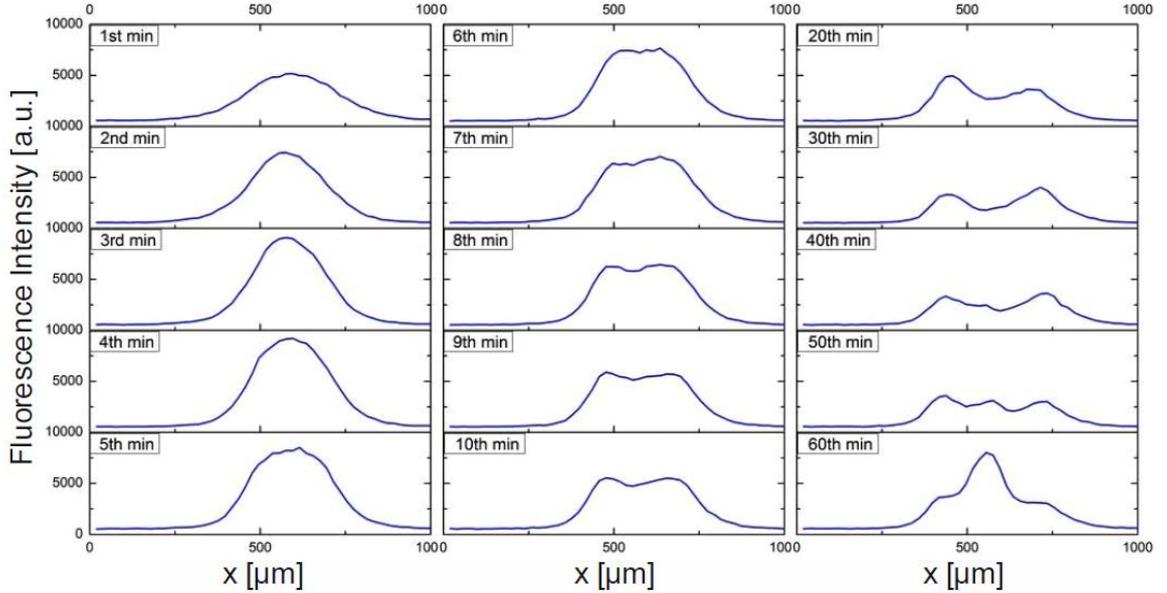
Figure 2.3: Deposition measured by in-situ monitored laser induced fluorescence images as a function of time from top to bottom and left to right. Test conditions: EBD, 0.60 J/cm^2 , 1000 Hz , 3.6×10^6 pulses, $3.5 \times 10^{-4} \text{ mbar}$ Naphthalene. Figure taken from [1].

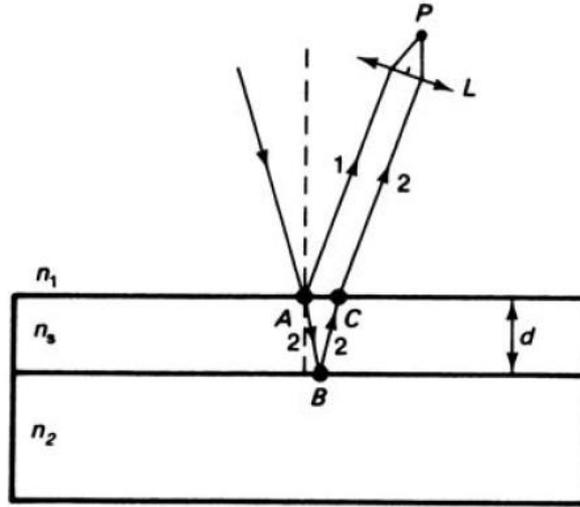
Figure 2.4: A simple anti-reflective coating consisting of one layer can be described with two ray interference on thin layers. The ray reflected on first interface (1) interferes with the ray reflected on second interface (2). Image taken from [4].

To realize an AR coating the destructive interference condition needs to be met. The interference is destructive if the optical path difference $\Delta\tau$ of two beams is an odd manifold of half the wavelength λ . Image taken from reference [4].

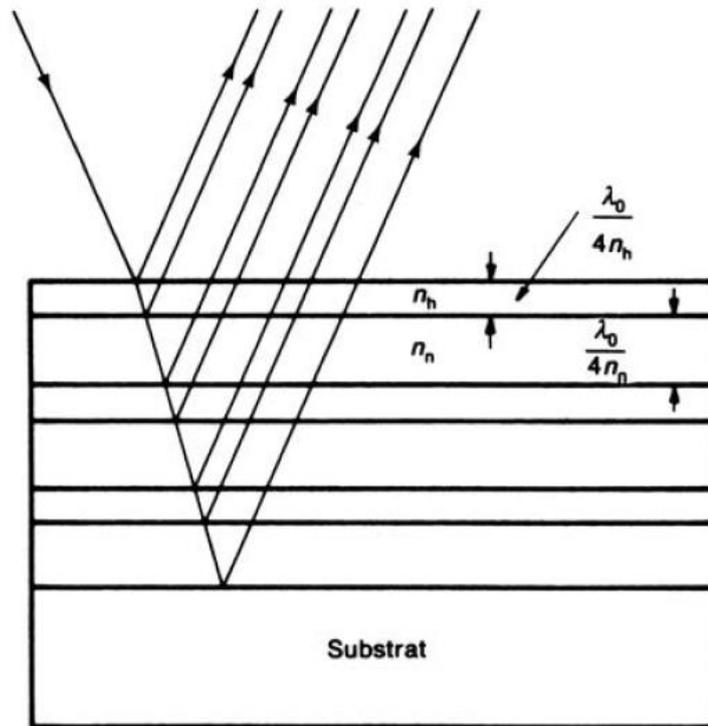
Figure 2.5: A dielectric mirror consists of periodical layers with alternating high n_h and low refractive indices n_n . Figure taken from [4].

By using layers periodically with alternating high n_h and low refractive indices n_n the reflected light from each layer interferes constructively with light reflected from other layers.

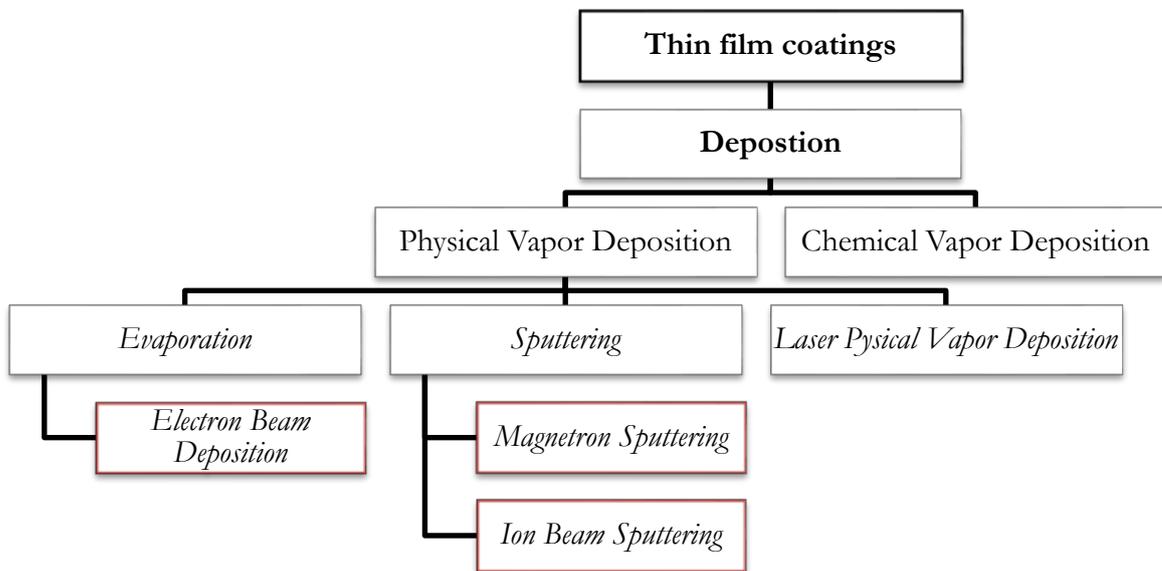
Figure 2.6: Organogram of different techniques to produce thin films. Only those processes are shown which are of interest.

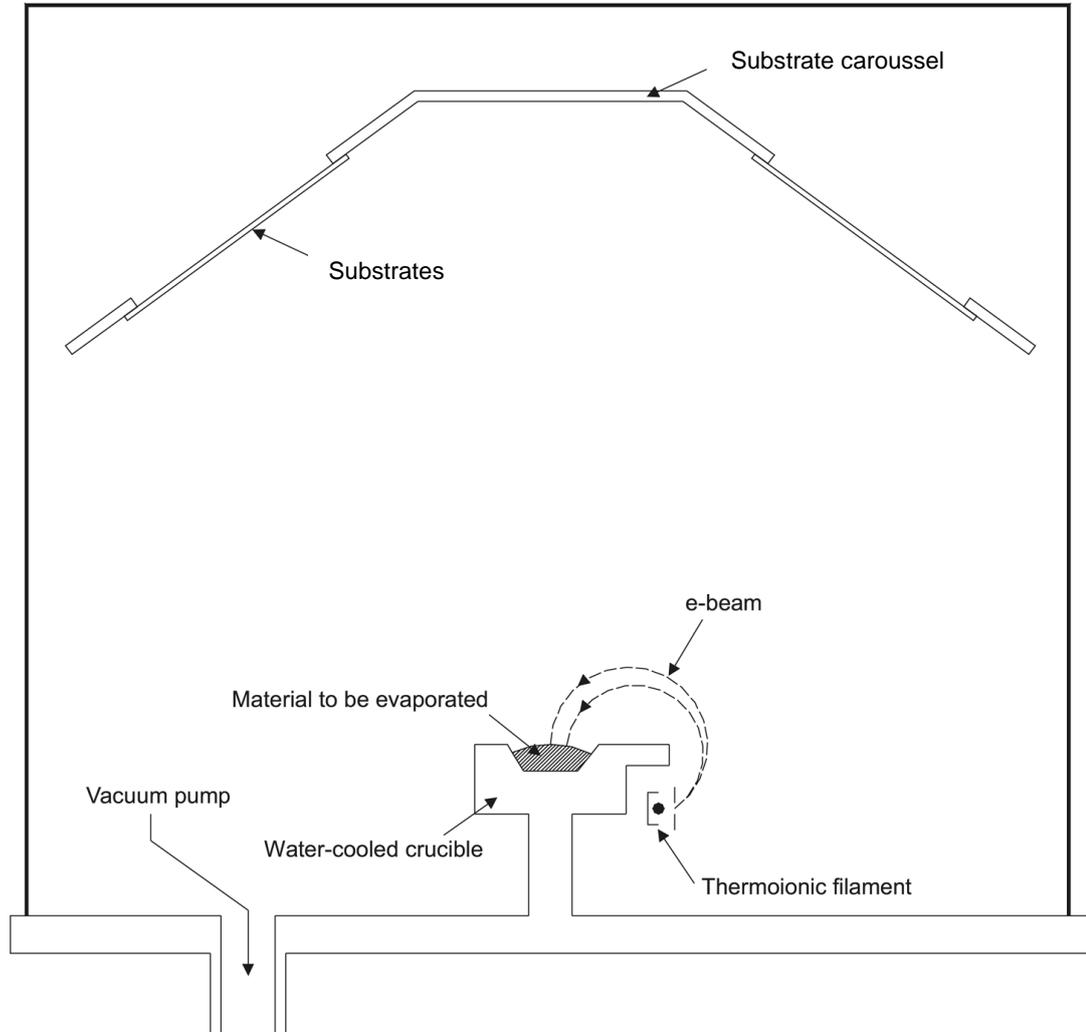
Figure 2.7: In electron beam deposition process target material is evaporated by electron beam and deposits on substrates. The circular electron beam is due an electromagnetic field. Image taken from [6].

Electron Beam Deposition (EBD) is widely used for laser optics. It is one of the most common processes for producing optical coatings [10]. An electron beam heats the coating material which then evaporate, see **Figure 2.7**. These atoms have a low kinetic energy of 0.1-0.3eV.

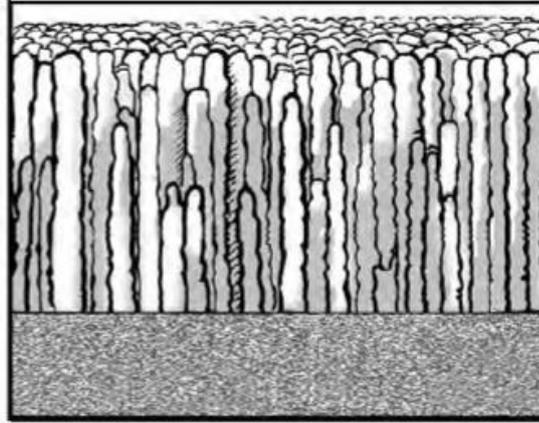
Figure 2.8: Columnar growth of EBD coatings. Image taken from [11].

During deposition on the substrate micro crystals condense in direction perpendicular to the substrate surface and form columnar structure, see **Figure 2.8**.

The resulting layers are porous with a low compactness of 90%. EBD show a high laser induced damage threshold (see **Table 2.1**) which makes them suitable for laser applications. But in the porous layers of the coating gases of the atmosphere (like water) is adsorbed. Therefore EBD coatings show a so called vacuum effect, the diffusion of water and gas in and out of the layer. This mechanical stress reduces laser induced damage threshold and makes the coatings unsuitable for space applications. The coatings show a temperature drift of the reflected wavelength and high tensile stress due to water diffusing in and out of porous layers. EBD is a very effective technique which has a high reliability and allows mass production. But defect density of the coating is high with more than 100 defects per cm^2 [11].

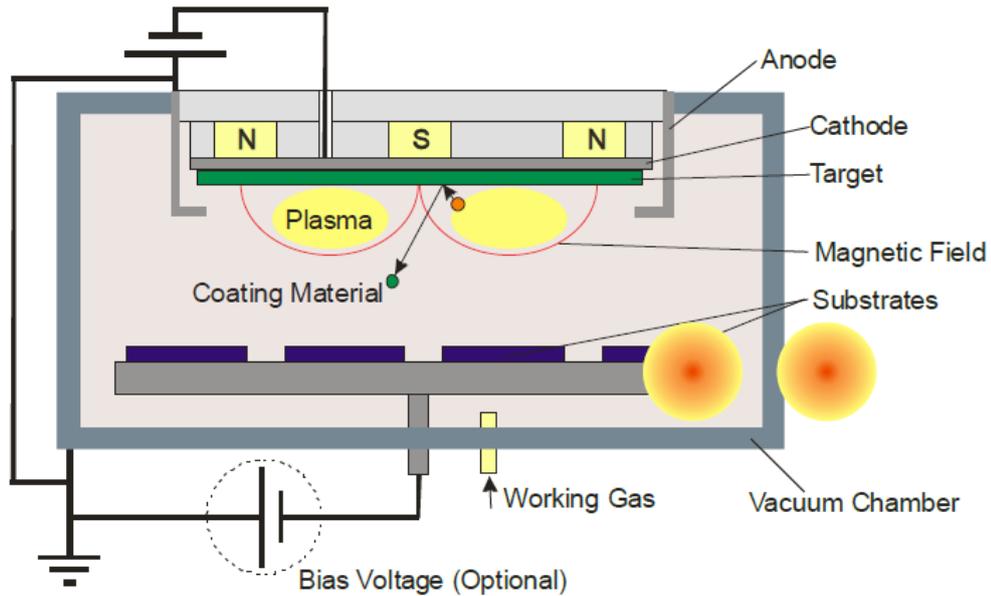
Figure 2.9: Schematic drawing of Magnetron Sputter system. The electric field accelerates Ar^+ ions towards the target which causes the coating material to be sputtered onto the substrate. Image from [7].

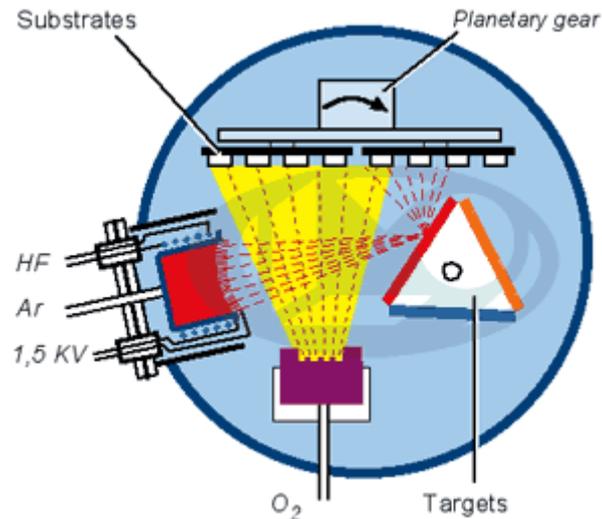
Figure 2.10: Ion beam deposition technique accelerates ions in collimated beam onto a target. By this, material is sputtered onto the substrate. The injection of oxygen allows the target material to oxidize. Image from [11].

Ion Beam Sputtering (IBS) utilizes an ion source to generate a focused ion beam directed at the target to be sputtered, see **Figure 2.10**. The ion source consists of a cathode and anode with a high voltage of 2-10 kV creating an electrostatic field inside the ion source. When argon gas is injected into the ion source, the high electric field causes the gas to ionize, creating plasma inside the source region. The Ar^+ ions are then accelerated from the anode region to the exit aperture (cathode) forming a collimated ion beam. The resulting ion beam impinges upon the target material and, via momentum transfer between the ion and the target atoms, sputters this material onto the sample.

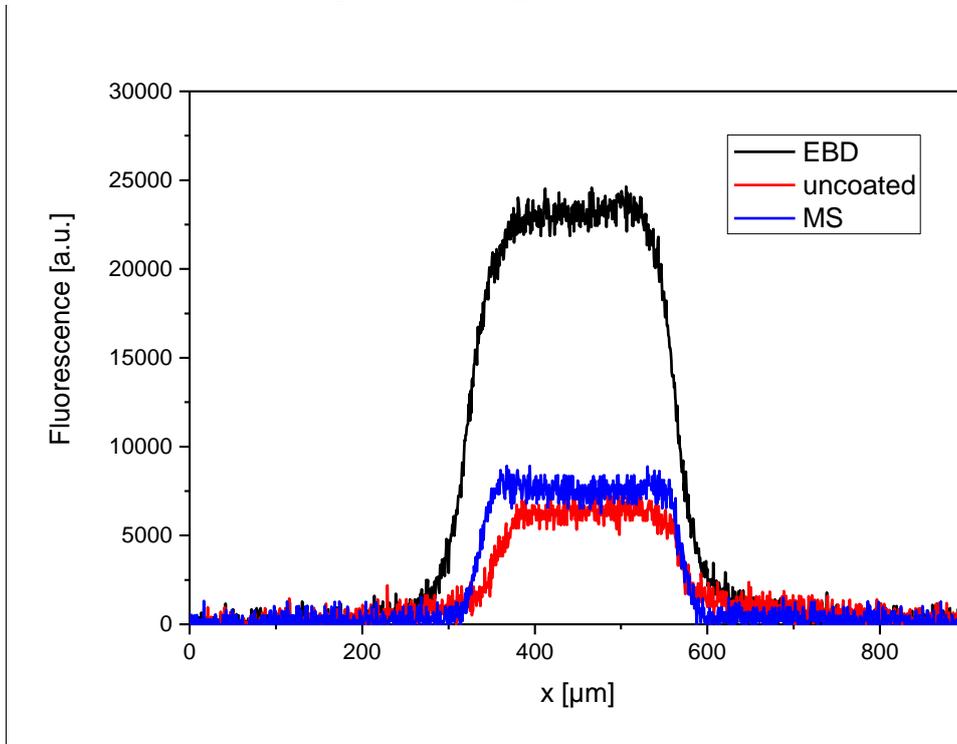
Figure 2.12: Intensity line scans of fluorescence microscopy figures. EBD shows a higher fluorescence to MS, uncoated fused silica. Test conditions: 355 nm, peak fluence of $100\text{mJ}/\text{cm}^2$, 6×10^5 pulses, naphthalene pressure of 3×10^{-4} mbar. Taken from [2].

On this basis it is expected that EBD will show worst results in LIC test with HR optics. EBD shows vacuum effect due to high porosity and compact coatings like MS and IBS have shown much better results in LIDT than EBD. On AR coatings it was found that deposit growth is much smaller on MS coatings than on EBD coatings, as seen in **Figure 2.2**. The contamination is detectable with fluorescence imaging which shows how strong the difference between MS and EBD on AR optics is, see **Figure 2.12**.

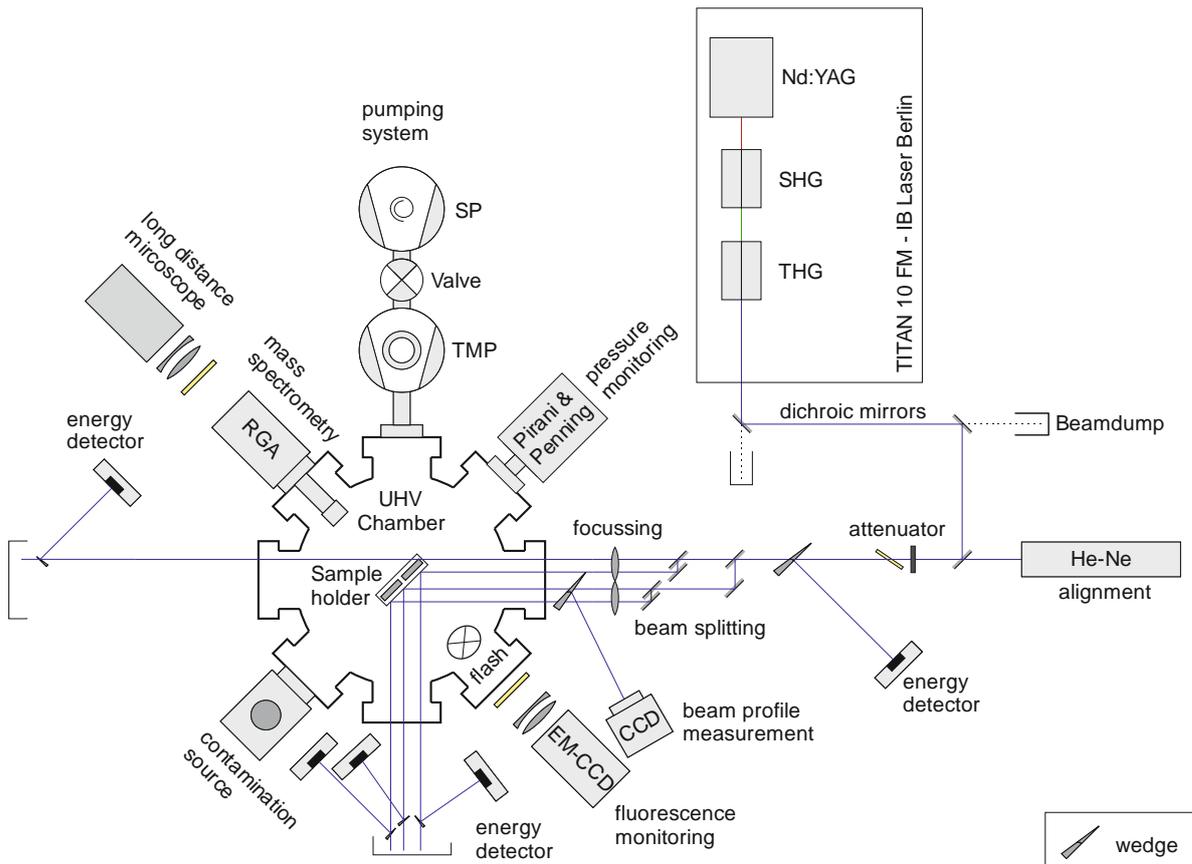
Figure 3.1: Laser-induced contamination test bench for testing HR coated optics.

In order to perform laser-induced contamination tests for space optics a test procedure has been developed, as there is no standard test to measure and qualify laser-induced contamination. Space conditions are replicated in the ultra-high vacuum chamber (UHV) chamber. The contamination process is enforced by specifically evaporating an organic contaminant into the UHV chamber. An UV laser with similar properties as the one operating in ALADIN is used to irradiate optical samples which are placed inside the UHV chamber. A fast repetition rate of 1000Hz and high contaminant concentration compared to laser systems working under space conditions are used during LIC tests. This allows rapidly growing contamination and better investigation of the contamination process. The existing LIC test bench [1] was modified to allow investigation of 45° HR coated optics with a special interest in in-situ damage imaging with a long distance microscope, see **Figure 3.1**.

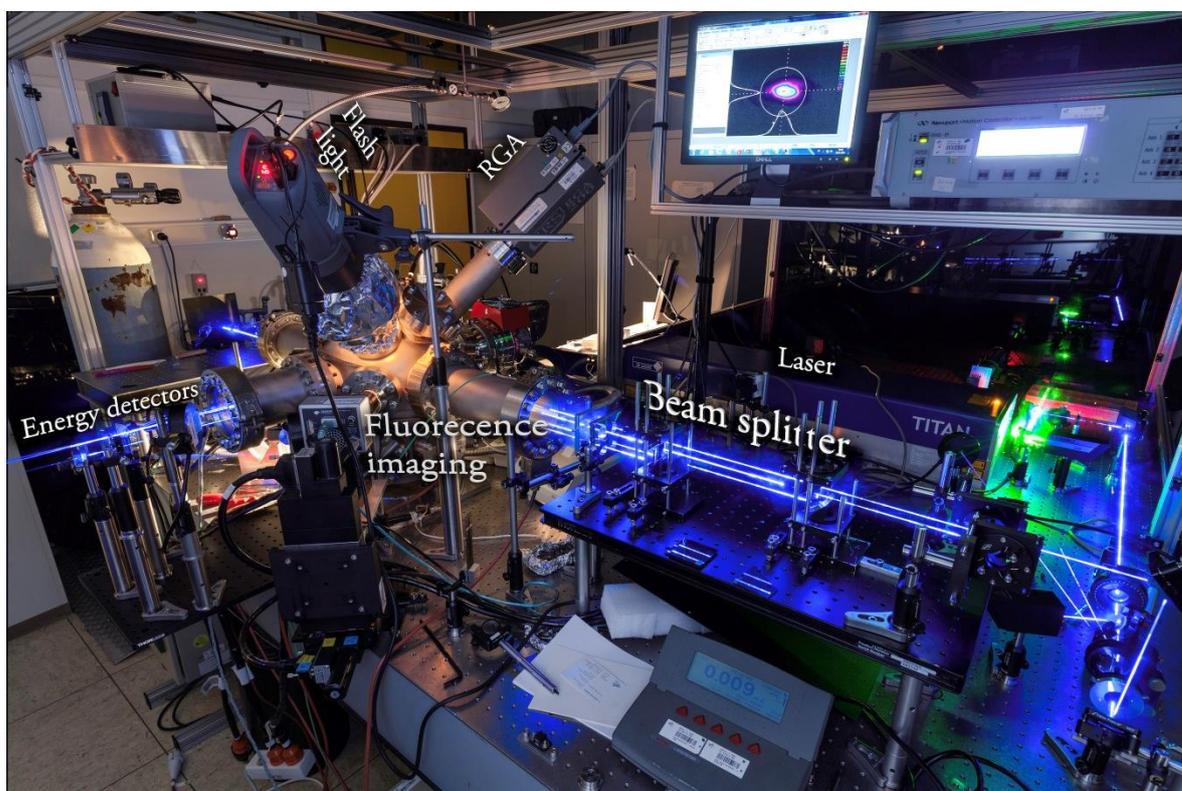
Figure 3.2: *The LIC test bench in the laboratory. From the Titan laser (far right) the UV light is split into four separate beams (front). Connected to the UHV chamber (left) is the flash light (top left), mass spectrometer (top right), the EMCCD camera for fluorescence imaging (front left) and energy detectors (left).*

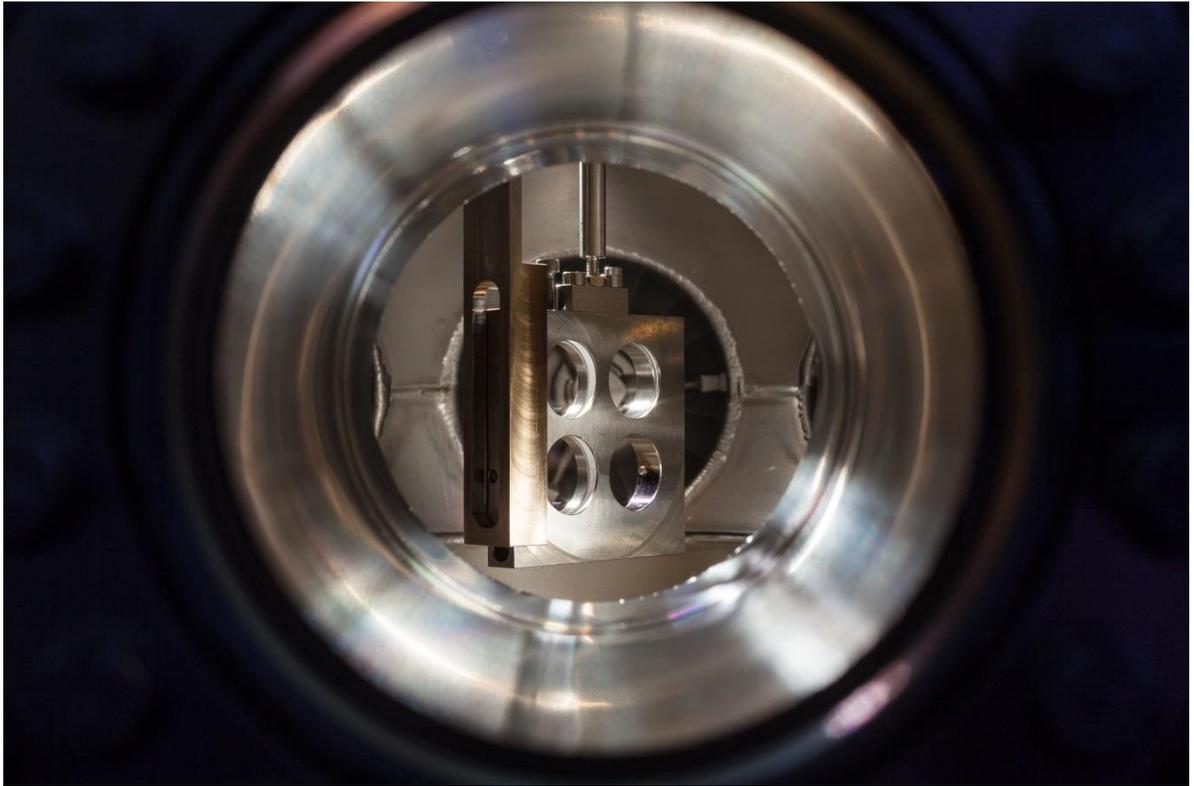
Figure 3.3: The sample holder inside the UHV chamber during LIC test, in the back the TMP can be seen.

The sample holder gives the possibility to host four samples with a size of 1". A translation stage gives the possibility to perform several tests on the samples under same vacuum conditions by moving samples in one plane (y – up and down). To allow irradiation of four optics simultaneously the laser beam is split into four separate beams.

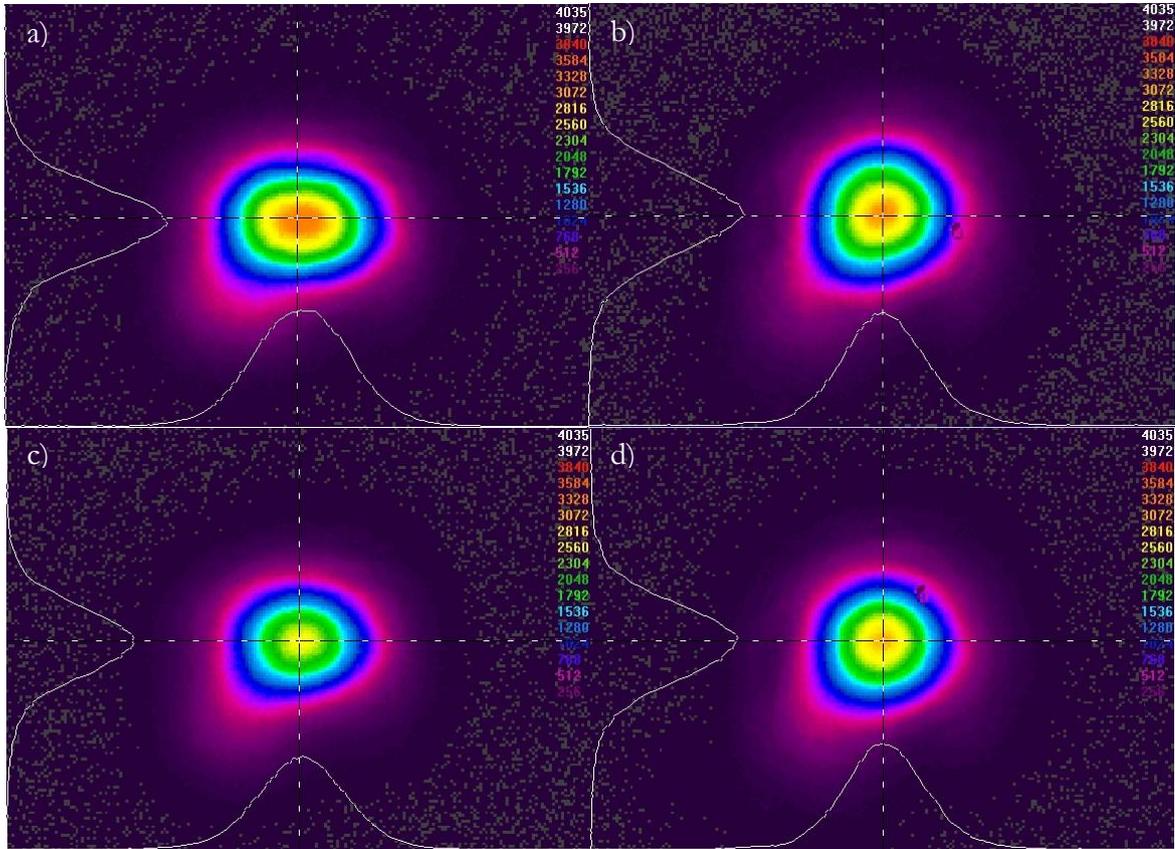
Figure 3.4: Beam profiles at each sample position. Shown are the upper left a), upper right b), lower left c), and lower right d) sample position as seen from beam entrance port of the UHV chamber, compare **Figure 3.1**.

The mean radius of all beams is about $130\mu\text{m}$ with a standard deviation of 9%. This allows the fluence to be below the damage threshold of samples ($<5\text{J}/\text{cm}^2$), but high enough on samples that contamination occurs.

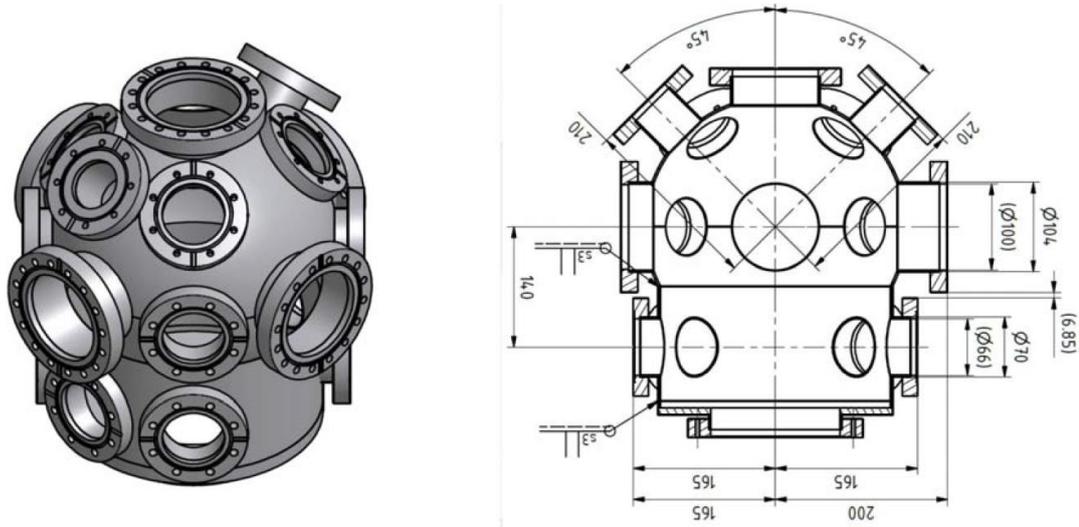
Figure 3.5: 3D sketch (left) and technical drawing (right) of the DLR developed UHV chamber for LIC tests.

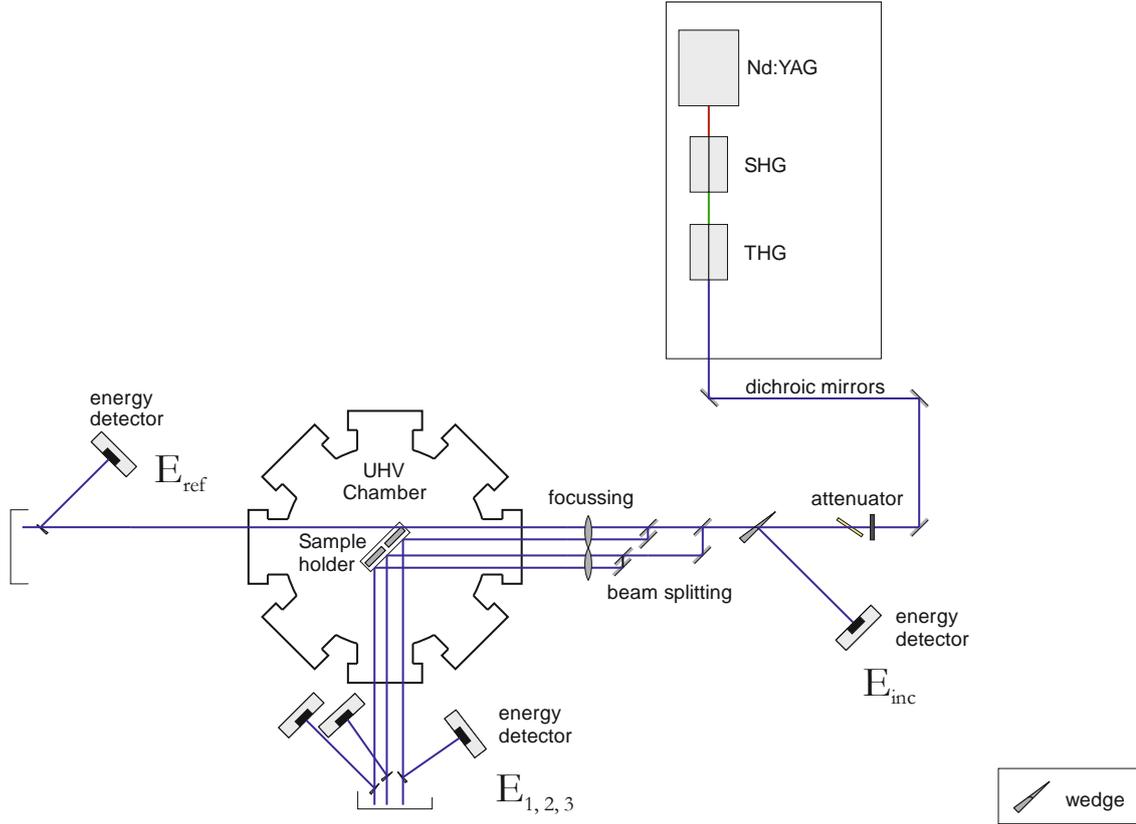
Figure 3.6: Energy detectors recording the pulse energy of the incident beam E_{inc} , the reference beam E_{ref} and the sample beams $E_{1,2,3}$.

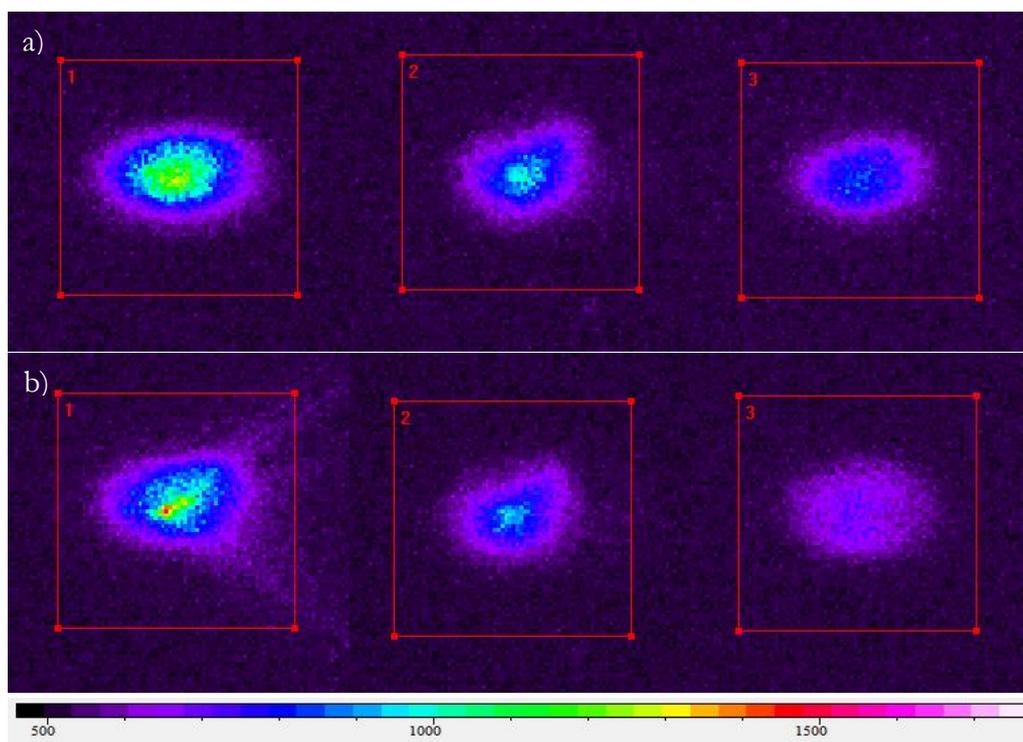
Figure 3.7: Example images of laser-induced fluorescence recorded during LIC test. From left to right samples coated with IBS (1), MS (2) and EBD (3). First row a) shows fluorescence after 5min and second row b) after 30min. ROI is displayed in red.

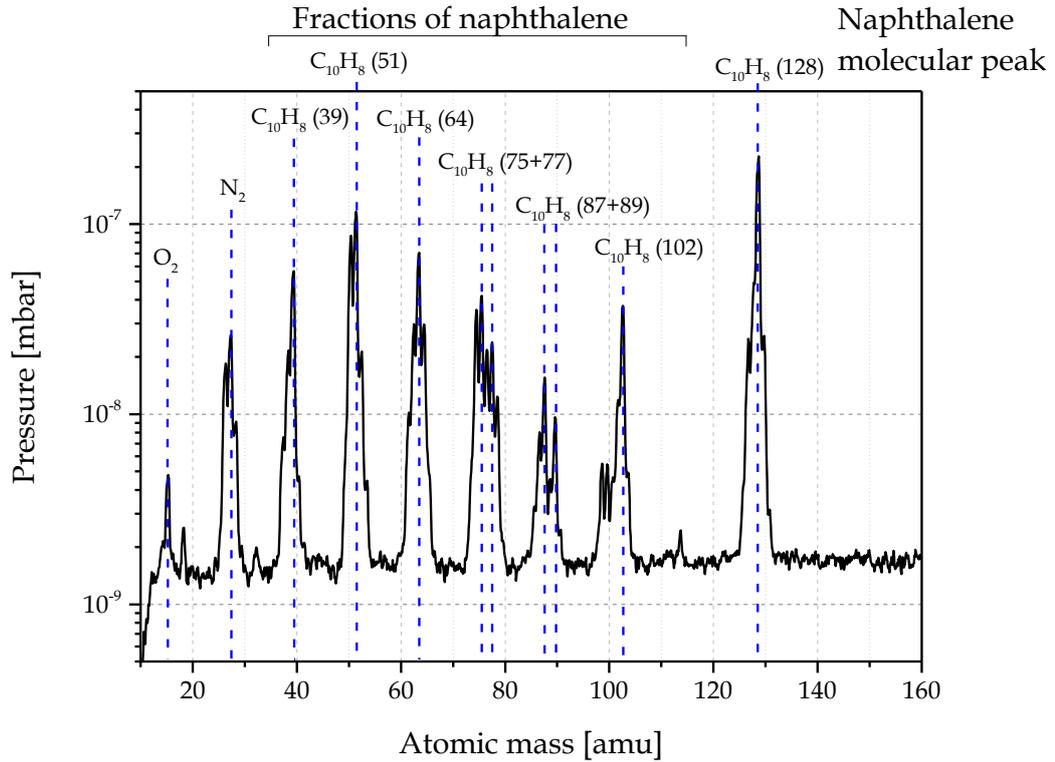
Figure 3.8: A sample mass spectrograph which is typical for a contamination pressure of 3.5×10^{-5} mbar recorded by the RGA.

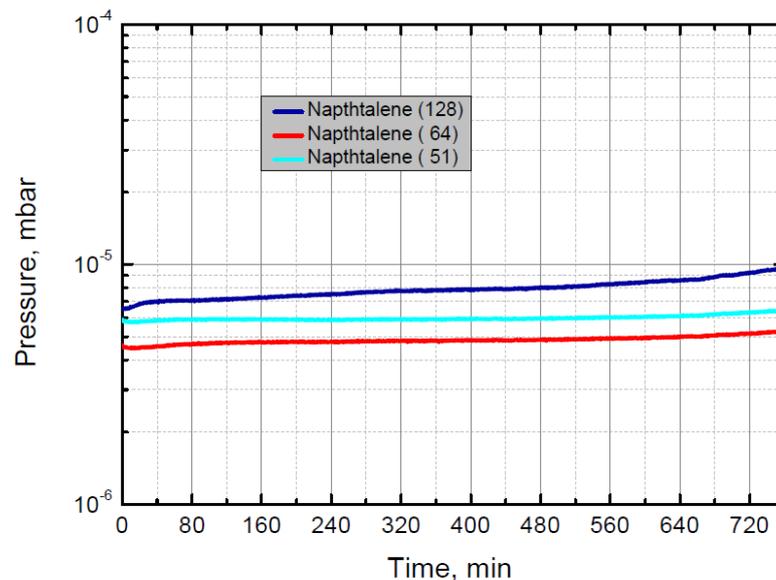
Figure 3.9: Tracking partial naphthalene pressure over 750min in the UHV chamber. Graph taken from [1].

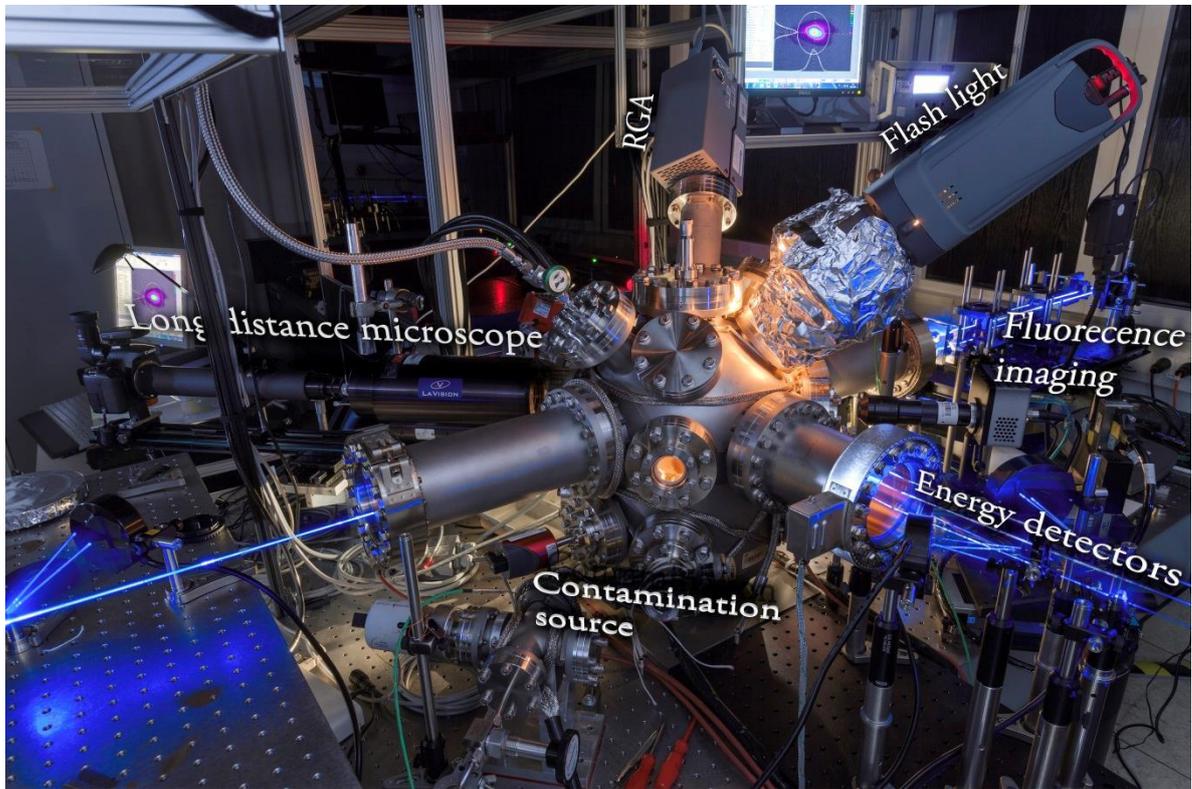
Figure 3.10: *The long distance microscope (left from the chamber) and flash light (top right from the chamber) for taking images of samples with a high magnification and contrast during LIC tests. At the bottom of the UHV chamber is the contamination source (bottom, center). The pulse energy of the reference beam (left) and probe beams (right) are detected with energy detectors.*

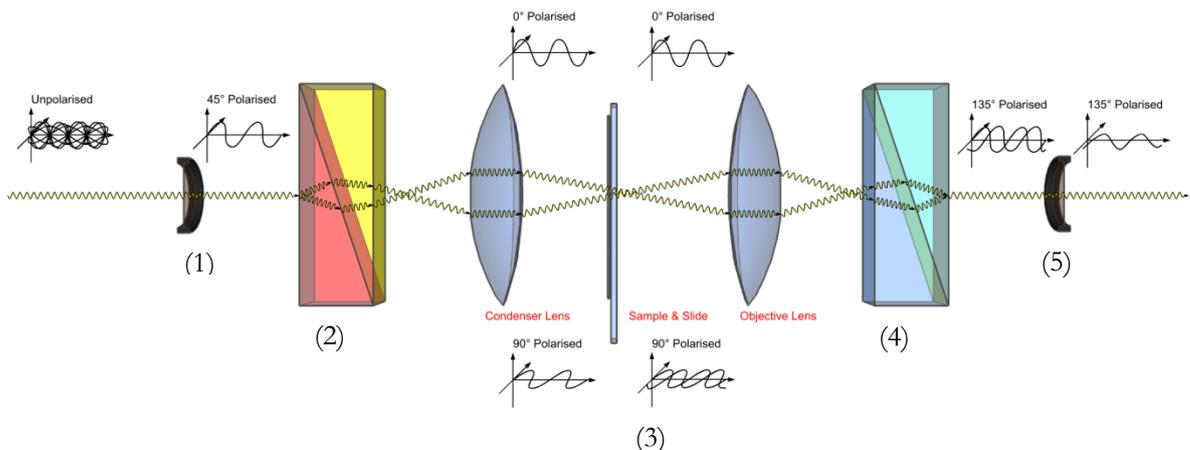
Figure 3.11: Diagram illustrating the path of light through a differential interference contrast microscope. [14]

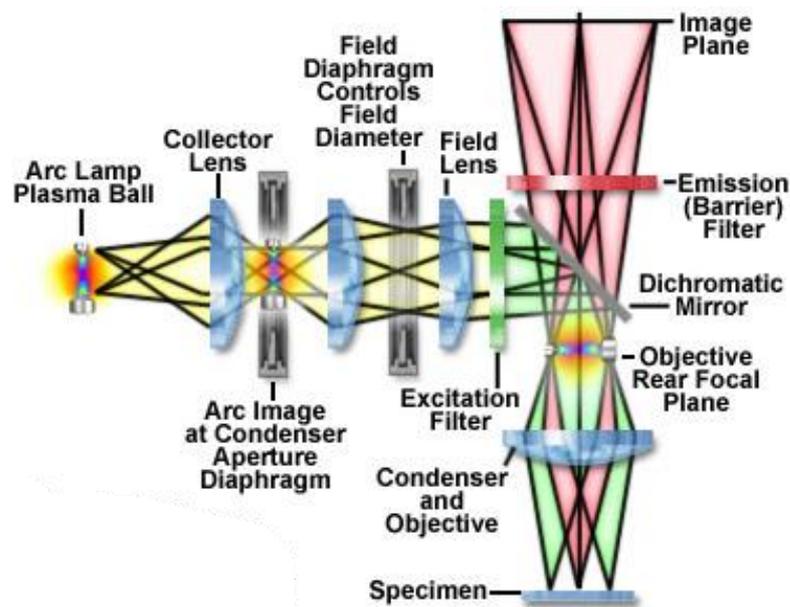
Figure 3.12: Schematic drawing of the basic principle of a fluorescence microscope. The UV light from the mercury vapor lamp (Arc Lamp) passes the Excitation Filter. The UV light (colored green) illuminates the Specimen (or sample) and light emitted from the sample (colored red) is imaged by an objective on the Image Plane. Figure taken from [15].

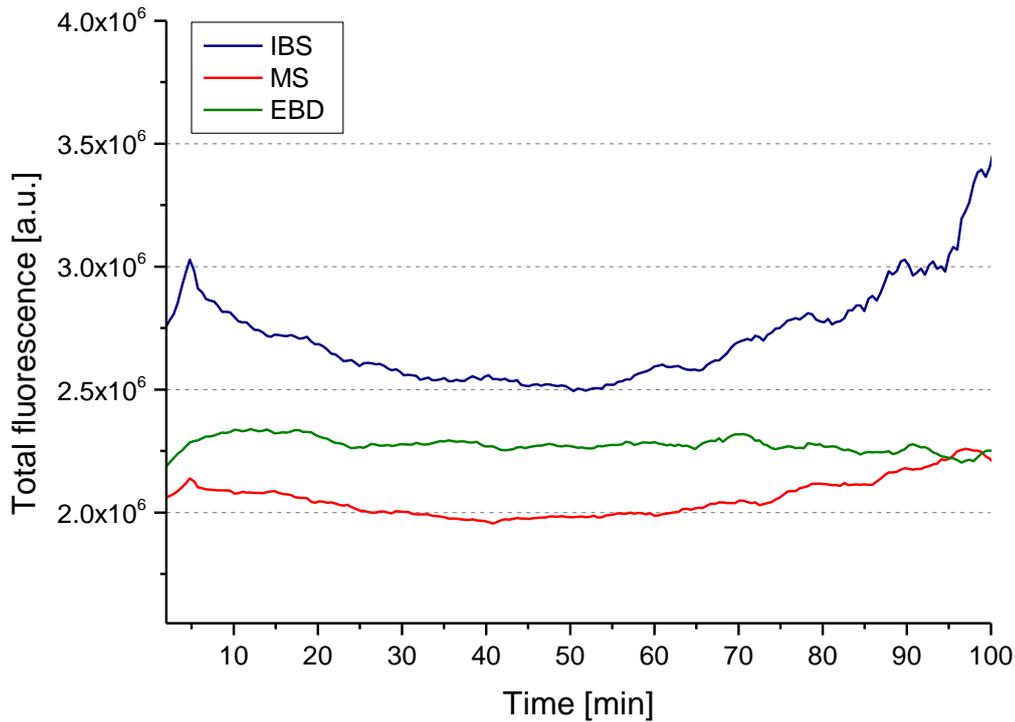
Figure 4.1: Total fluorescence measured by in-situ laser-induced fluorescence imaging during LIC test. In comparison are HR coatings made by EBD, MS and IBS process.

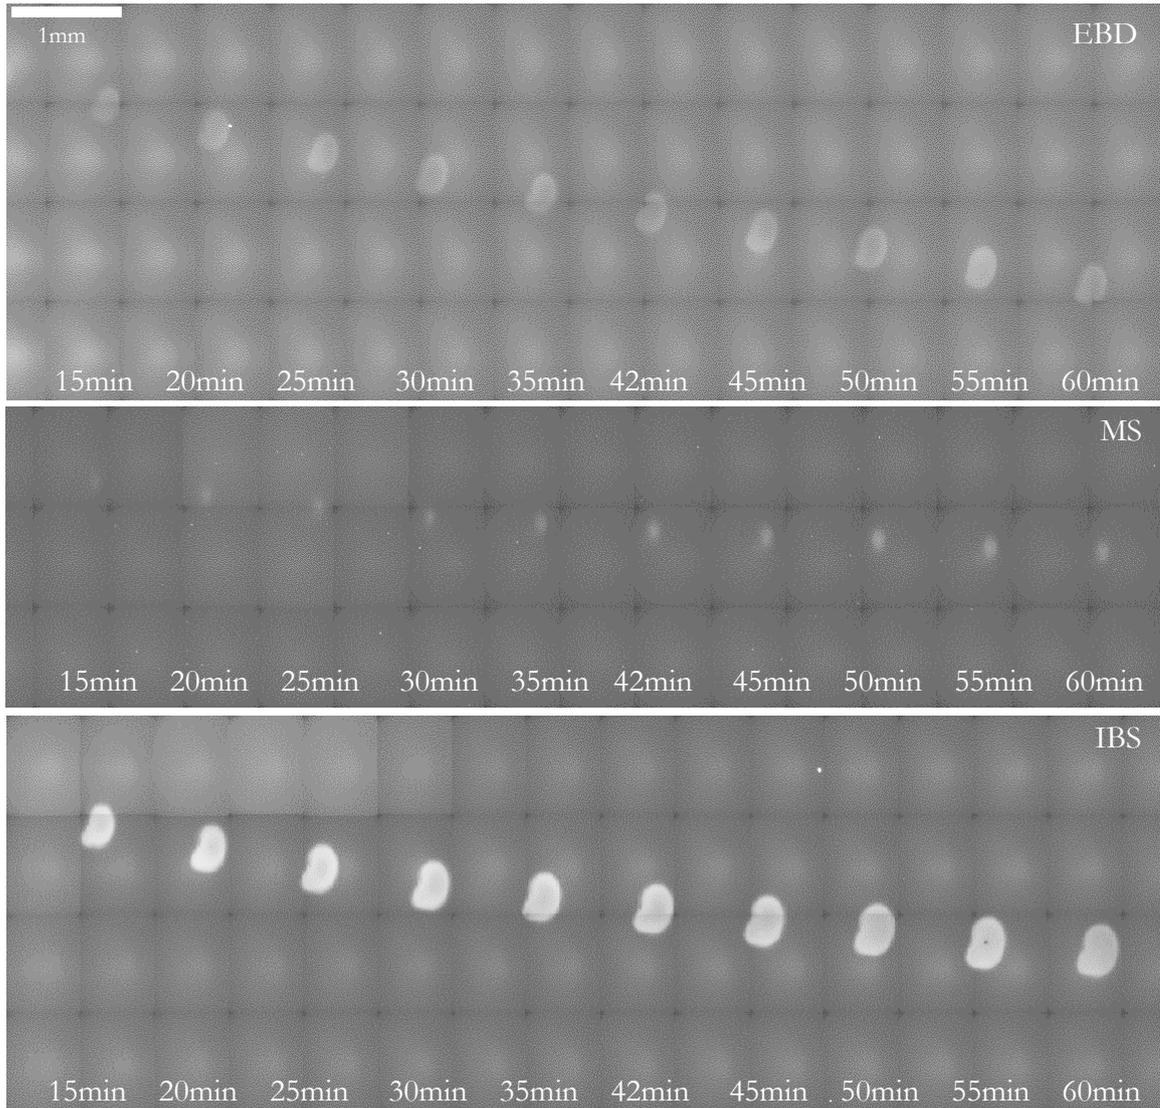
Figure 4.2: FM mosaic image of EBD (top), MS (middle) and IBS (bottom) samples after LIC tests. Laser irradiation time varied from 15min up to 60min.

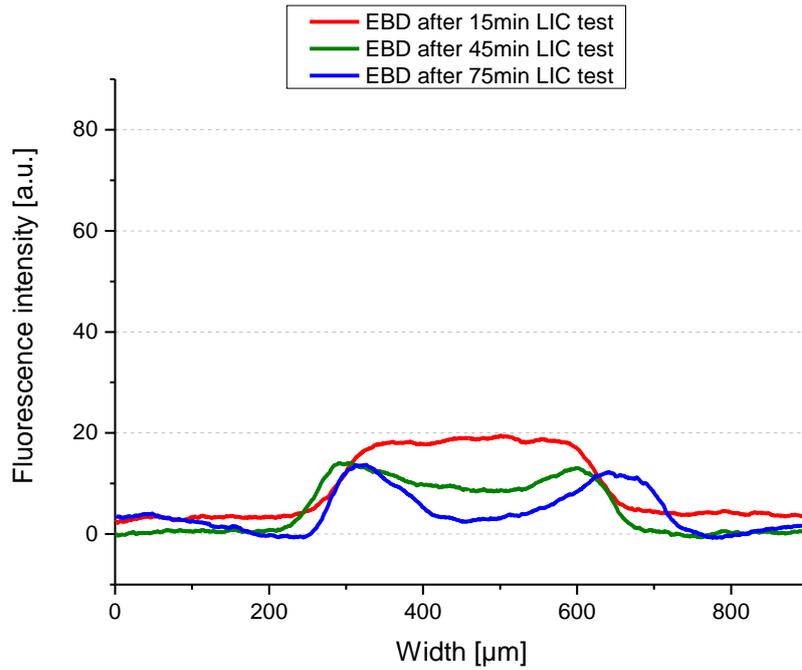
Figure 4.3: Plot of line scans through the deposit in x direction of LIC tests after 15min, 45min and 75min. FM images from EBD sample show a transition from pancake to doughnut shape.

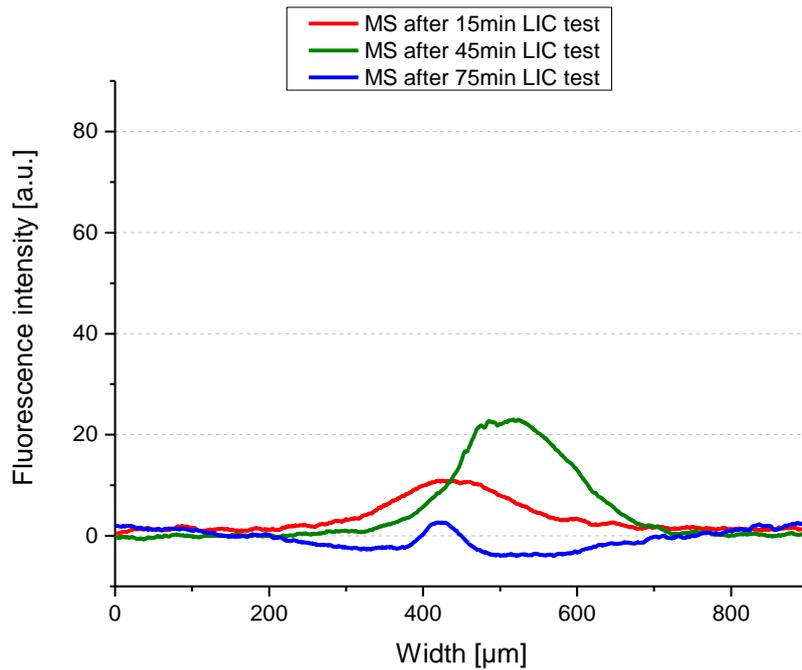
Figure 4.4: Plot of line scans through the deposit in x direction of LIC tests after 15min, 45min and 75min. FM images from MS sample show a Gaussian shape.

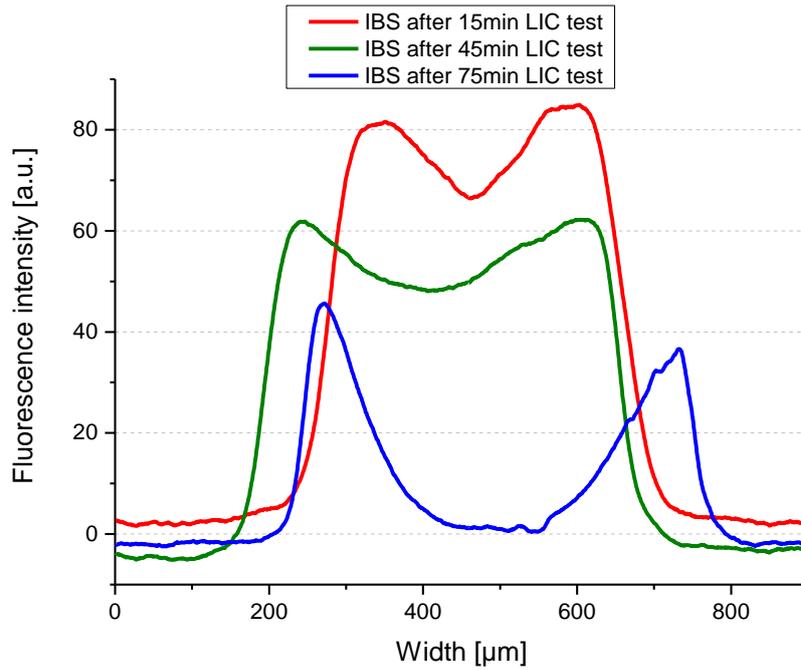
Figure 4.5: Plot of line scans through the deposit in x direction of LIC tests after 15min, 45min and 75min. FM images from IBS sample show a doughnut shape.
