Master Thesis

Laser-induced contamination on high- reflective optics

University of Applied Science Darmstadt
DLR - German Aerospace Center
(Deutsches Zentrum für Luft- und Raumfahrt)

February 2014

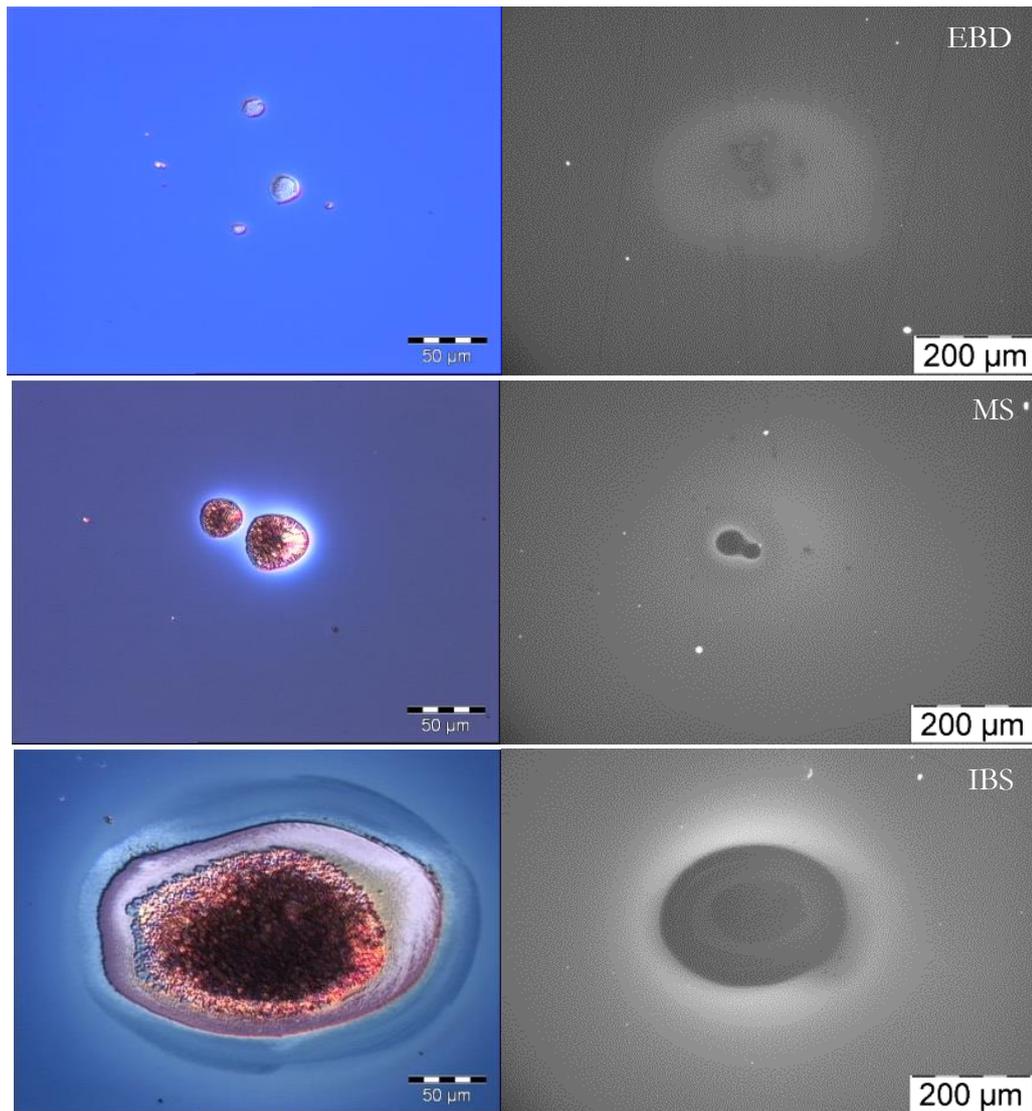
Figure 4.6: DIC micrograph (left) and FM micrograph (right) in comparison of each sample after 60min LIC test. From top to bottom: EBD, MS and IBS samples are shown.

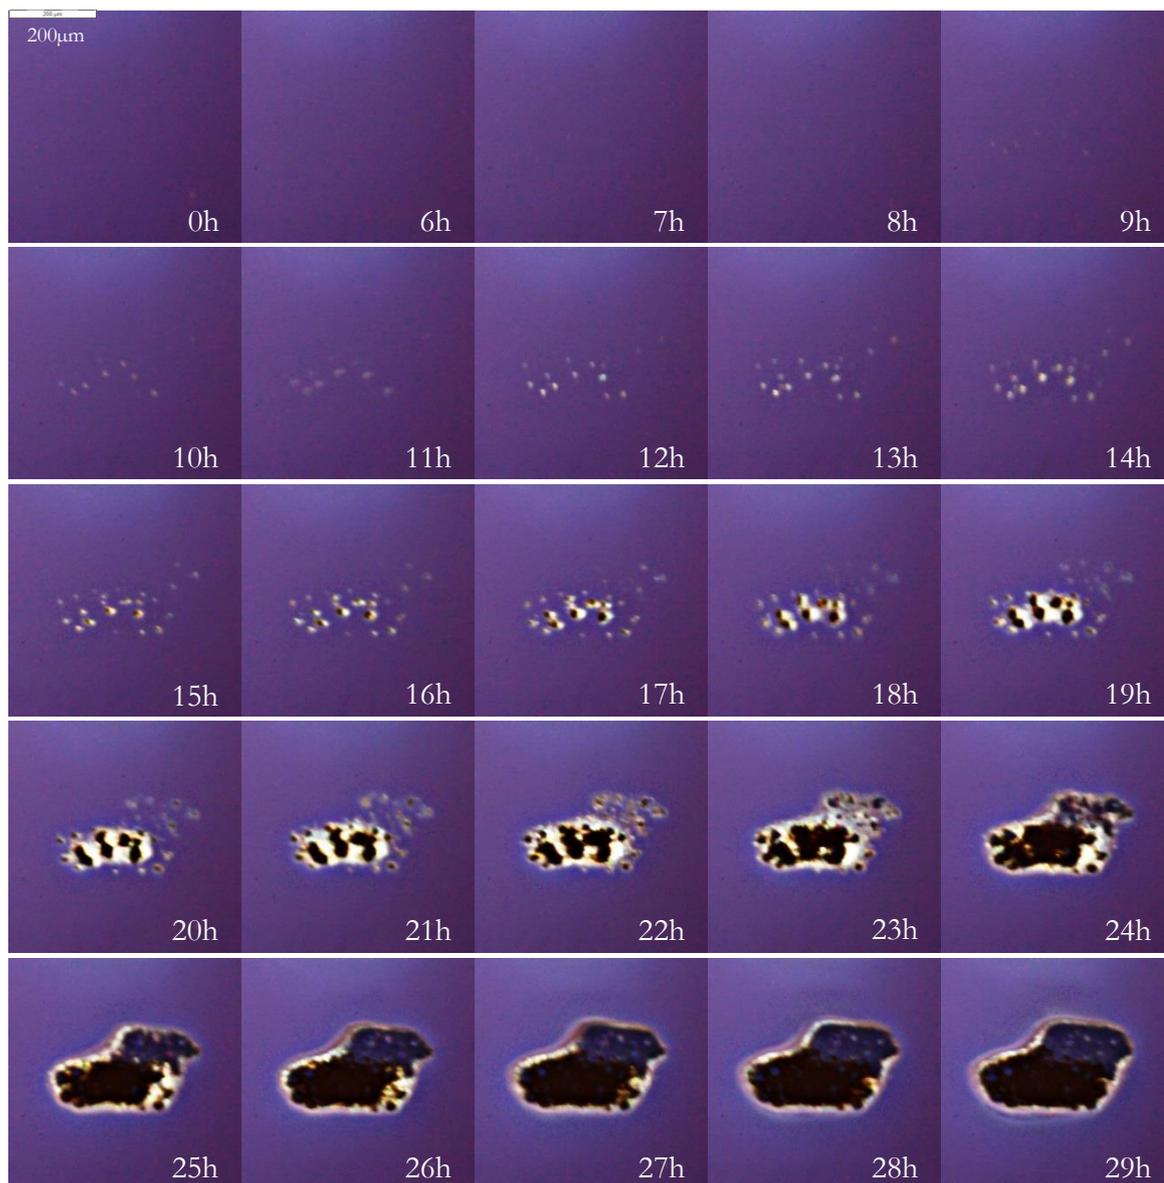
Figure 4.7: In-situ long distance microscope images of EBD sample during LIC test. Test conditions are $H_p=400\text{mJ}/\text{cm}^2$ with a contamination pressure of $3.1\times 10^5\text{mbar}$.

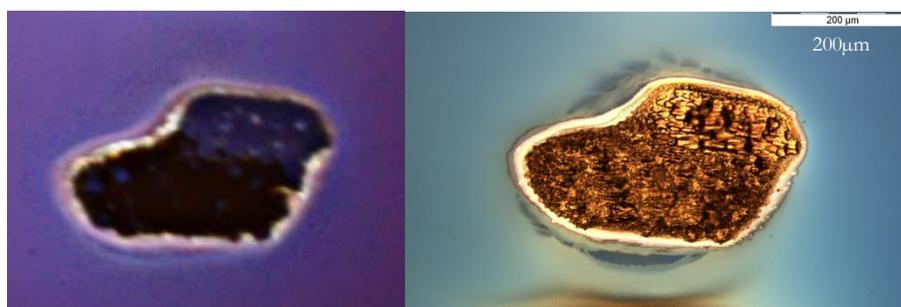
Figure 4.8: In-situ long distance microscope image (left) taken after 29h in comparison with DIC micrograph (right) of EBD sample taken after LIC test.

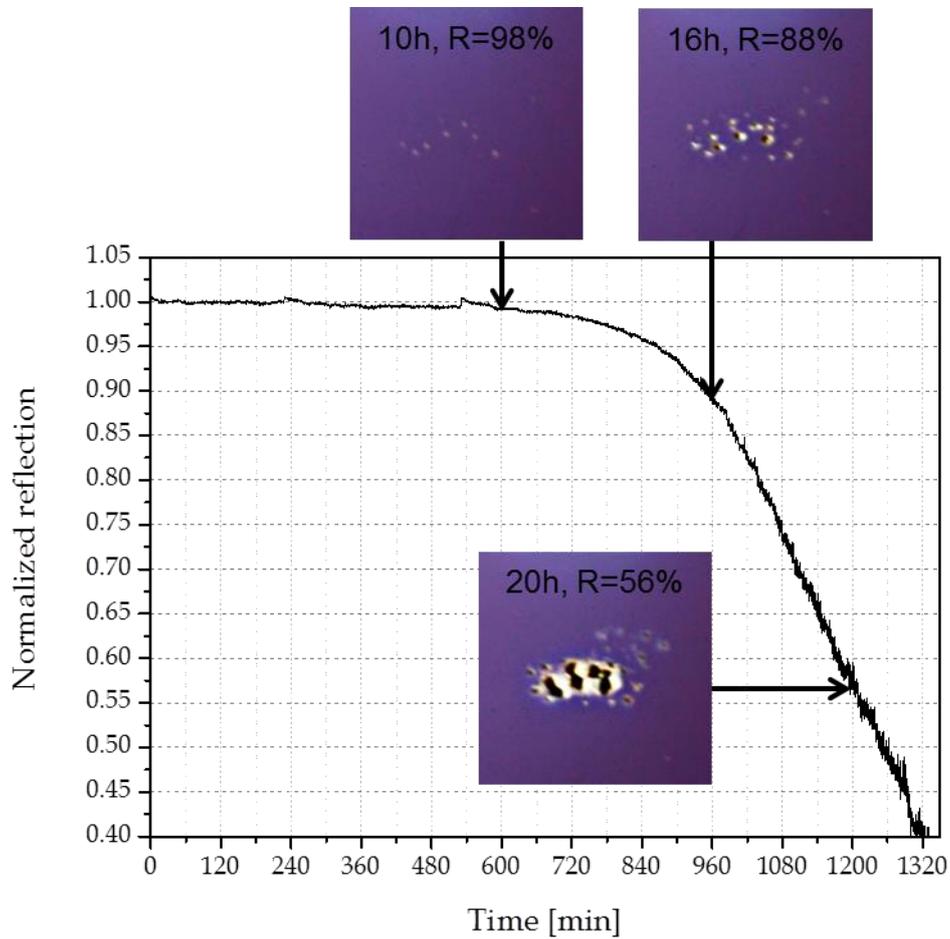
Figure 4.9: Normalized reflection measurement of the EBD sample during a LIC test, from measurement seen in **Figure 4.7**.

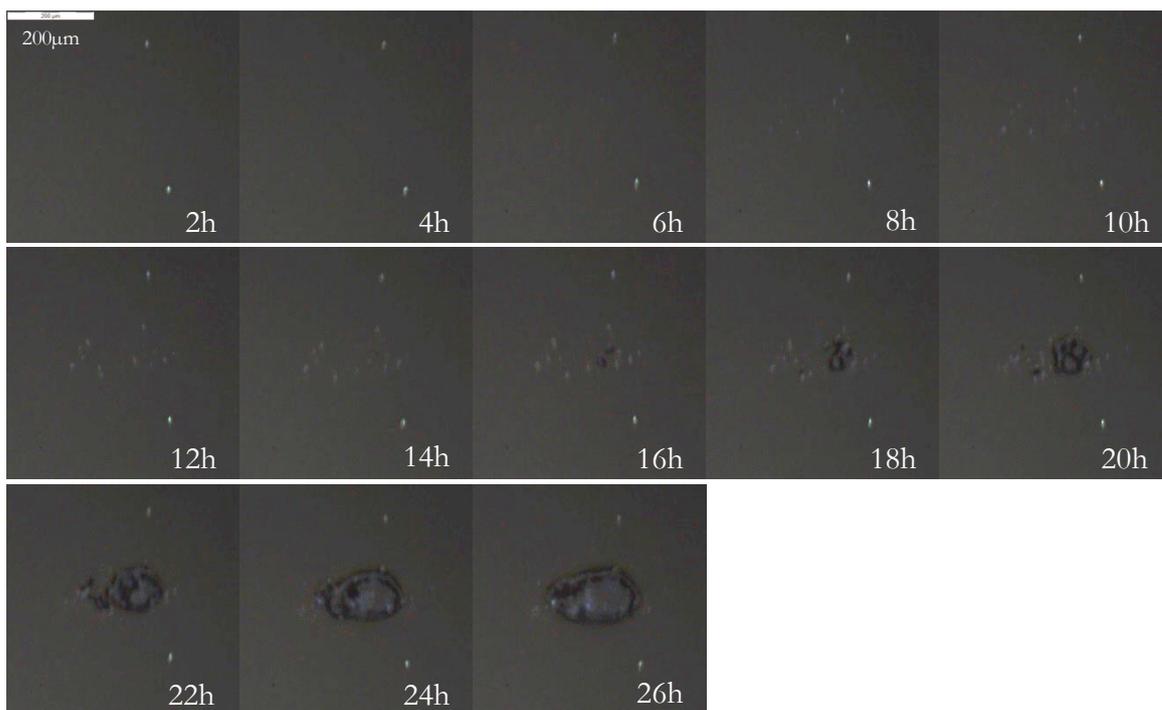
Figure 4.10: In-situ long distance microscope images of MS sample during LIC test. Test conditions are at a fluence of $660\text{mJ}/\text{cm}^2$ with a contamination pressure of $1 \times 10^{-5}\text{mbar}$.

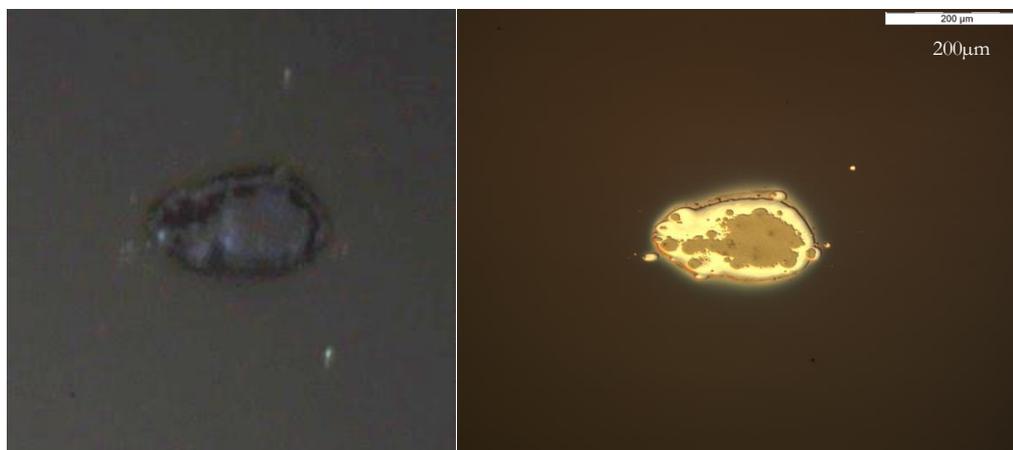
Figure 4.11: In-situ long distance microscope image (left) taken after 26h in comparison with DIC micrograph (right) of MS sample taken after LIC test.

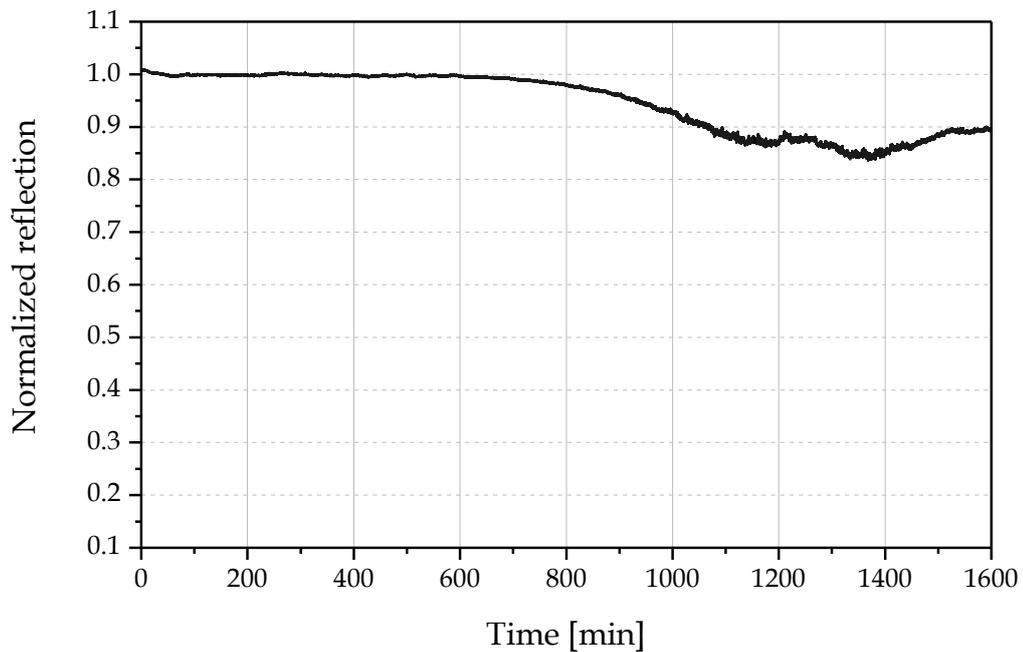
Figure 4.12: Normalized reflection measurement of the MS sample during a LIC test, from measurement seen in **Figure 4.10**.

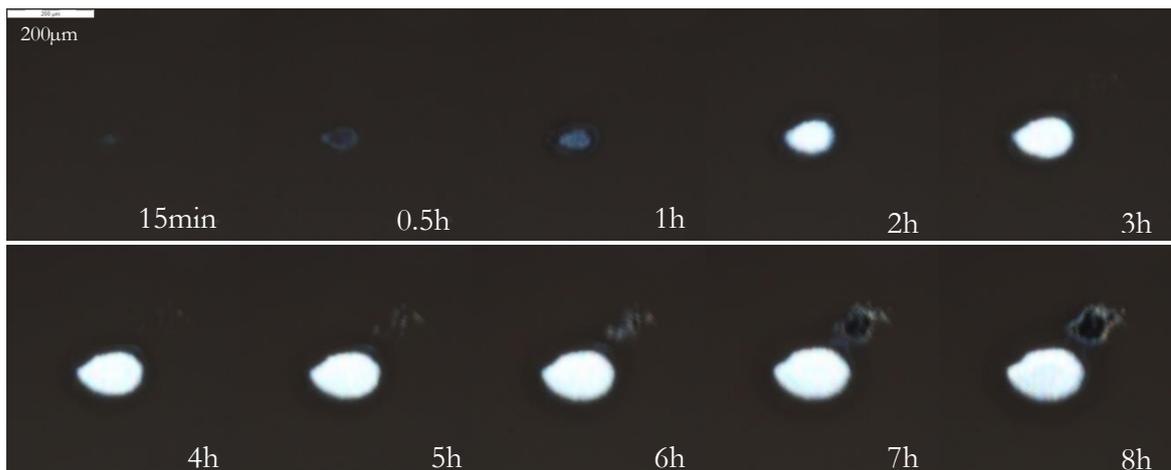
Figure 4.13: In-situ long distance microscope images of IBS sample during LIC test. Test conditions are $H_p=360\text{mJ}/\text{cm}^2$ with a contamination pressure of $3.5 \times 10^{-5}\text{mbar}$.

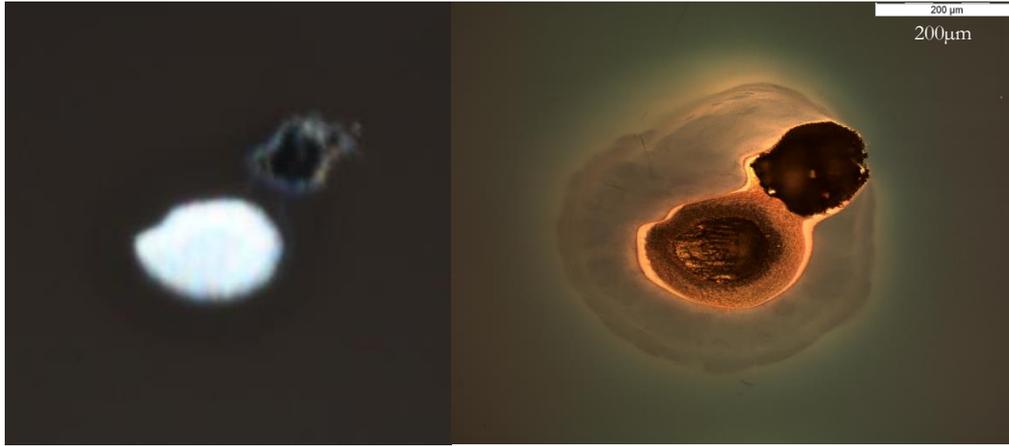
Figure 4.14: In-situ long distance microscope image (left) taken after 8h in comparison with DIC micrograph (right) of IBS sample taken after LIC test. The damage has a diameter of about $500\mu\text{m}$.

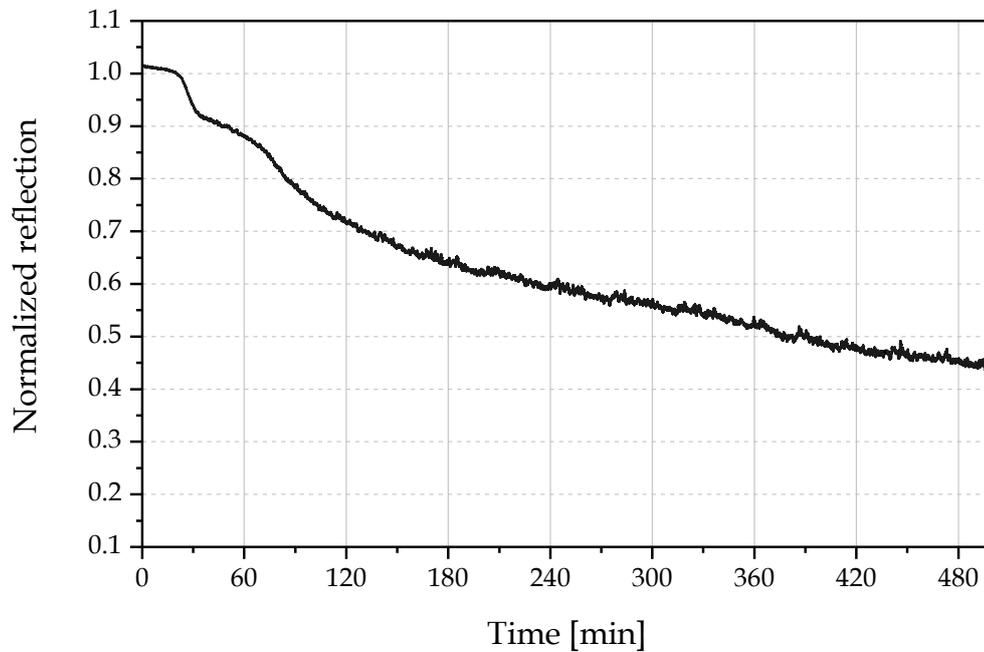
Figure 4.15: Normalized reflection measurement of the IBS sample during a LIC test, from measurement seen in **Figure 4.13**.

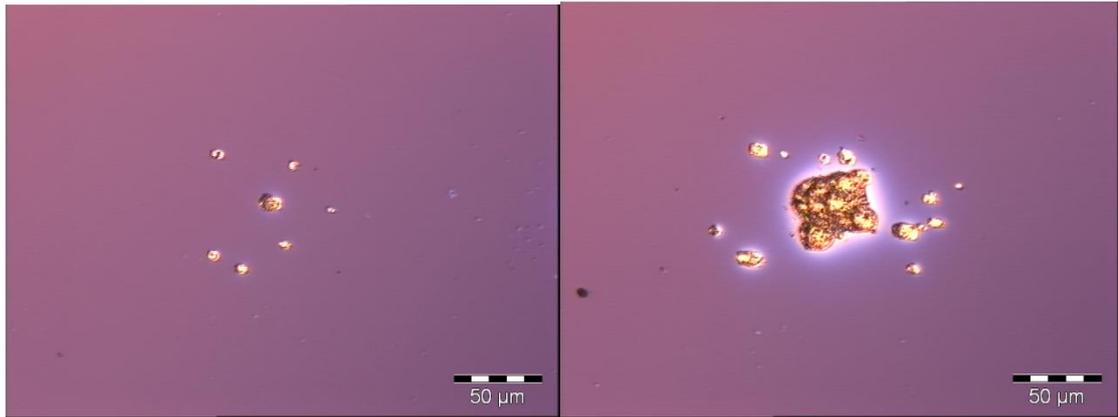
Figure 4.16: Localized damages on MS samples after LIC test with 75min (left) and 95min (right) irradiation time. Test conditions are a fluence of $262\text{mJ}/\text{cm}^2$ with a contamination pressure of $4.8 \times 10^{-5}\text{mbar}$.

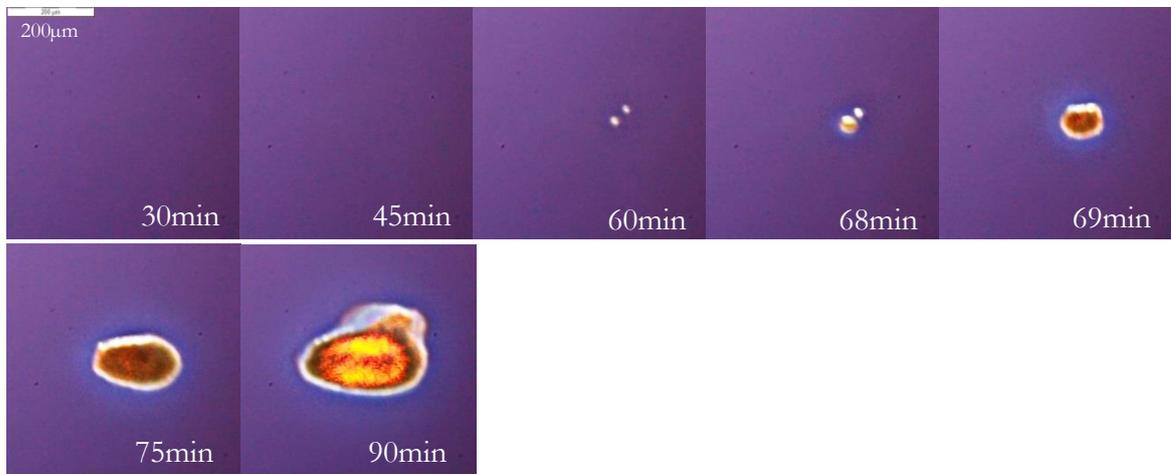
Figure 4.17: In-situ long distance microscope images of EBD sample during LIC test. Test conditions are $H_p = 1250\text{mJ}/\text{cm}^2$ with a contamination pressure of $4 \times 10^{-5}\text{mbar}$.

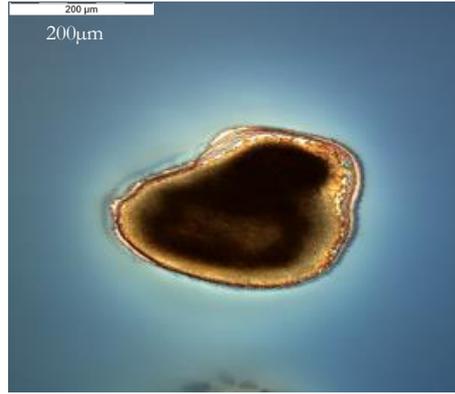
Figure 4.18: DIC micrograph of EBD sample after 90min LIC test.

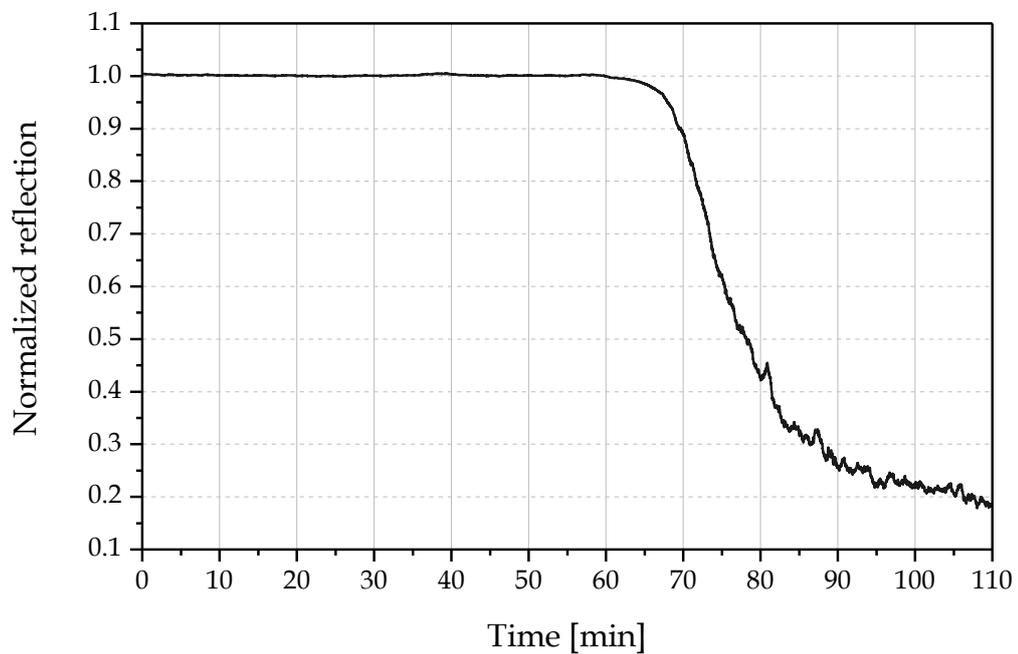
Figure 4.19: Normalized reflection measurement of the EBD sample during a LIC test, from measurement seen in **Figure 4.17**.

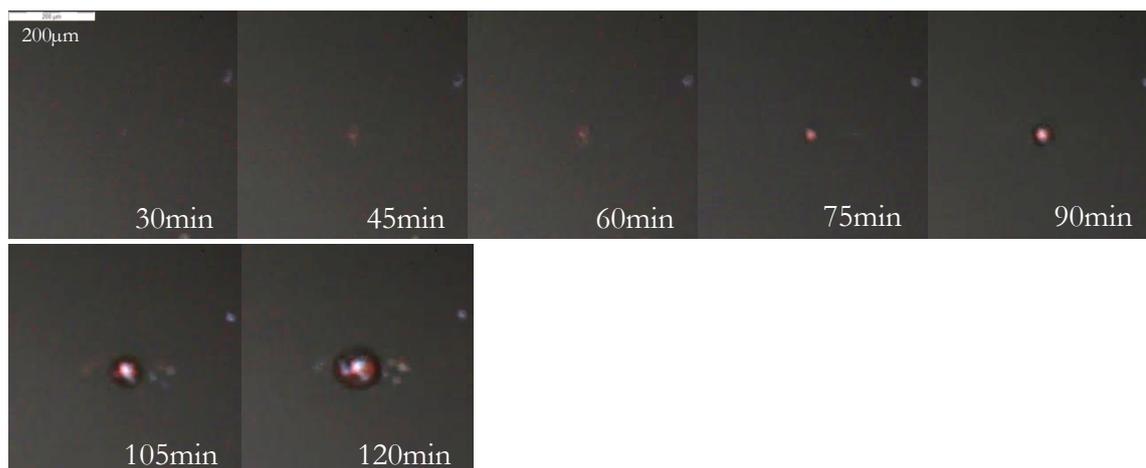
Figure 4.20: In-situ long distance microscope images of MS sample during LIC test. Test conditions are a fluence of $1050\text{mJ}/\text{cm}^2$ with contamination pressure of $4 \times 10^{-5}\text{mbar}$.

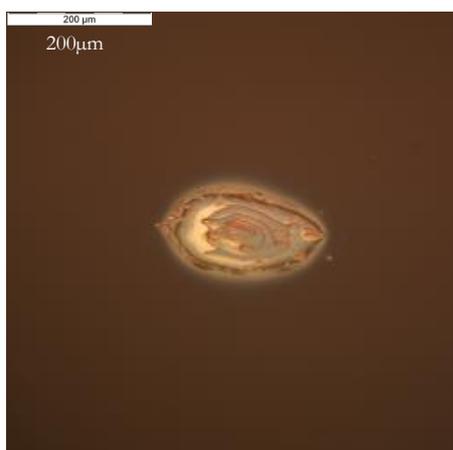
Figure 4.21: DIC micrograph of MS sample after 120min LIC test.

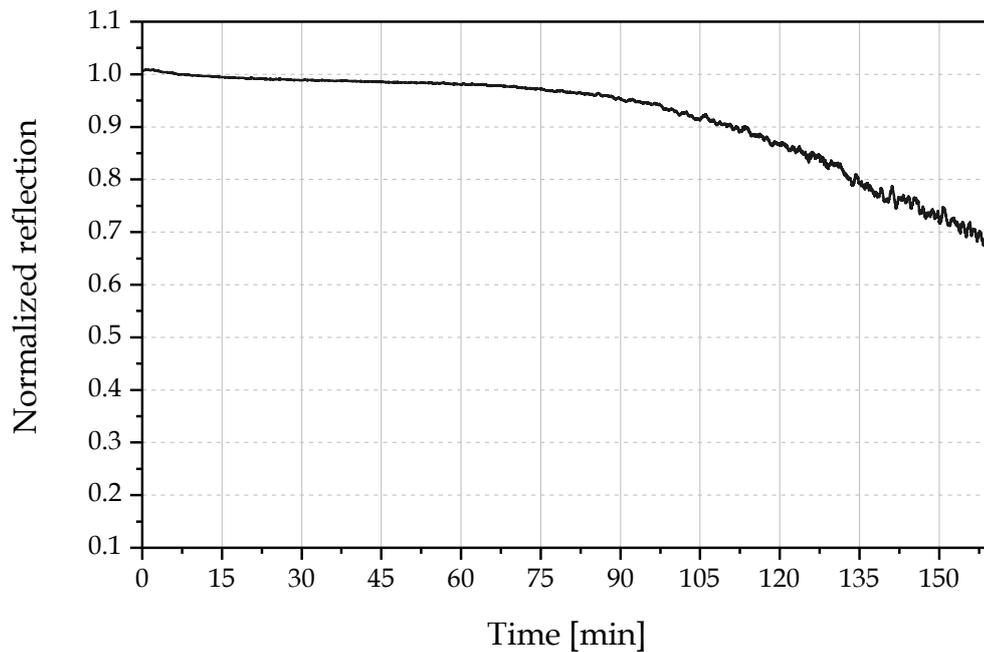
Figure 4.22: Normalized reflection measurement of the MS sample during a LIC test, from measurement seen in **Figure 4.20**.

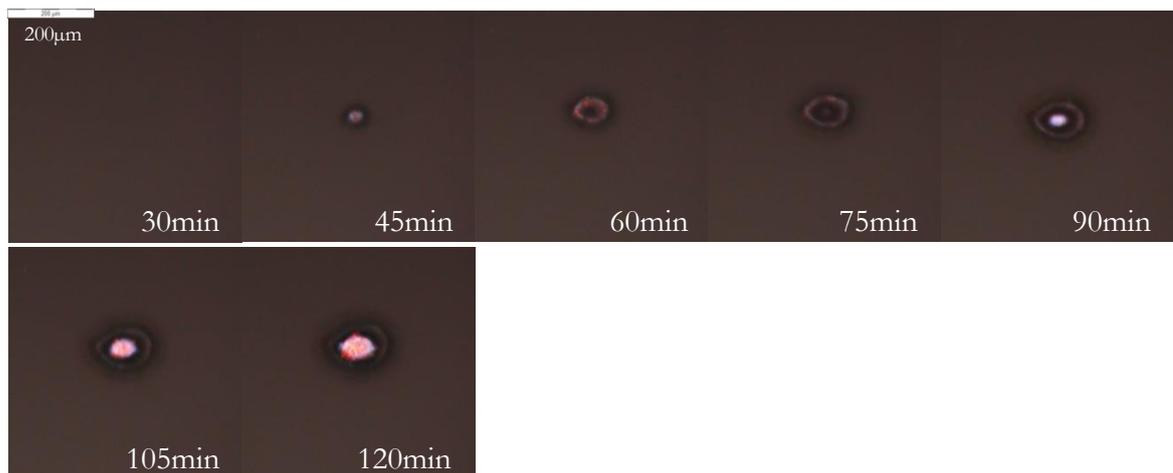
Figure 4.23: In-situ long distance microscope images of IBS sample during LIC test. Test performed with a fluence of $740\text{mJ}/\text{cm}^2$ and contamination pressure of 3.5×10^{-5} mbar.

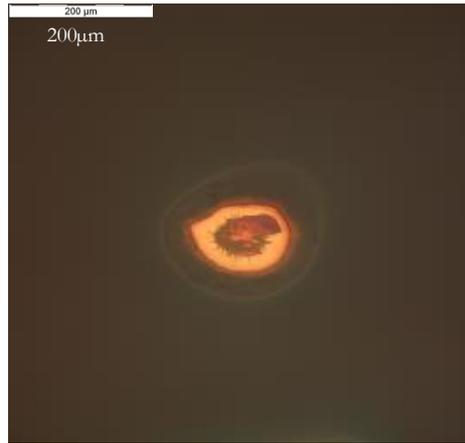
Figure 4.24: DIC micrograph of IBS sample after LIC test.

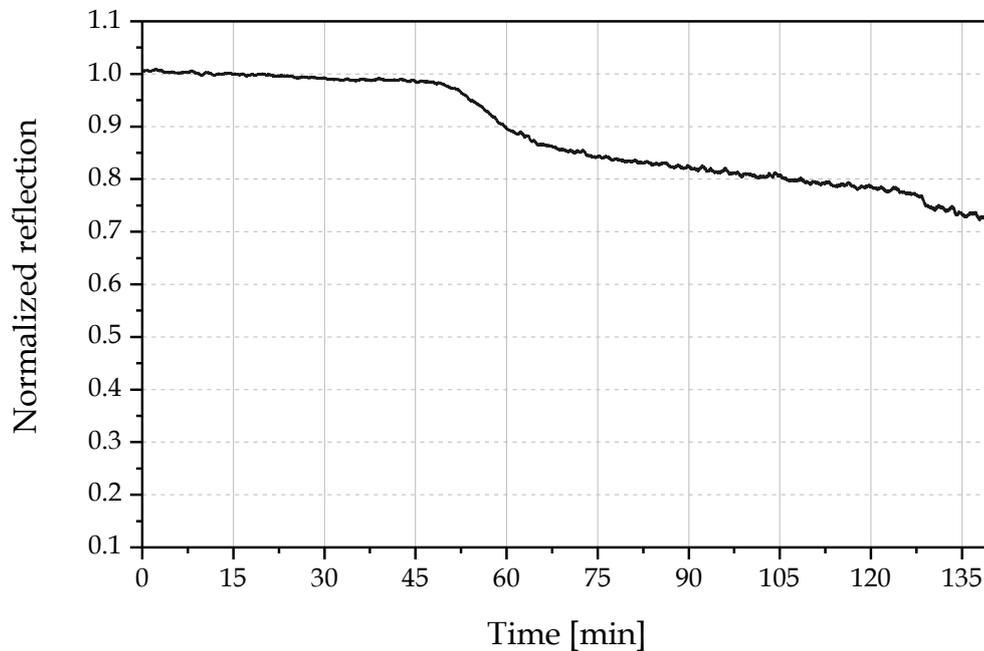
Figure 4.25: Normalized reflection measurement of the IBS sample during a LIC test, from measurement seen in **Figure 4.23**.

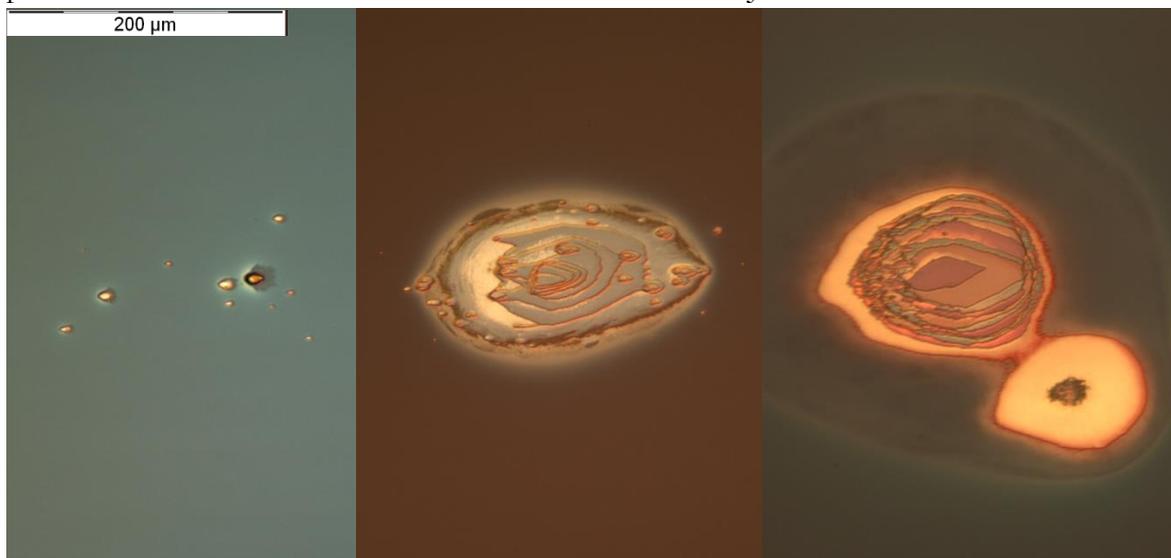
Figure 4.26: Ex-situ DIC micrographs after LIC test of EBD (left), MS (middle) and IBS (right) samples.

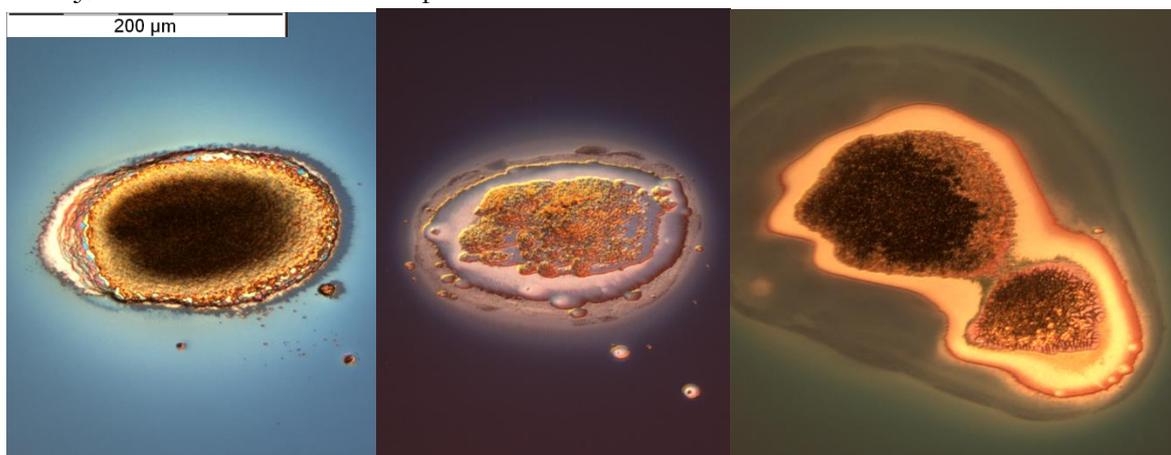
Figure 4.27: Ex-situ DIC micrographs after LIC test of EBD (left), MS (middle) and IBS (right) samples.

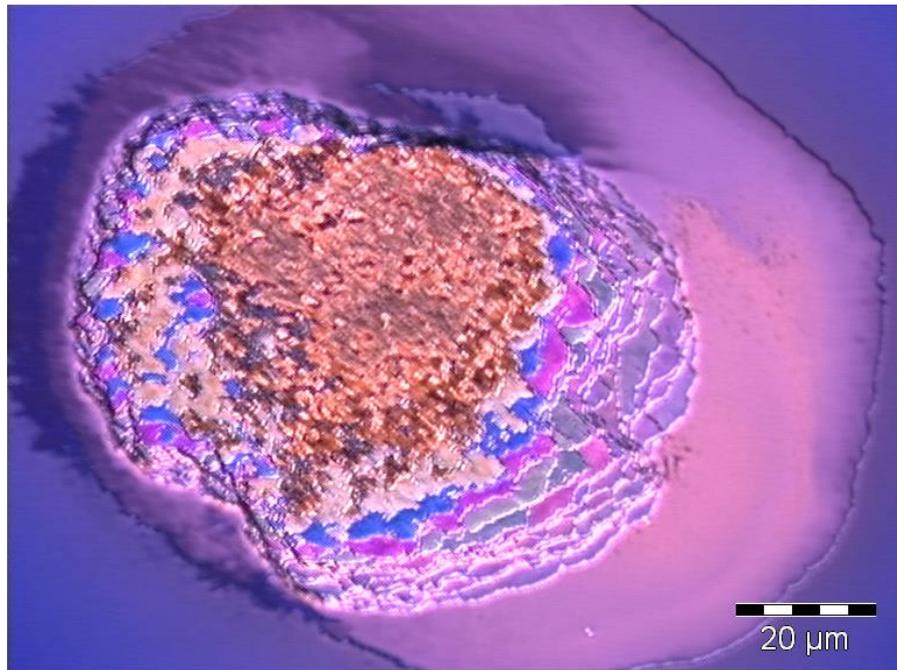
Figure 4.28: HR EBD sample damage after LIC test. About 15 layers of the HR coating are visible. The damage is about $1.6\mu\text{m}$ in depth.

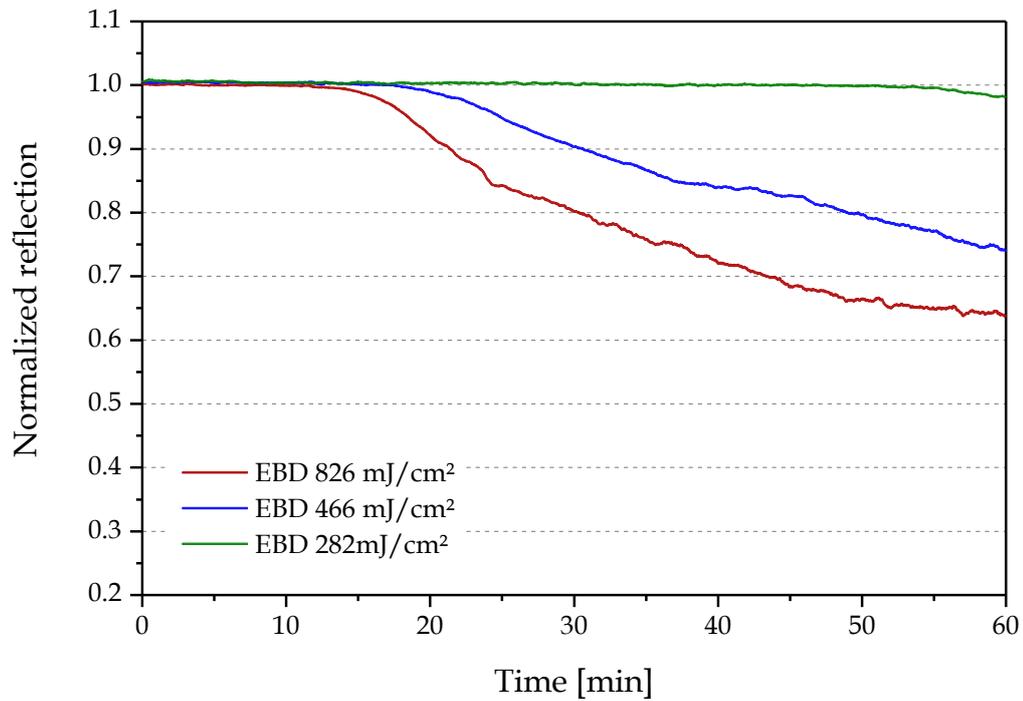
Figure 4.29: Normalized reflection during LIC test of EBD in dependence of fluence.

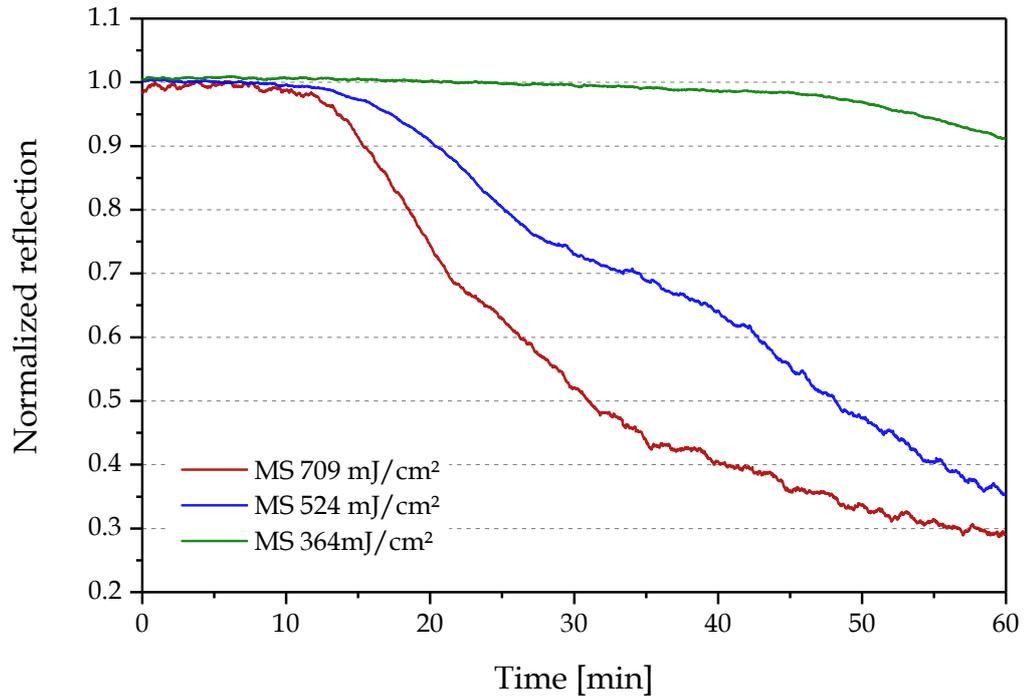
Figure 4.30: Normalized reflection during LIC test of MS in dependence of fluence.

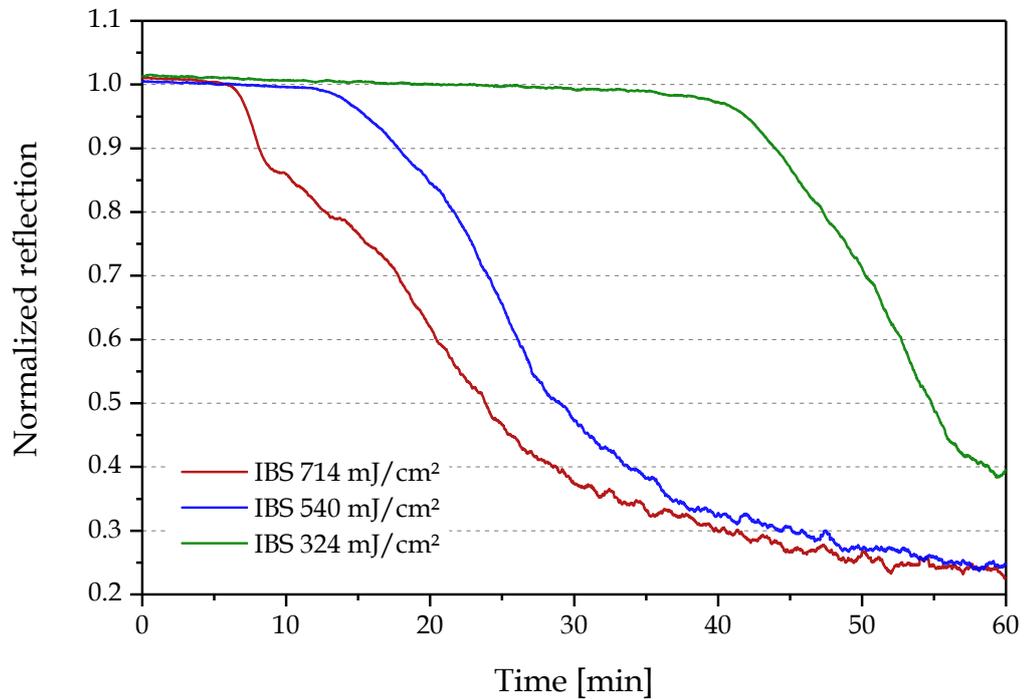
Figure 4.31: Normalized reflection during LIC test of IBS in dependence of fluence.

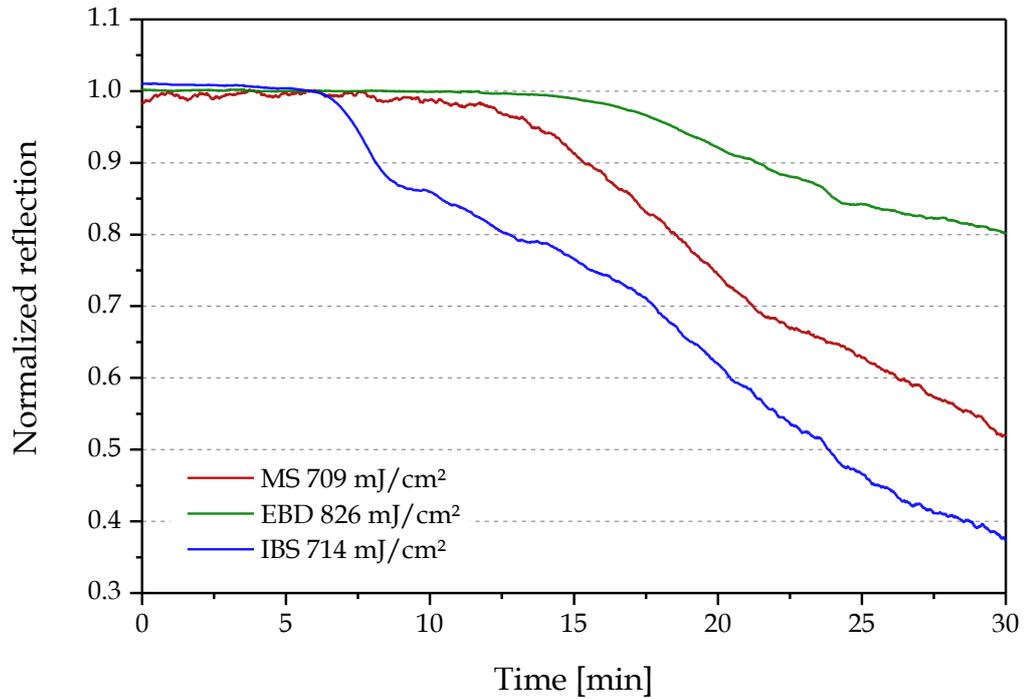
Figure 4.32: Normalized reflection of HR optics as function of irradiation time. Contamination pressure was 1.1×10^{-4} mbar with a peak fluence of $750 \text{ mJ}/\text{cm}^2$.

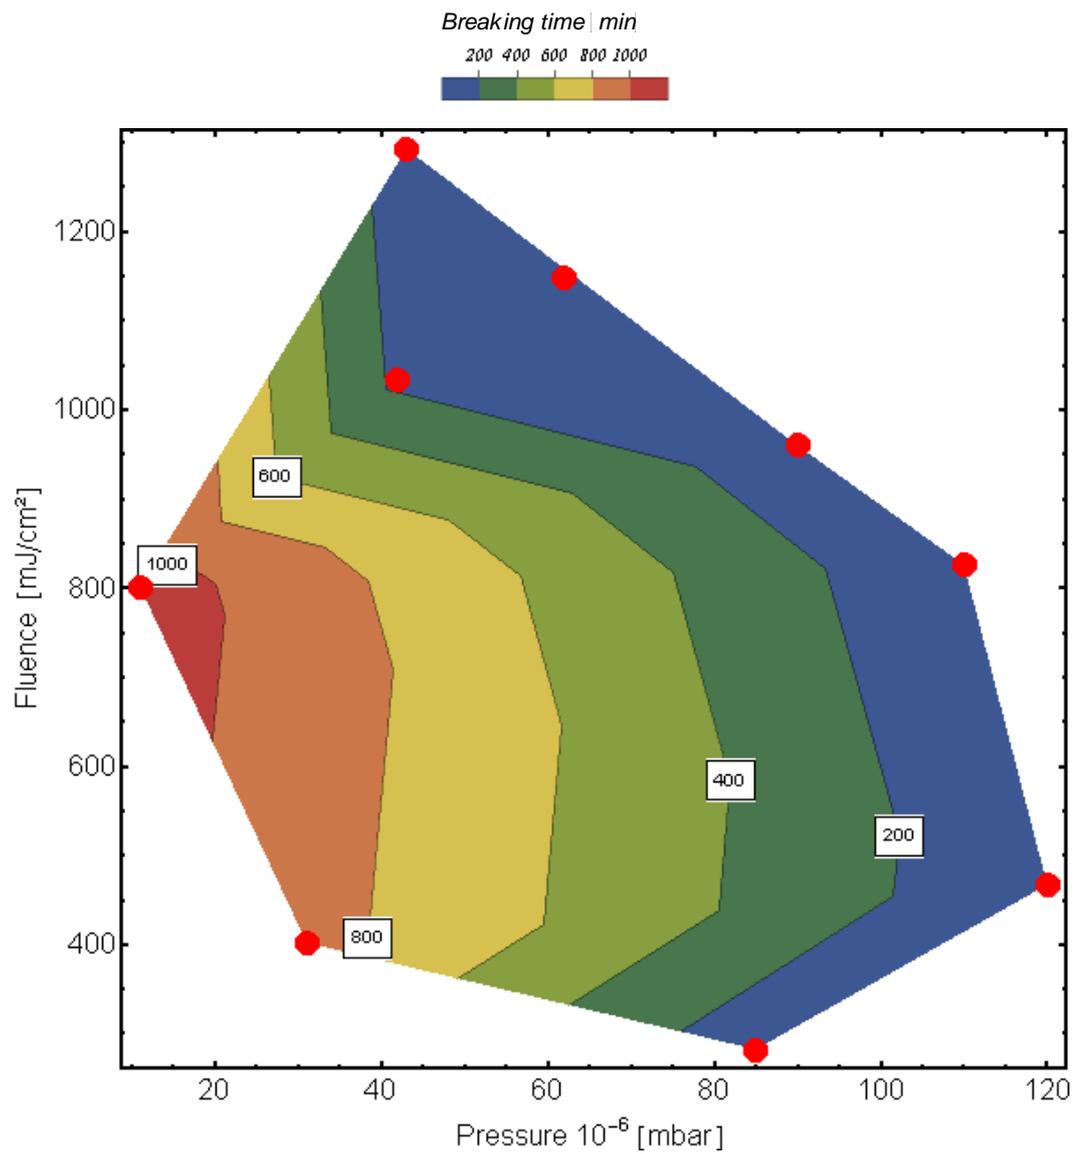
Figure 4.33: Surface plot of the break point of EBD samples in dependence of contamination pressure and fluence.

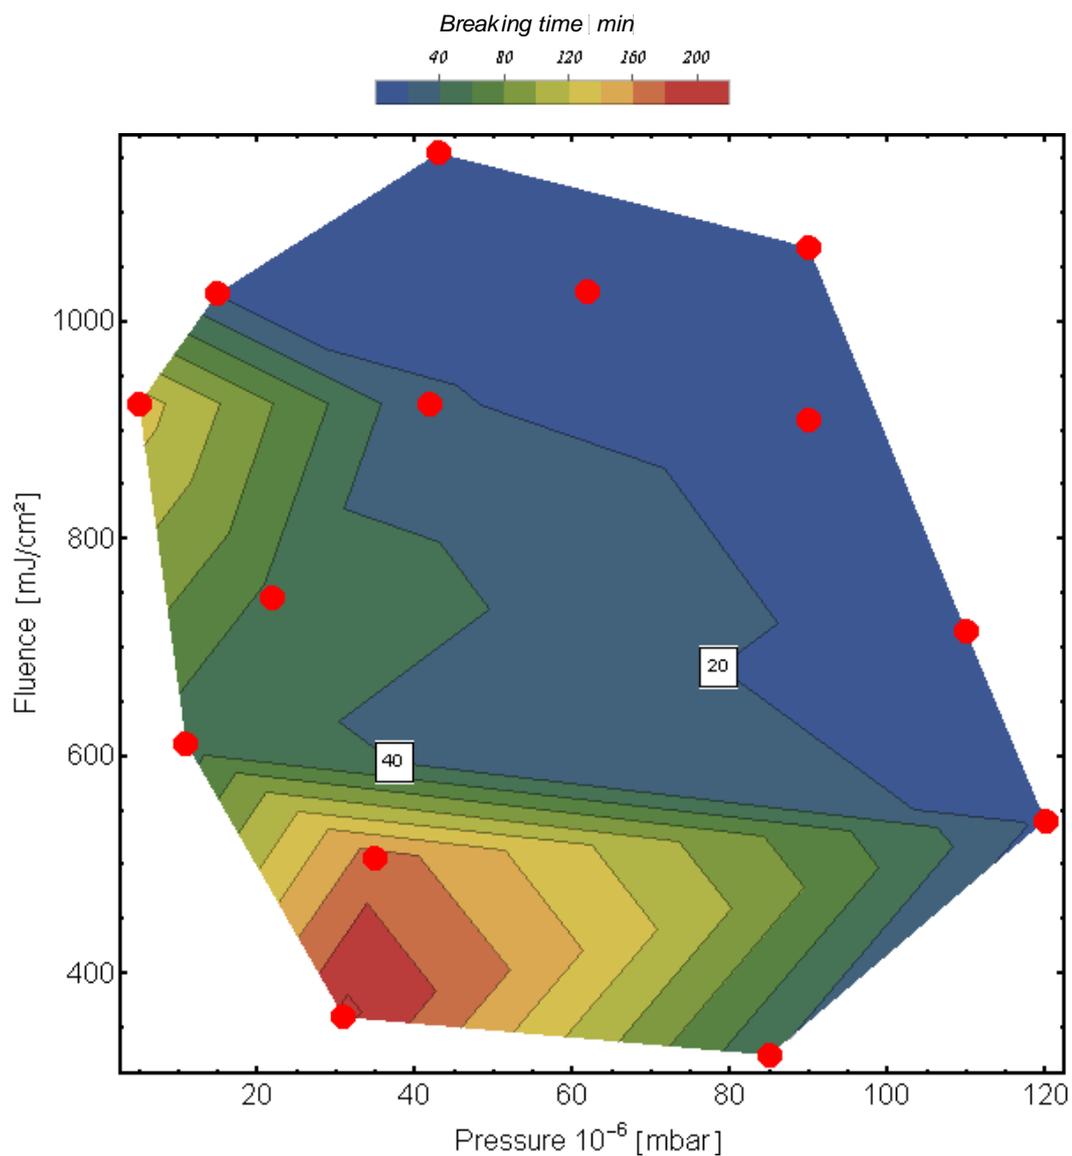
Figure 4.35: Surface plot of the break point of IBS samples in dependence of contamination pressure and fluence.

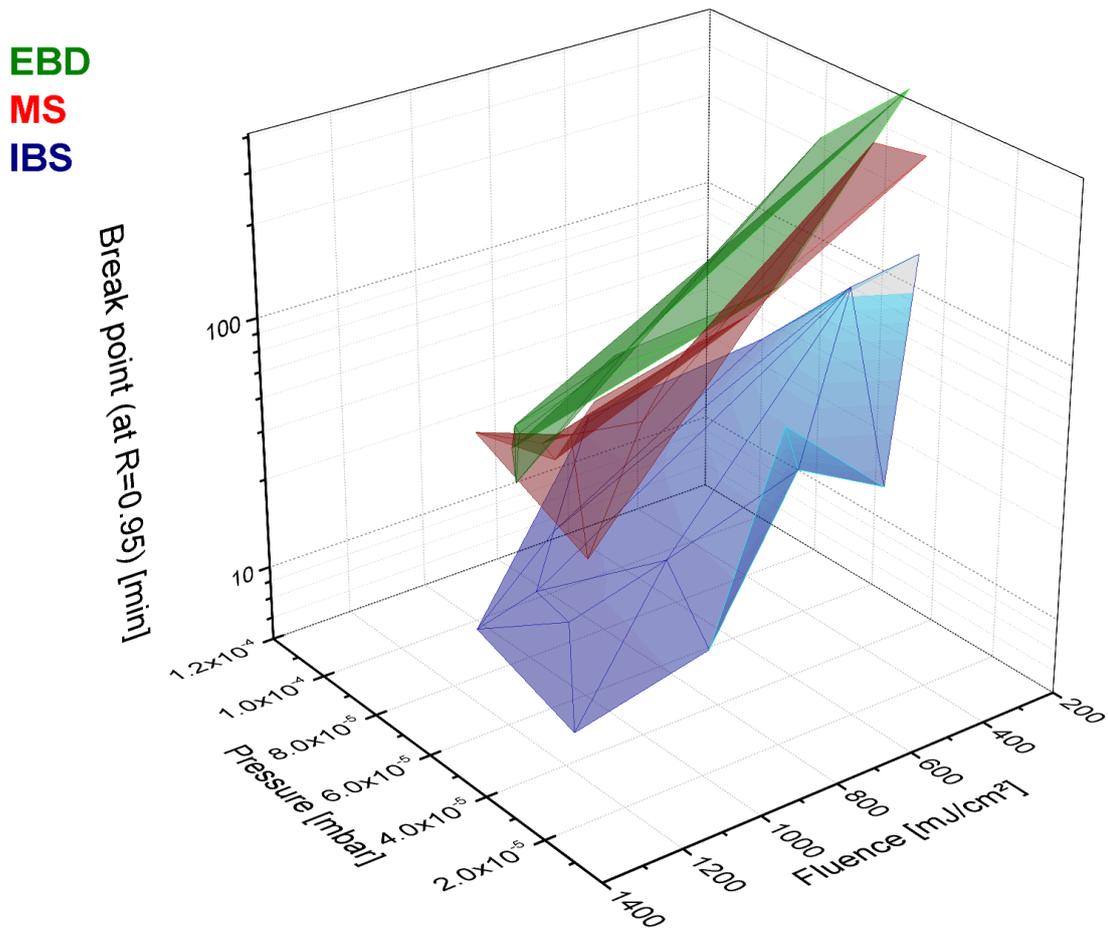
Figure 4.36: 3D-plot of the break point in dependence of fluence and contamination pressure of EBD (green), MS (red) and IBS (blue).

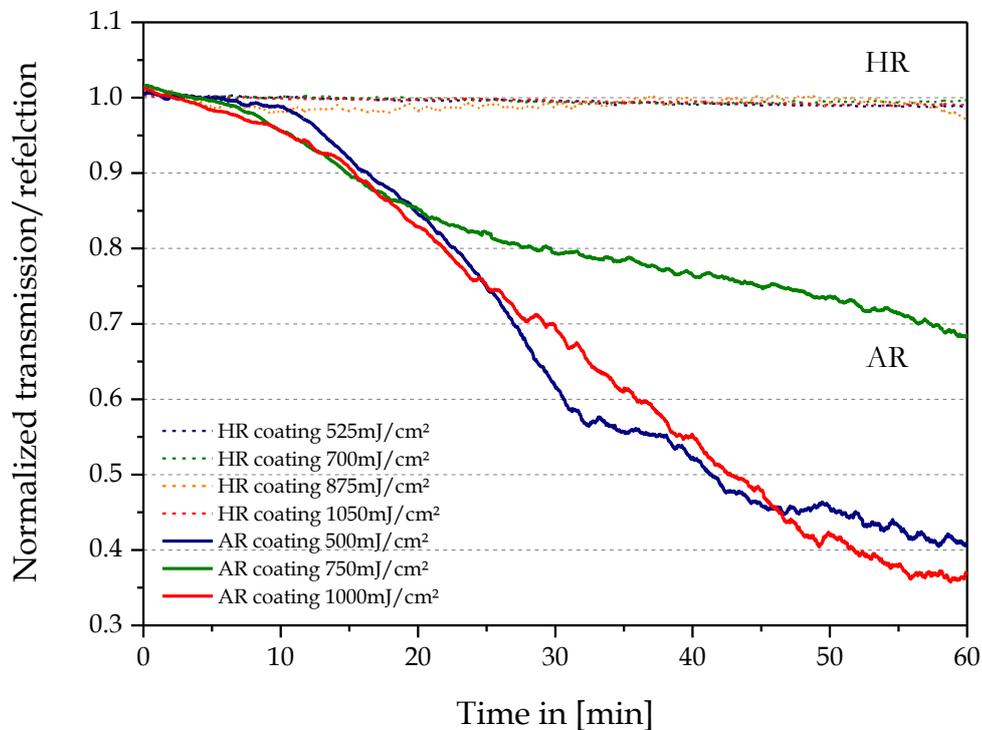
Figure 4.37: Normalized transmission for AR sample and normalized reflection for HR sample during LIC tests with different fluence. Samples are coated in EBD process.
