## Introduction

This work focuses on monitoring the ground motion and infrastructure stability in an urban environment, namely in the city of Bucharest. The city is located in the southeast of Romania and covers an urban area of about 285 km<sup>2</sup>. Due to its position on the banks of Dambovitza River and high underground water levels, the risk of subsidence in the area is significant. Moreover, its closeness to Vrancea seismic area increases the risk of seismic induced deformation in the area. Bucharest is a fast developing city with the average construction rate of 8-20% new buildings with respect to the existing ones. Consequently, the civil engineering industry faced new challenges related to the need of having taller buildings with deeper underground levels, a developing network of subway lines and more bridges with large diameter pillars' foundations. All these new works have an important impact upon the upper ground stability.

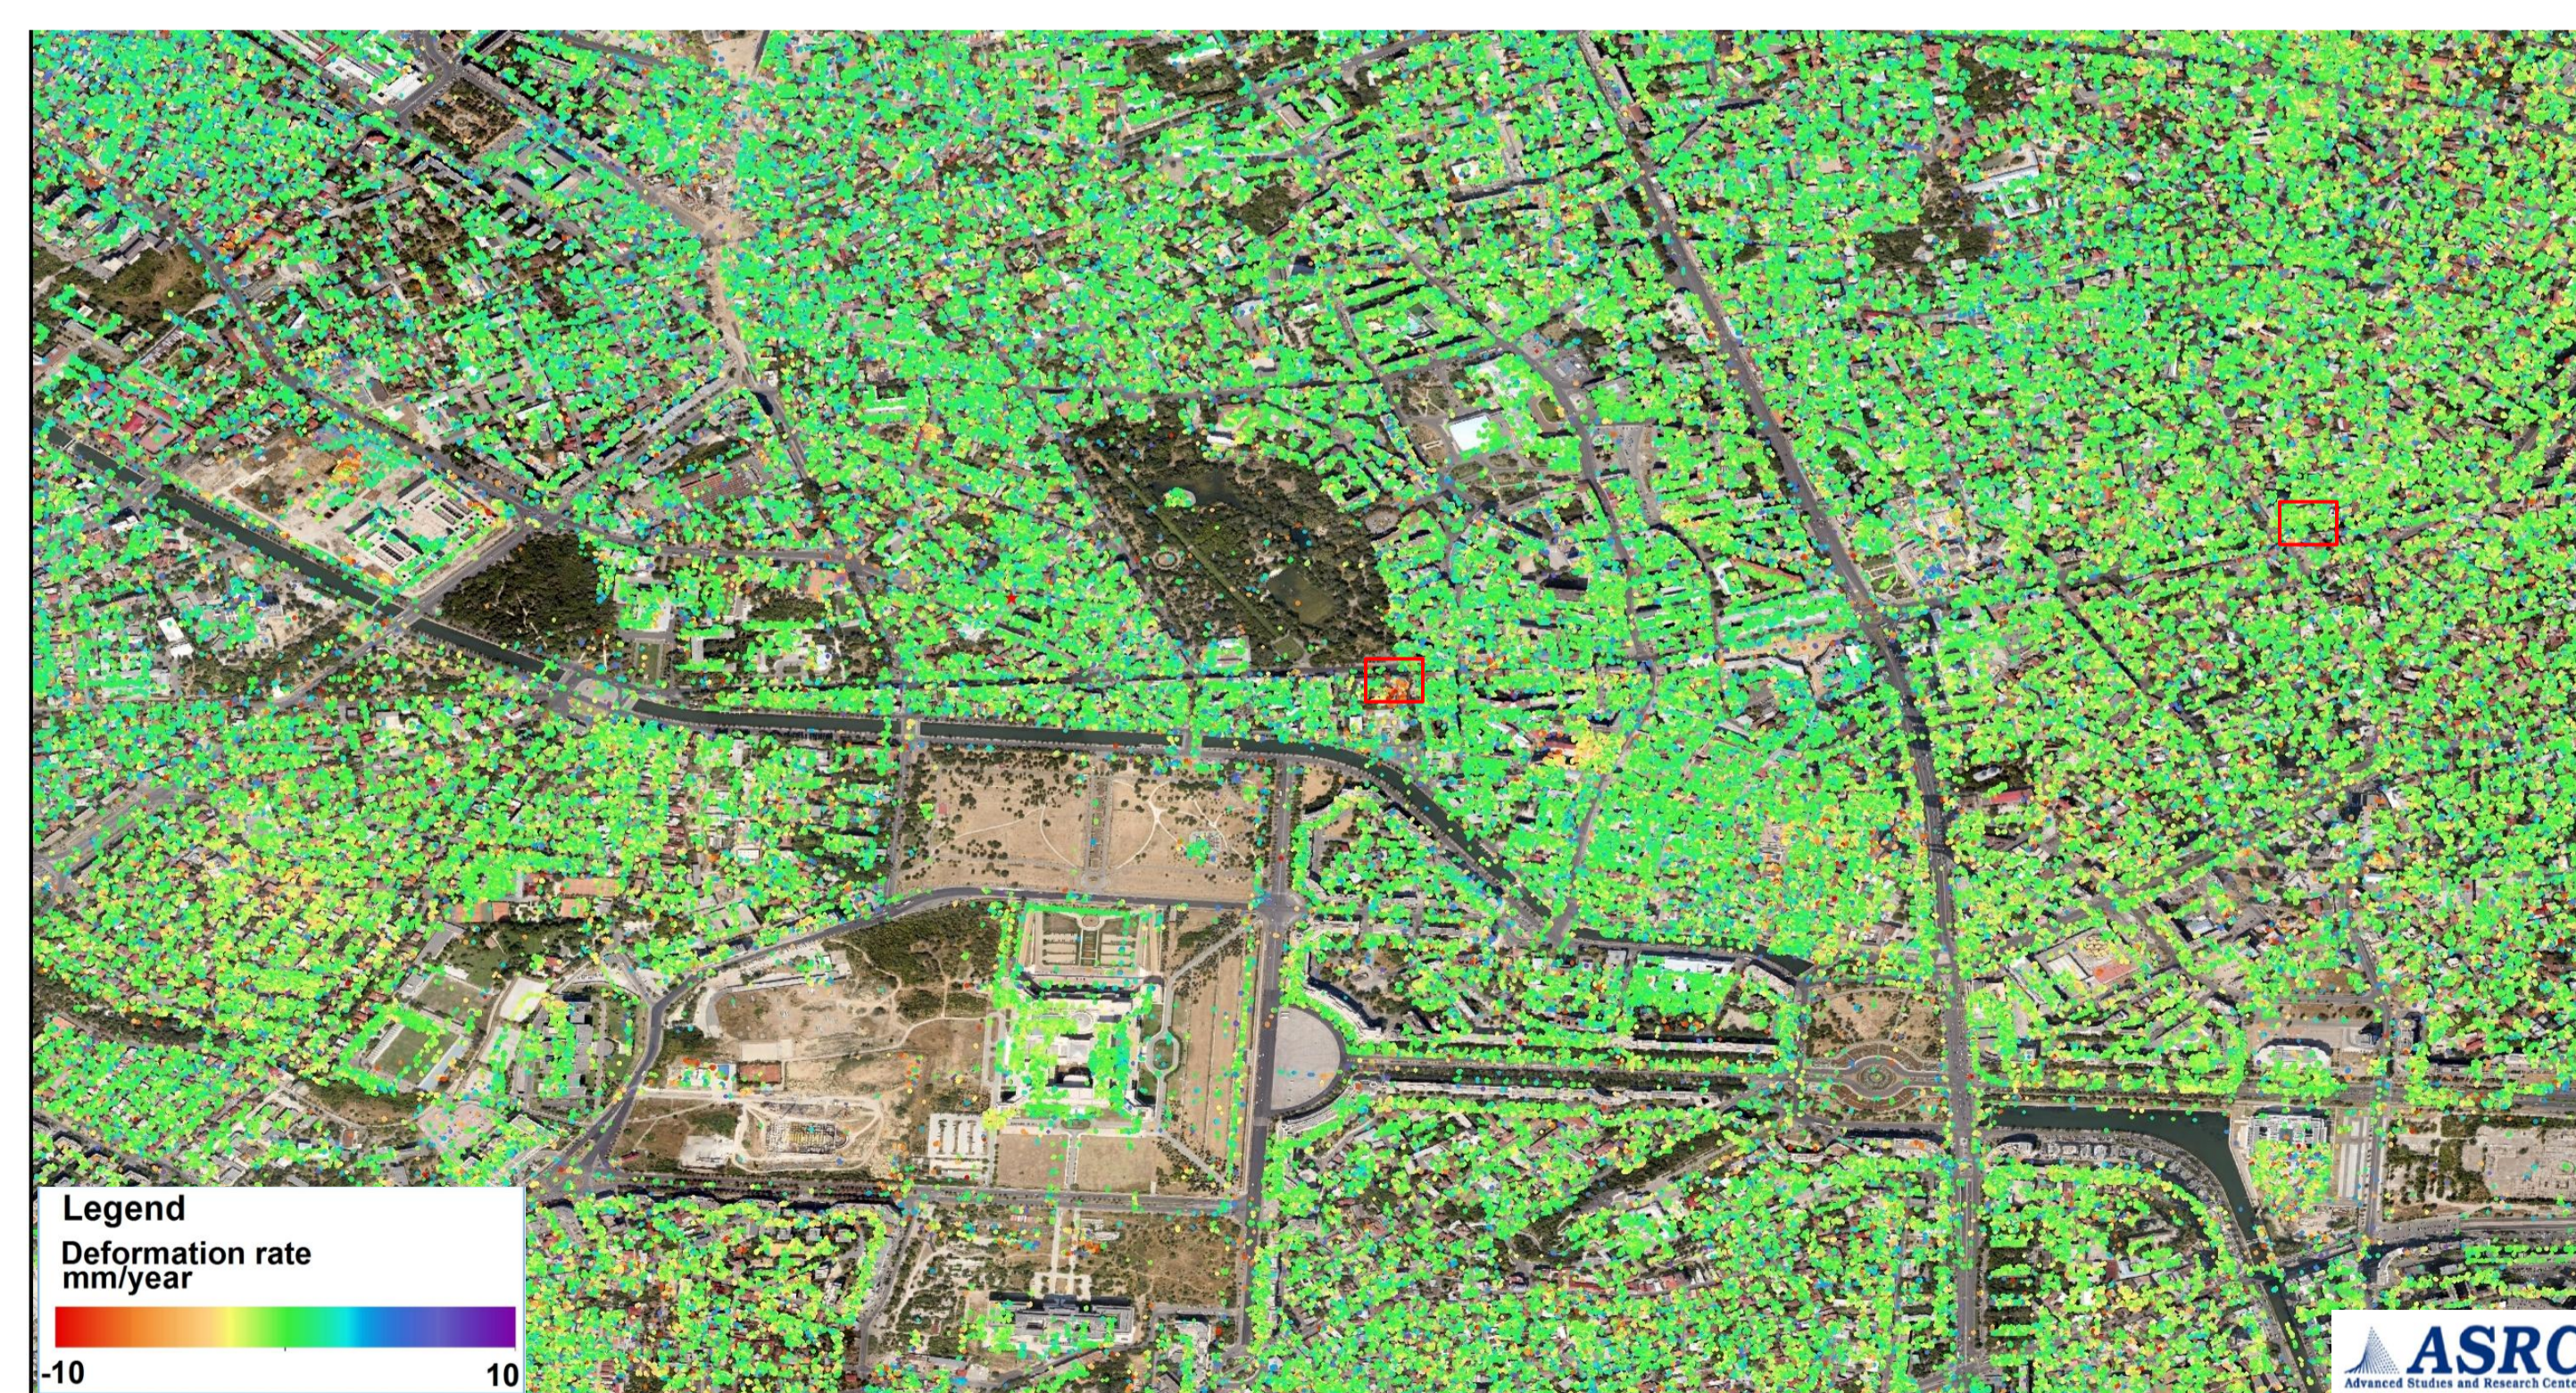
Fig. 4 Zoom-in view of the PSI deformation map on the central part of Bucharest; local subsidence and uplift areas may be identified, but also stable ones. Two examples are given in Figures 5 and 6.
