Going Beyond the Possible, Going Beyond the “Standard” of Spacecraft Integration and Testing!

– A Summary of the DLR Mascot AIV Activities within the Hayabusa2 Project from the First Unit
Hardware Test to Final Check-out before Launch –

Mascot, a small 11 kg Asteroid Lander on-board JAXA’s Hayabusa2 space probe, was launched on December 3rd, 2014. To catch this particular launch opportunity its development timeline needed to be heavily compressed so that current and well established verification processes could not be followed in order to finalize the project in the given time. Applying a unique mix of conventional and tailored model philosophies it was possible to dynamical adapt the test program to accomplish for the shortest planning and a suitable weighing of costs and risks. A strategy of Concurrent AIV helped to identify and mitigate design and manufacturing issues and shortened the test timeline further from a general 4-5 year phase to 2½ years. This paper provides a summary of the performed Mascot development process and its verification strategy which goes beyond the possibility of today’s *Standard* of Spacecraft Integration and Testing.

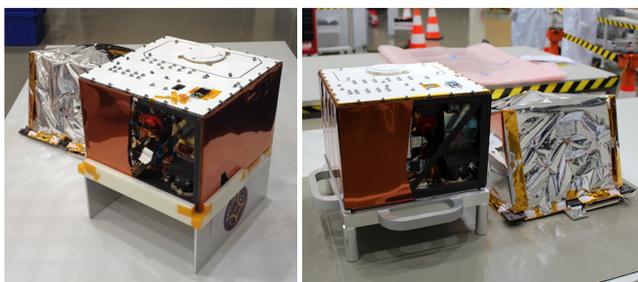
Fig. 5. Mascot EQM (left) and Mascot FM (right) after their respective final assemblies.

Since the EQM and the FM (Figure 5) performed near-parallel activities before being shipped only 3 months apart, comparing the thermal test results of both programs revealed some unexpected findings. There were differences in reaching steady state conditions with the used QM+FM Battery units. Although identical in design, indications were strong of an insufficient insulation. Since for flight there was still the decision to be made to use either the FM or the FS Battery, uncertainty about this non-similar thermal behavior had to be understood.

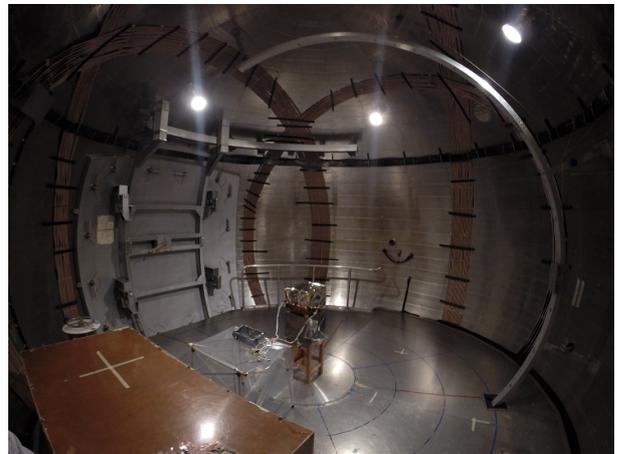
Fig. 7. Mascot FM during magnetic cleanliness test inside JAXA's Mu-chamber at ISAS Sagamihara.

Apart from the thermal behavior also the magnetic cleanliness of these two units had to be verified, which otherwise could have had a significant impact for the Magnetometers performance. Since the Mascot FM was undergoing the conducted EMC test inside the Mu-chamber, the IR-tested battery models were integrated after one another and dedicated measurements with the Magnetometer got clarifications for the batteries magnetic signature.

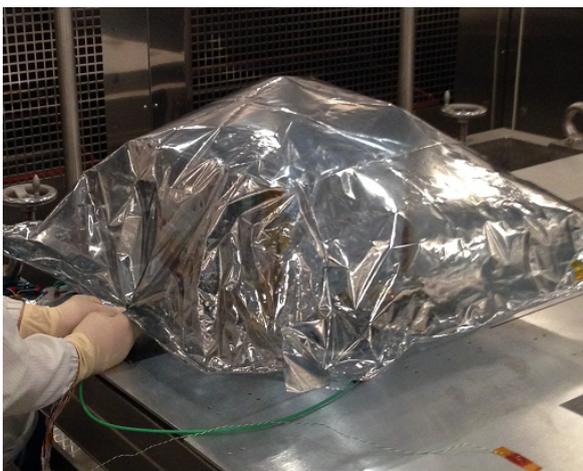
Fig. 8. Mascot FM during preparation for its low-temperature test inside JAXA's climate chamber at ISAS Sagamihara.

As mentioned above (section 1.4), during the last thermal vacuum test of the FM, the necessary heater power for the Microscopes duty cycle was found to be different than specified. Further investigation of this non-conformance indicated a mission critical situation for this instrument as a too low power output of the heating system would lead to severe damage during the relative cold cruise conditions. Disassembling the entire payload and sending in back to the manufacturer was not possible due to the tight schedule. A simple measurement of the heater resistance was also not

possible, as the redundant heating circuits were protected by thermostats which close the circuits only at a defined temperature of -30°C . Access to these thermostats was not possible and putting the unit or only the thermostats in such a temperature regime (e.g. by local cooling) without a controlled overall environment could have endangered other sensible instruments inside Mascot as neither cleanliness nor possible condensing droplets from surrounding moisture could be predicted. A small task force developed a quick and subtle strategy to put Mascot in a controlled climate chamber with controlled dew-point and where the low temperature requirements could be achieved. However, according to standardized verification processes such a method and at this point in time would have been non-negotiable. Mascot would have needed either to take the risk of losing one of its four instruments during cruise or would have needed to call a launch delay of the Hayabusa2 mission.

The solution to this problem was found once more in the good cooperation with the Hayabusa2 team being able to negotiate critical issues in a practical orientated best engineering sense. With a quick and thorough risk assessment (see table 2), the confirmation to use a suitable and available chamber, taking extra cleanliness and condensation precaution by sealing Mascot inside a clean bag and flushing it through the entire process with high purity dry nitrogen, the system and the payload teams could agree on this test. After a cooling/drying phase for about 4h in the chamber going from room temperature to -35°C at a rate of $15^{\circ}\text{C}/\text{h}$, the thermostats switched and the measurement of the heating circuits, which were extended and routed to the outside of the chamber, could be performed. The heater lines were indeed mixed-up which resulted in a higher heater resistance that very likely would have led the Microscope to see damaging low temperatures during cruise. The chamber was heated-up slowly back to room temperatures, Mascot was removed from the chamber and its protecting bag and a concluding inspection and functional performance test showed no alterations and a fully functional system.

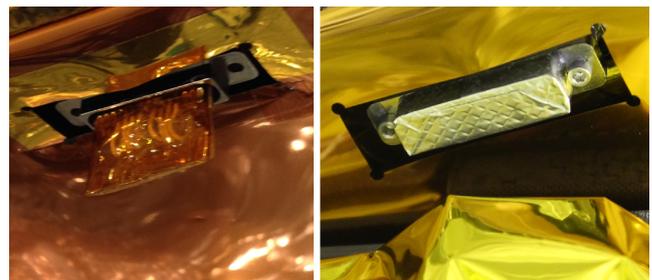
Fig. 9. Mascot termination plug; Left: EM, Right: FM (refurbished EM)

Shipping time did indeed prevent another green-tag item from being ready. A termination plug, short circuiting the open lines of Mascot's single external accessible data connector used for hardwired commanding during ground tests, did not manage to find its final destination. Without a proper termination plug, however, the on-board computer could not make use of its redundant signal path. The risk assessment list was carefully answered and it was agreed to refurbish an available EM terminator on-site with available flight-like materials into an FM (Figure 9).

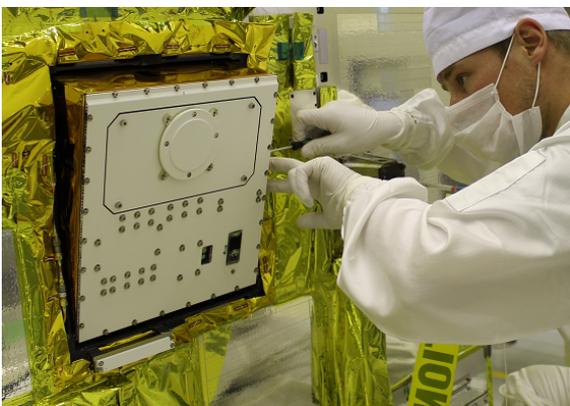
Fig. 13. Final hands-on activities on the Mascot FM including securing the shifted grounding plate, Frame-MLI adaptations and re-installation of the termination plug.

The EQM successfully performed its program for cruise thermal vacuum, shock and vibration, conducted and radiated electromagnetic compatibility (EMC) and full functional tests of all subsystems and instruments. After some small refurbishments the EQM was shipped to Japan to undergo the first part (thermal vacuum) of the *Hayabusa2 Spacecraft Level* acceptance tests, testing also basic communication with the mother spacecraft. During this period late change request from the Hayabusa2 team to make modifications on the systems frame-MLI and the repositioning of the main grounding plate were discussed and which were agreed with the Mascot team to be implemented with the soon to arrive FM (Figure 13).
