AUTOMATIC DAMAGE DETECTION FOR SENSITIVE CULTURAL HERITAGE SITES

KEY WORDS: Cultural heritage, change detection

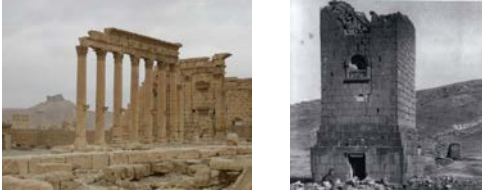
Figure 1. Temple of Bel (left) and tower tomb of Elahbel (right). Photos taken by T. Paulette in 2005 and by Wolfe Expedition in 1885, respectively.

Outside the walls of the city its ancient necropolis is to be found. Here under examination is the western necropolis, better known as Valley of the Tombs. This cemetery contains some impressive built tombs belonging to the architectural type of the tower tombs (e.g. Tower tomb of Elahbel, Tower tomb of Atenatan, Tower tomb of Julius Aurelius Bolma, Tower tomb of Kithoth Tomasu). These tombs were erected during the 1st and 2nd centuries A.D. to serve the wealthy inhabitants of the city, and their existence and preservation alongside the study of the burial customs to be detected within the tombs, consist of an important source of information for the lives of the elite class of that time. The tower tombs contained rich decoration such as wall paintings, funerary sculptures, inscriptions, and sarcophagi. Photographic documentation of the described sites is reported in Fig. 1.

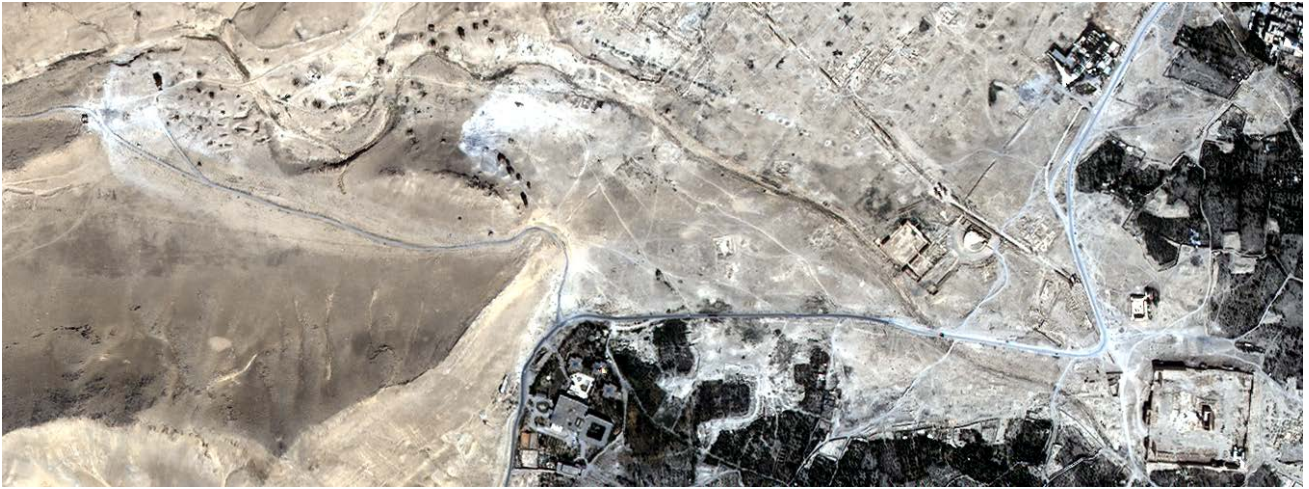
Figure 2. Subset of the WorldView-2 image acquired on the 27th of August 2015 (©European Space Imaging / DigitalGlobe).

Figs. 2 and 3 report the subsets of two WorldView-2 datasets acquired outside the city center of Palmyra, Syria, on the 27th of August and 2nd of September 2015, respectively. Henceforth we refer to these two dates as t_1 and t_2 .

At time t_1 the Islamic State (IS) had already destroyed several Cultural Heritage (CH) sites in the area, namely the tower tombs of Atenaten, Iamliku, and the Banai family, the temple of Baalshamin, and the Abu Behaeddine shrine. Between t_1 and t_2 , other tower tombs and the temple of Bel have been damaged. In the figures the temple of Bel is located in the bottom right, while the tower tombs are scattered in the upper left part of the image.

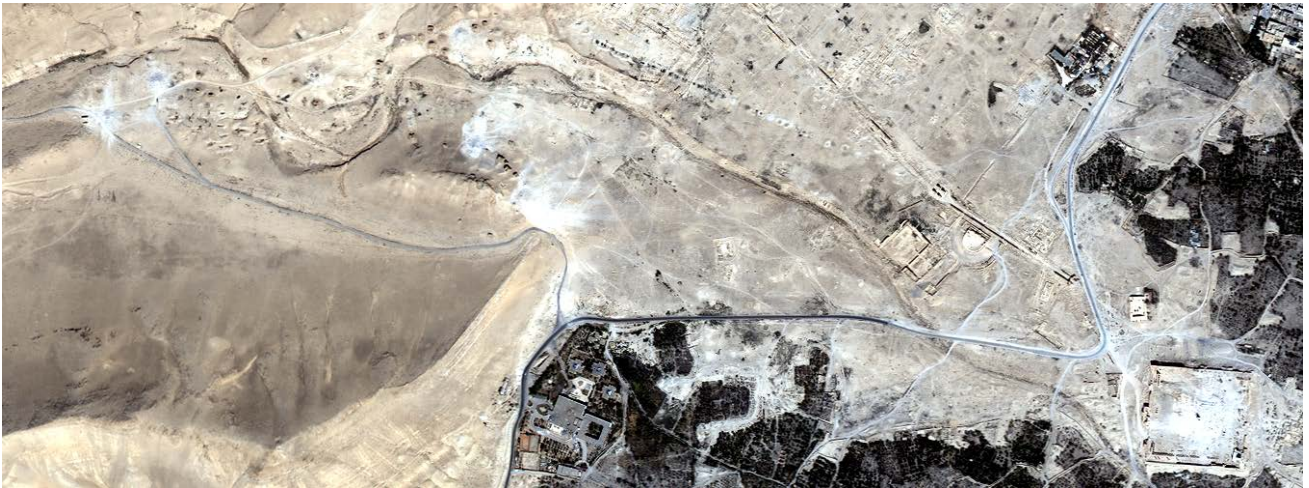
Figure 3. Subset of the WorldView-2 image acquired on the 2nd of September 2015 (©European Space Imaging / DigitalGlobe).

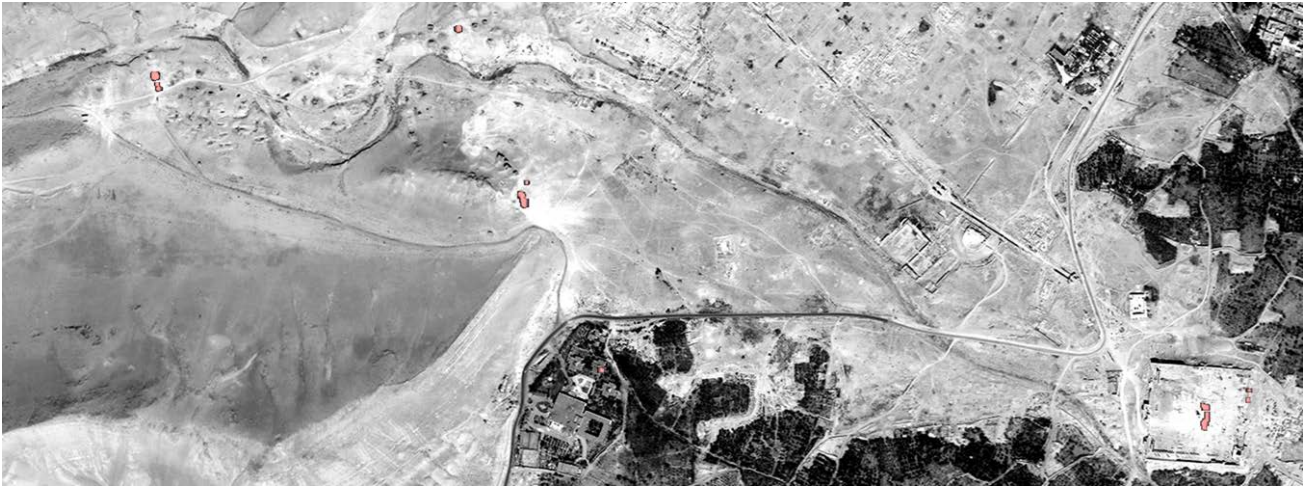
Figure 5. Post-processed change map overlaid on the 2nd of September 2015 WorldView-2 image (©European Space Imaging / DigitalGlobe).

Results are reported as red areas in Fig. 5. All of the tower tombs in the image destroyed by the IS between t_1 and t_2 are

correctly detected from the algorithm, well agreeing with the report on the situation in Palmyra in (Cuneo, 2015). On the right, the destruction of the central part and the eastern wall of the temple of Bel are also detected. The only false alarm is given in the lower central part of the image due to an artifact in the dataset acquired at time t_2 (see Fig. 6).
