Sulfur Poisoning of Ni/CGO Anodes: A Long-Term Degradation Study

Matthias Riegraf, Rémi Costa, Günter Schiller, K. Andreas Friedrich

German Aerospace Center (DLR), Stuttgart, Germany

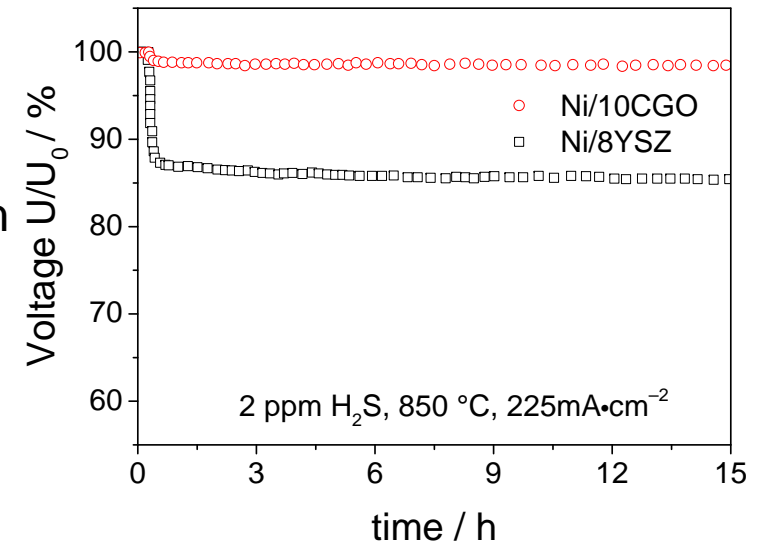
- Sulfur-containing impurities in common SOFC fuels
- Surface poisoning of Ni-based anodes with sulfur
- Higher short-term sulfur tolerance of Ni/CGO than Ni/YSZ in H_2/H_2O fuels [1]
- CO conversion on Ni/CGO possible even under severe sulfur poisoning conditions
- Long-term stability?

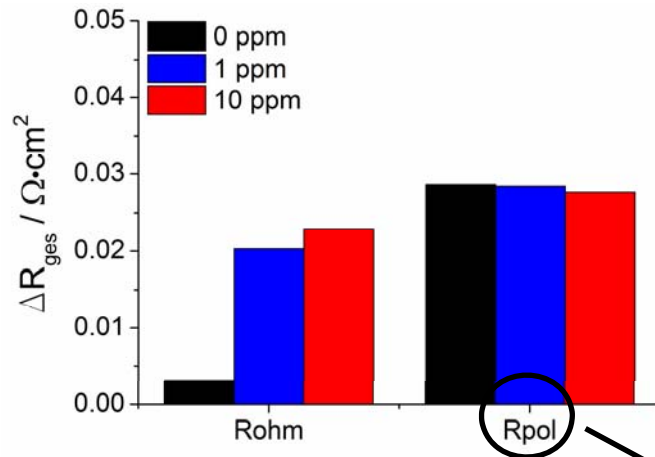
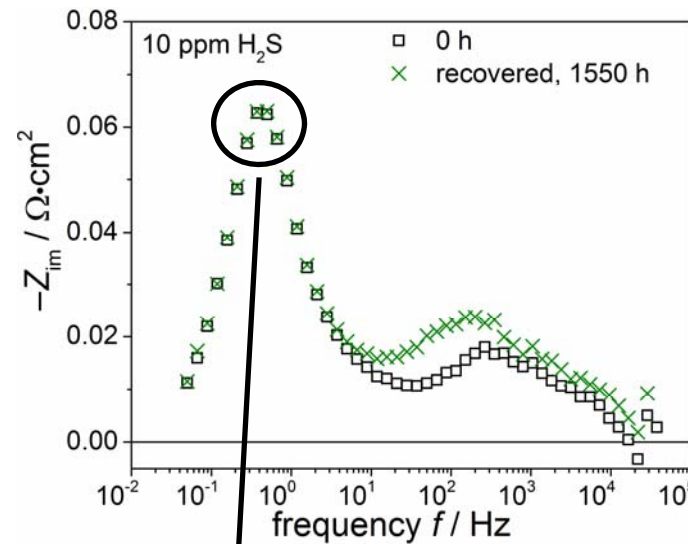
$T = 0.5 \text{ A} \cdot \text{cm}^{-2}$, 100 % H_2

- No resistance increase of anode charge transfer process
- No microstructural changes visible
- Increase of ohmic resistance due to electronic conductivity decrease of CGO?
