# Durability Testing of a Newly Developed Hydrophilic Anti-Soiling Coating for Solar Reflectors

**Abstract.** Anti-soiling coatings for solar reflectors are one of the most useful technical tools to reduce the amount of soiling accumulated on the reflector surfaces, contributing to reduce the water consumption and to increase efficiency in concentrating solar fields. A new anti-soiling coating formulation based on the hydrophilic effect has been recently developed by Tekniker and Rioglass. Reflector samples with this innovative coating were assessed through an accelerated aging test campaign as well as an outdoor exposition at the PSA by CIEMAT and DLR. According to the results obtained, the coating exhibited an appropriate behavior, which implies that the new product represents a promising solution to reduce water consumption.

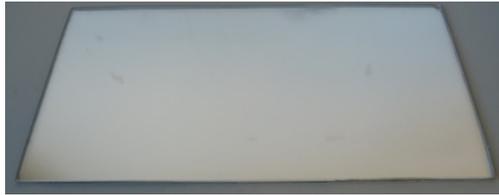
**FIGURE 1.** Picture of one of the reflector samples with anti-soiling coating, manufactured by Tekniker and Rioglass

Twenty reflector samples were manufactured by Tekniker and Rioglass and sent to the PSA to be tested in the OPAC laboratory (a joint research group between CIEMAT and DLR). All the samples contained an anti-soiling coating layer in the front surface (see Fig. 1). Additionally, some extra samples were manufactured without any coating to be tested as reference material.
