Improved Representation of Destructive Spacecraft Re-entry from Analysis of High Enthalpy Wind Tunnel Tests of Spacecraft and Equipment

James C. Beck^{a*}, Ian Holbrough^a, Thorn Schleutker^b, Ali Guelhan^b

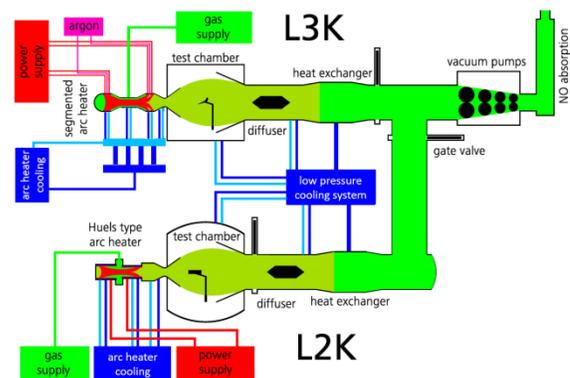
Fig. 1. LBK Facilities.

The L2K facility is one of the wind tunnels in the Hypersonic Technology Department of DLR Cologne. Along with the higher pressure L3K facility, it is part of the LBK facility, as shown in Fig.1 [8]. Significant advantages of the LBK tunnels are that they are supersonic and run at Mach numbers of between 3 and 8. While this is well below the flight Mach number (~Mach 25), it is more representative than many arc-heated facilities, which run in either the subsonic or transonic range. This allows something of the shock structure to be understood.

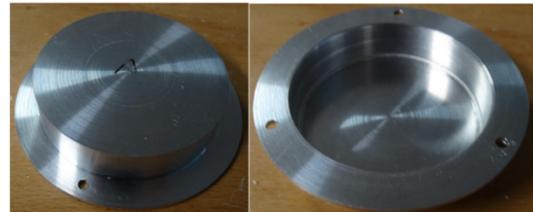
Fig. 2. Top-hat aluminium sample.

The test samples were designed specifically for this campaign. Previous testing on aluminium 7075 samples considered either thin coupons or thick monolithic samples, neither of which are representative of spacecraft structures. To address this problem, a 100mm diameter top-hat model with an 80mm top and 2mm thickness has been used, which is shown in Fig. 2.

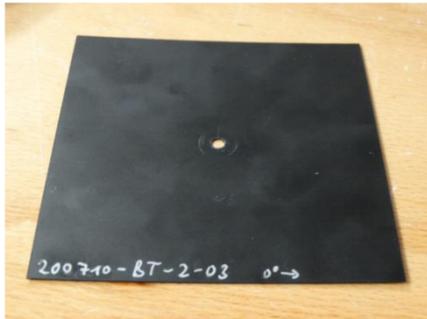
Fig. 3. CFRP Facesheet Sample.

stresses in circular CFRP pieces will not be representative of the behaviour of the flat panels, which are usually seen on spacecraft. Therefore, for this activity it has been decided to focus on sandwich panel facesheets, which are the major use of CFRP on spacecraft. An example of the 100x100mm sample is shown in Fig. 3.

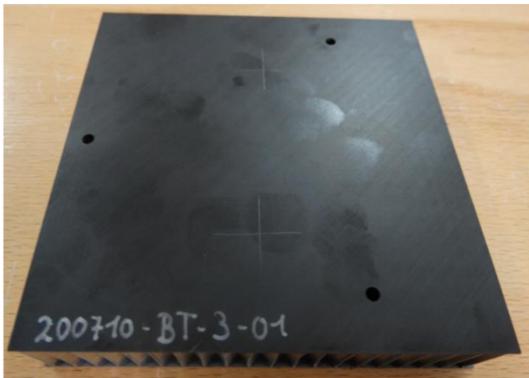
Fig. 4. CFRP Sandwich Panel.

Dialogue with another ESA project [7] has suggested use of sandwich panel samples of 20mm thickness as this is the standard for spacecraft external panels. It is worth noting that this results in panels that are relatively thick in relation to their 100mm dimension and raises the question as to whether the influence of the panel edges is too large. However, thinner sandwich panels are not standard, and it was decided to use standard panels for this test campaign given that the knowledge of panel demise behaviour is still very poor. A sample is shown in Fig. 4. The honeycomb material selected is a standard 3/16inch (4.8mm) cell size with a 25 μ m foil thickness and is manufactured from AL5056 alloy. A Hexcel Redux 312 UL film adhesive is used to join the facesheet to the honeycomb. The CFRP facesheet and honeycomb samples have been obtained from INVENT. The sandwich panel tests reported here use 4ply (0.3mm thick) facesheets, whereas the bare facesheets are 8ply (0.6mm thick).

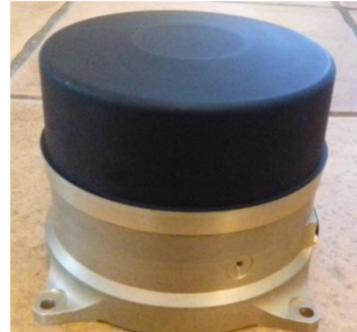
Fig. 5. Reaction Wheel Engineering Model.

With a reaction wheel having been identified as a key priority for testing, significant effort was placed into obtaining a suitable model. In dialogue with engineers from Rockwell Collins, a test object based on an RSI1.6 reaction wheel with a diameter of 120mm was proposed for testing. This has a smaller flywheel than the spacecraft flight reaction wheel, but has a similar architecture and utilises a similar ball bearing unit and the same flywheel material. Therefore, representative tests are expected. The test object is shown in Fig. 5.

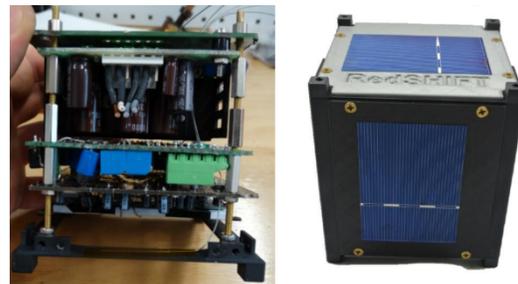
Fig. 6. CubeSat Test Object.

A CubeSat test object has been constructed by purchasing a structure from EnduroSat and attaching a number of electronics cards, side panels and a dummy solar array. The base structure is aluminium and the four electronics cards used (a sound card, logic board, power supply and mobile phone battery) have been attached using the steel spacer rods as shown in Fig. 6.

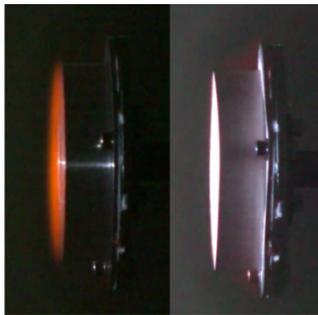
Fig. 7. Top Hat During (left) and after Outgassing.

During the heat up of the aluminium top hat, a number of interesting observations were made. Fig. 7 shows a red glow around the sample, which is understood to be due to the outgassing of the zinc components in the AL7075 alloy. The thermocouple data demonstrates that the top hat is close to isothermal and that the temperature at the start of the outgassing is 330°C and that the outgassing is completed at about the time that the melt temperature of aluminium is reached. Thermocouple TC1 is on the front face with TC2 and TC3 on the flange.

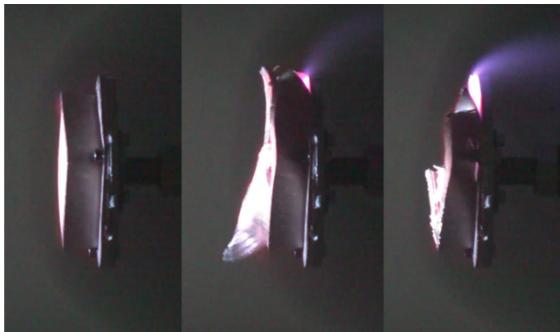
Fig. 8. Failure of Aluminium Top Hat.

The top hat is then observed to undergo a catastrophic failure. As shown in Fig. 8, the top of the hat moves inwards and the bottom outwards. The top

hat is blown apart, the walls fail and only a few remnants attached by the screws to the sample holder remain. No large parts were retrieved from the wind tunnel, confirming that the failure was indeed catastrophic.

This suggests that contiguous aluminium parts may not melt resulting in shear of small droplets, but can fail in some form of more catastrophic manner which is essentially caused by the tearing of the protective oxide layer under deformation of the molten material it contains.

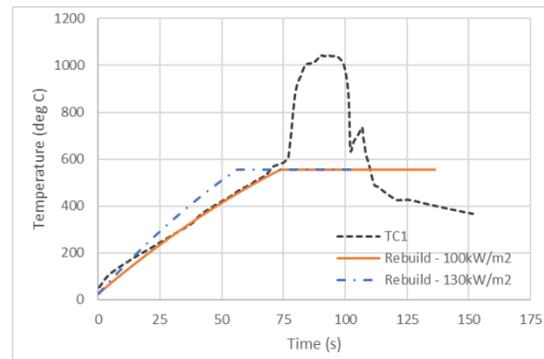
Fig. 9. Aluminium Top Hat Test Rebuild.

Performing a simple isothermal model rebuild on the top hat test using the SAM code [10] and the heat fluxes calculated via CFD rebuilds yields Fig. 9. Using the nominal 100kW/m² flux provides a very good reconstruction of the front face temperature profile. It is interesting to note that the point at which the code would predict a full demise of the top hat is about 40s after the catastrophic failure seen. This suggests that the aluminium is some way from being fully molten when it fails catastrophically, but that it occurs after the melting point is reached at the surface, due to the protective oxide layer. In this case the catastrophic failure occurs once approximately one-third of the material is predicted to have melted, which suggests that current models of aluminium failure in re-entry tools could be conservative.

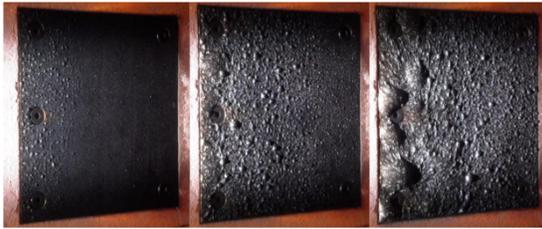
Fig. 10. Bubbles in Aluminium Shear Test.

The strength of the aluminium oxide layer is confirmed in the shear tests. In this case outgassing is evident in the production of small bubbles which gradually grow as shown in Fig. 10. The motion of the bubbles downstream and their bursting can be seen clearly, and therefore, it is likely that these are gas bubbles. These should be distinguished from the larger bulges of liquid aluminium which can be seen in the right hand image of Fig. 10.

The shear forces are estimated at 25N/m² via CFD rebuilds using the TINA code, and it is clear that these forces are insufficient to tear the oxide layer. Indeed, the molten aluminium inside the oxide layer is observed to sag under gravity, which eventually causes the failure of

the oxide ‘bag’ and the release of the molten aluminium contained within.

In this test, there are some useful images from the high speed camera. It is evident that the oxide bag does not simply tear, but continually tears and reforms, with the mass being released in bursts.

The rebuilds of the shear test, again using a simple isothermal model in SAM, suggest that at the time of the material slump under gravity approximately 40% of the aluminium mass is molten, which is reasonably consistent with the timing of the oxide failure in the top hat test. This suggests that the motion of the molten aluminium drives the oxide layer failure, and the subsequent demise of the aluminium structure.

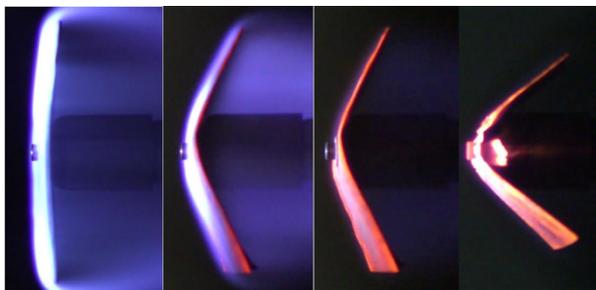
Fig. 11. Sequence of Stills from CFRP Test.

The purpose of the stagnation configuration CFRP test was to assess the likelihood of a charred CFRP material, where the matrix is essentially completely ablated, losing its structural integrity under aerodynamic load. The idea was that the carbon fibres may break, resulting in fragments reaching the ground that pose no risk. In practice, the test did not proceed as expected. As shown in Fig. 11, the panel essentially folded in a 2D manner, and very little flutter of the carbon fibre was observed as the facesheet retained something of its structural integrity. This continued until the bending of the panel was significant enough that sufficient fibres could be removed leading the panel to break.

As soon as the facesheet was placed into the flow, the outgassing due to pyrolysis started. The plies on the facesheet could be seen to be slightly lifted such that the gas could escape, resulting in a rippled surface and

It was evident that the heat fluxes are higher at the edges than at the centre of the sample, which is consistent with the CFD calculations and the thinning of the boundary layer with the acceleration around the corner. With the bending of the sample, it could also be observed that the heating to the stagnation region was higher than the heating on the flat, inclined surface.

The first major fibre removal occurred after more than 10 minutes of test time, showing that the CFRP material is highly resistant to the heat flux. It was noticeable that the increased bending tightened the radius of the stagnation region and resulted in increased heat fluxes and more fibre removal.

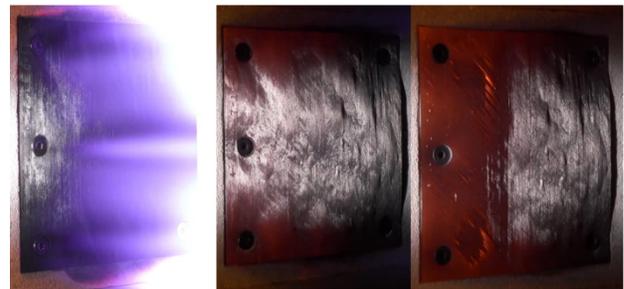
Fig. 12. Stills from CFRP Shear Test.

In the shear test, the pyrolysis of the CFRP matrix again begins as soon as the sample enters into the plasma flow, with outgassing immediately evident. The surface of the facesheet becomes uneven due to the plies being lifted by the pyrolysis gas pressure as it finds routes through to the surface to escape. The outgassing and the uneven surface are shown clearly in Fig. 12.

Once the outgassing is complete, the fibres can be seen to be removed layer-by-layer from the front of the sample. Whereas 25N/m^2 was insufficient shear to damage the oxide layer on the aluminium samples, it is sufficient to augment the loss of oxidising carbon fibres from facesheets. This mechanical effect can be observed by the different plies having fibres at different orientations, at least three such layers are visible in the right hand pane of Fig. 12. The temperature of the sample can also be seen to increase as it thins.

The removal of the material from the bolts is also interesting as there is no tearing involved. Previous work with aluminium facesheets has shown that the facesheet needs to tear to be removed from an insert, where a CFRP facesheet does not [6]. This is consistent with the observations here, and the most likely explanation is the difference in the coefficient of thermal expansion between the CFRP material and the steel bolts.

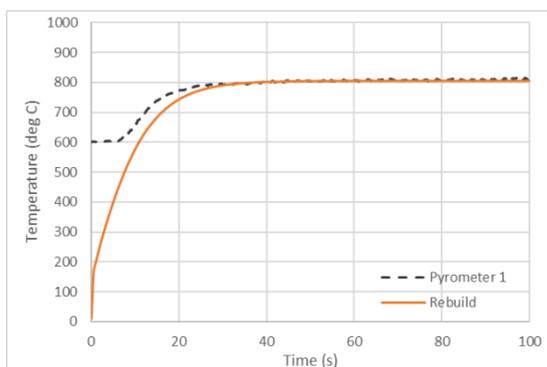
Fig. 13. CFRP Stagnation Test Rebuild.

The temperature measurements show a steady state of 800°C, which would result in the CFRP being assumed to be fully charred in a few tens of seconds within the current model in the SAM code. At this point it is assumed that the panel is relatively weak and would no longer pose a casualty risk were it to reach the ground. Given that these facesheets are very light, this is indeed likely to be the case. However, it is clear that the integrity of the facesheets is maintained well after the pyrolysis gassing is complete. Therefore, these items can be expected to remain essentially intact through the re-entry, especially as they will rapidly slow due to their low ballistic coefficient. As a consequence, the current model is considered over-optimistic in its consideration of the demise of the facesheet. However, as shown in Fig. 13, the heat up of the sample and the radiative equilibrium temperature in the early stages of the test are well represented, even using a simple 1D solution. The key open point for casualty risk assessment is the criterion by which the composite sample can be considered to be demised.

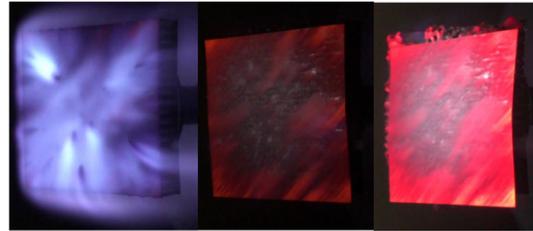
Fig. 14. Stills from CFRP Sandwich Test.

The first of the CFRP sandwich panel tests is performed in the standard stagnation configuration with the panel normal to the flowfield. Outgassing begins 2s after the sample is inserted into the flow and stops at 11s at which point the second ply of carbon fibres is visible. This can be seen in the first two panes of Fig. 14. The final pane shows the compression of the honeycomb which begins at 26s and is complete at 46s. Melting of the honeycomb at the top edge of the sample can also be observed.

Some of the compressed honeycomb remained within the facesheets and was retrieved after the end of the test. This demonstrates the relatively low mass of aluminium which is used in the honeycomb core of these standard panels. Also worth noting is that the hexagonal pattern was visible in the glue, which shows that the glue has not been fully oxidised, and that only slight damage to the facesheet was observed.

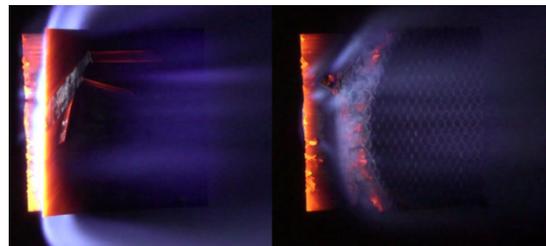
Fig. 15. Facesheet Removal in Panel Test at 30°.

Moving to a 30° angle of attack resulted in removal of the facesheet as demonstrated in Fig. 15. Of particular interest here is the recession of the honeycomb. Previous testing of panels with inserts [7] has suggested that the honeycomb removal is dominated by edge effects, and that the flow into the panel between the facesheets is minimal. This test suggests that this observation is driven by the presence of the insert/potting material, as it is not seen here. In this test, the recession can be well described by an elliptical profile, which is consistent with a laminar heat flux profile. This suggests clearly that the recession of the honeycomb is driven by the incoming heat fluxes and that the edge effects are not a factor.

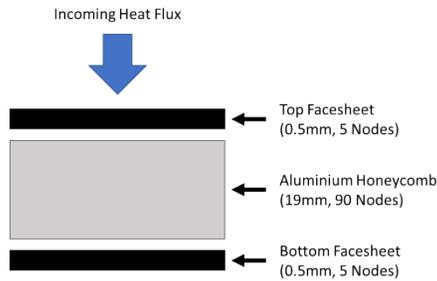
Fig. 16. 1D Sandwich Panel Model Layout.

The rebuilds here have been performed using a 1D conduction/ablation model (CAM) which has been embedded within the SAM simulation framework using the area averaged flux value of 120kW/m² derived from CFD runs. The 1D model consists of two facesheets of 0.3mm thickness and a proxy aluminium core of 19.4mm thickness which uses a density of 40kg/m³ and a thermal conductivity of 1.2W/mK (the remaining properties used are those of standard aluminium). The layout of the model is given in Fig. 16, with the facesheet thicknesses varied to be appropriate to the specific test.

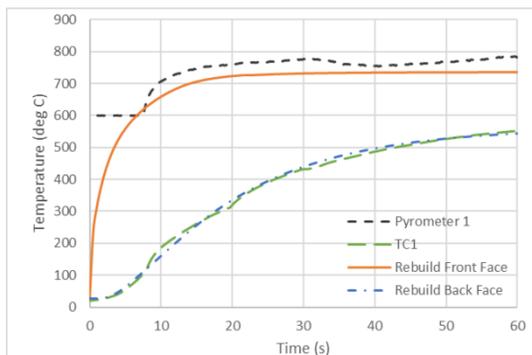
Fig. 17. Rebuild of CFRP Panel Test.

Fig. 17 shows that the front face temperatures are very well captured in the test with the panel at 90° to the flow. The back face temperature is also extremely well represented in the model, suggesting that the conductivity of the honeycomb and the density of the proxy 1D material provides a very accurate thermal diffusivity. It is interesting to note that there are no clear jumps in the thermocouple reading from the honeycomb collapse, which might be expected. Instead, the thermal link between the front and back faces is consistent even during the honeycomb collapse, which is not explicitly modelled. Such an excellent rebuild is not generally expected with the simplified models used.

Interestingly, this simplified model also performed very well in the other sandwich panel tests at 60° and 30° angle of attack, suggesting that it could become the basis of a practical sandwich panel model for destructive re-entry tools.

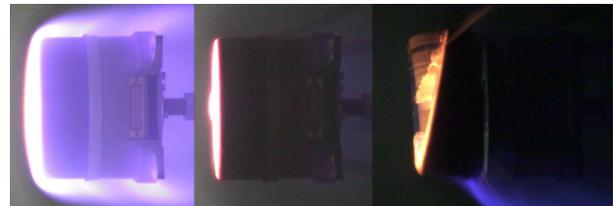
Fig. 18. Reaction Wheel Cover Failure.

top hat tests. The flow sequence to the failure of the reaction wheel housing is shown in Fig. 18. There is a very bright radiative emission from the pyrolysis of the paint soon after the test start which is shown in the left hand pane. The emission also allows some of the flow structure to be observed. Impingement of the flow on the base/housing connection can be observed, and it is evident that the flow is separated downstream of this location. The heating appears to be mainly on the front surface with the slightly raised housing centre emitting clearly more radiation than the remainder of the test object.

The red emissions indicate the outgassing of zinc, as observed in the top hat tests. There is also evidence of blue outgassing along the sides of the test object. The first evidence of some shape change of the front face occurs at 70s, with the slightly raised surface appearing to be pushed back slightly. By 90s, the front surface appears flat, and by 97s, the location of the end of the ball bearing unit (BBU) can be seen as shown in the centre pane of Fig. 18, with the front face of the housing being clearly molten material within an oxide bag. Very minor wobbling of the housing can be observed at 107s, with the major motion beginning at 122s. At 125s, the front face collapses and the housing is blown off, as shown in the right hand pane, and the sides of the housing still appear to be solid whilst the front face is completely removed.

The housing was retrieved from the floor of the wind tunnel, and essentially confirms that it was removed in a single piece. The lack of damage from landing on the floor of the tunnel suggests that it was still essentially solid at the time it was blown off. The housing removal is possible due to the failure of the glue between the housing and the base.

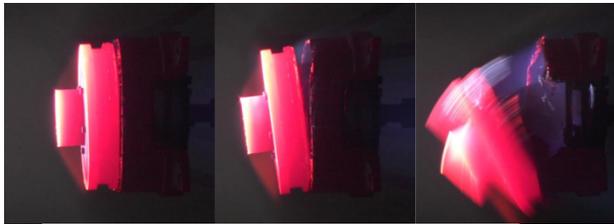
Fig. 19. Reaction Wheel Steel Part Removal.

Immediately on re-entering the flow, a red outgas could be seen. Again, the heating on the BBU and the edge of the flywheel could be seen from the radiative emission from the surfaces. A clear temperature profile could be seen in the BBU and flywheel, with a cooler region in the centre of the flywheel, which is consistent with CFD results on this configuration. Eventually, the aluminium rear structure became sufficiently molten that the BBU/flywheel structure was able to tear itself from the base under gravity as shown in the centre and right hand panes of Fig. 19. Once the flywheel had been removed, the exposed aluminium of the remaining housing was melted rapidly.

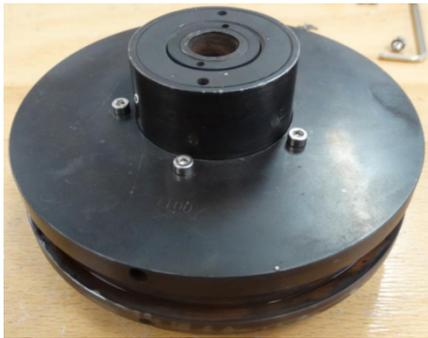
Fig. 20. BBU/Flywheel Test Object.

and the parts were also thermocoupled to provide extra data on the heat transfer. The test object is shown in Fig. 20.

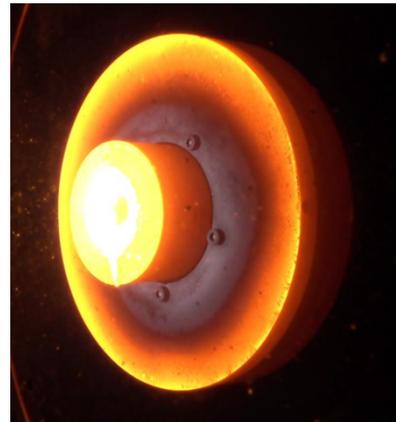
Fig. 21. BBU/Flywheel Under Test.

On insertion into the flowfield, green outgas is evident from the flywheel at 4s, and red outgas from 8s. At 20s, there is some evidence of surface change on the BBU front face, and it becomes white hot by 40s. At this stage, the relatively low thermal conductivity of the stainless steel, about 15W/mK , maintains a high temperature gradient through the material, and these temperature gradients can be clearly seen in the radiative emission. The front face of the BBU becomes steadily hotter to the point that the radiation is sufficiently strong that the centre hole cannot be seen. At this point there is some emission of very small particles from the BBU, the damage being observable in Fig. 21.

As the heat penetrates further into the BBU shaft, the particle emission stops. This is thought to be due to the reduction of the front face temperature due to the increased heat dispersion through the test object. The increased penetration of heat into the BBU is evident from the apparent sidewall colour. The temperature gradient on the flywheel is also evident with the central separated flow part being relatively cold, and the corner of the flywheel being yellow as shown in Fig. 19. It is noticeable that there is a clear conduction gap between the BBU and the flywheel and a large temperature difference between them is maintained. At approximately 450s, the object appeared to be in a thermally steady state.

The non-demise of the test object is driven by the high melting point of the stainless steel components, allied to the large radiating area. As only the front surface is heated, there is a much larger area for radiative cooling. This is confirmed using the thermocouple data and an energy balance.

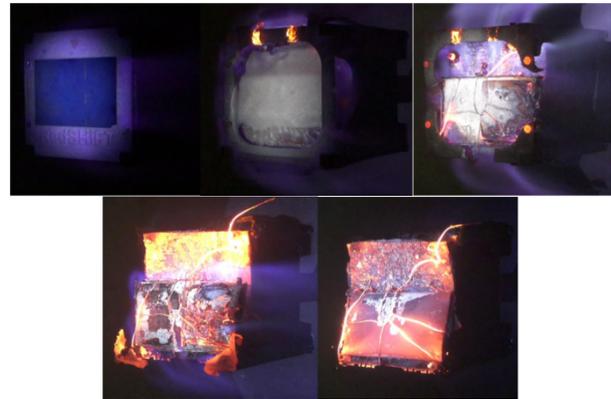
Fig. 22. CubeSat Test Demise.

The complete CubeSat is inserted into the flow as shown in the top left hand pane of Fig.22. Within 20s the polyamide plastic structures have failed leaving burning residue on the aluminium frame.

The next stage of the demise of the CubeSat begins with the outgassing of the sound card components. Following this, there is the first failure of the aluminium frame, at the centre of the front structural beam, as seen in the top right pane of Fig. 22. At 35s, there are visible aluminium drops shed from the structure. These drops are of the order of a few millimetres diameter, with their large size again being driven by the oxide film. The corners of the aluminium frame are observed to melt, followed by the top frame material as shown in the bottom right pane of Fig. 22. The sound card outgassing stops at about the same time. The aluminium side struts then begin to melt, and this recession is relatively fast.

The battery cover can be seen to have flaked, but not melted, and the GFRP sound card is also hot, but not molten in the bottom right pane of Fig. 22. The aluminium sides are melted down to the card level, and the larger radius of curvature of the overall geometry is evident in the flow structure. At this stage, there is an apparent steady state, although there is a continual slow sag of the structure.

The high speed camera data is very helpful in this case due to the complexity of the phenomena being observed, particularly in the failure behaviour of the aluminium struts, some warp is evident leading to a dislocation in the strut where the sides are displaced. This is more likely to be due to thermal stresses than aerodynamic forces and is most likely evidence that the material is very close to melt. The behaviour of the oxide film is also very clear.

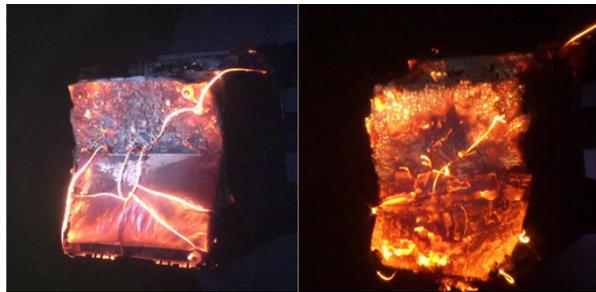
Fig. 24. CubeSat Electronic Board Heating.

The right hand pane of Fig. 24 shows the residue of the battery against the sound card, and the melting glass at the top of the sound card. The flow of the glass droplets can be seen, and is very slow. Tendrils of glass form, and the card warps, but does not lose its basic structure. Again, the structure as a whole slumps slightly, and the electronic components are all destroyed, but the GFRP cards are still structurally intact, and the steel rods and spacers which hold the cards in place provide the overall integrity of the structure.

On insertion into the flow, the battery outer layers, which had been expected to demise in the first test, quickly fail. The first GFRP melt on the sound card is observed before the battery inner layers fail resulting in some of the battery structure being pressed against the sound card protecting the lower parts. The left hand pane of Fig. 24 is just before this occurs and shows that the GFRP card is charred, but intact.

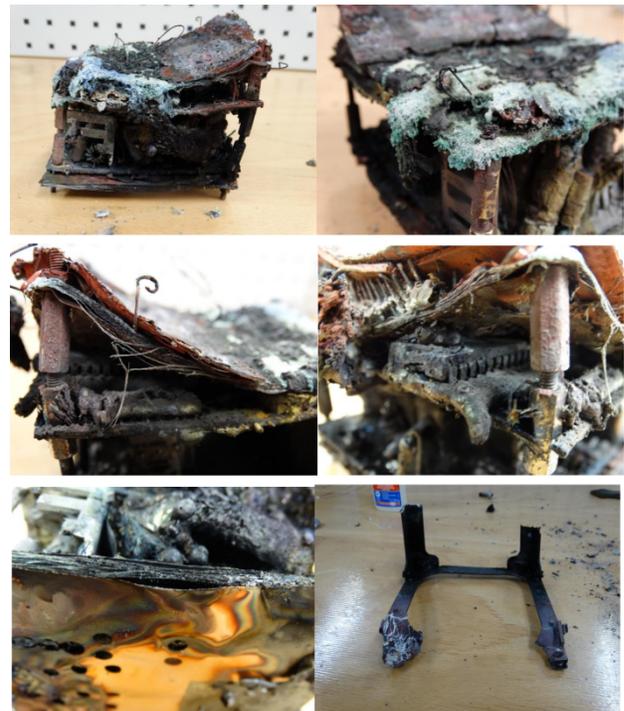
Fig. 25. CubeSat Remains.

As observed in the reaction wheel tests, a large amount of debris was collected from the floor of the wind tunnel post test. This included some aluminium structure parts, electronics components, and molten plastic. A post-test inspection of the remaining CubeSat structure was also undertaken, and a number of images are shown in Fig. 25.

The bottom panes show the delamination of the electronics boards to reveal copper layers, and also the remaining rear aluminium frame. The delamination of the boards suggests that in a complete re-entry, where a CubeSat would be expected to reach higher fluxes, the demise of such an object is still likely. However, this test suggests strongly, that some care is required to establish the demisability of even relatively small objects, and that the demise characteristics of common spacecraft components is not well known.
