FIRST TRIPLE REXUS CAMPAIGN – FLYING SYSTEMS TWICE ON ONE ROCKET CAMPAIGN

ESSEN, GERMANY
16-20 JUNE 2019

Katharina Schüttauf⁽¹⁾, Frank Hassenpflug⁽²⁾, Philipp Koudele⁽³⁾

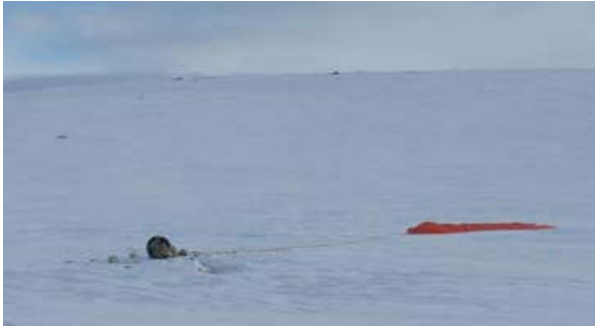
Figure 3. Indications of hard payload landing with fully stretched but closed canopy

REXUS 23 was launched on March 04, 2019. During the parachute sequence, an incident occurred concerning the main parachute's deployment. Instead of a nominal filling process right after the complete extraction as well as stretching of the suspension lines and the canopy, the main parachute did not fill correctly and remained in an unfilled condition with the canopy only acting as a streamer body. Until touchdown, 41seconds after the main parachute's activation, this condition remained unchanged, resulting in a hard payload landing with an impact velocity of approximately 55-60m/s. (see Figure 3) [4]

An investigation was immediately launched and completed on-range. The cause was identified. For the fixation of main parachute suspension lines on the designated nylon patch of the main parachute packing bag, a special breaking thread is used. During nominal parachute extraction, the stretched suspension lines rip the breaking thread fixations instead of being torn off the nylon patch and still enclosing the suspension lines. During the main parachute inspection one single loop of the respective breaking thread has been found around all suspension lines, approximately 90cm below the canopy base. After this analysis the following root cause conclusion can be drawn: Instead of ripping, the second or third (counted from the canopy base) fixation/breaking thread has been torn off the nylon patch and stayed undamaged around the suspension lines approximately 90cm from the canopy base and thus preventing the filling of the canopy. Without the correct canopy filling, the transverse opening forces are very small in comparison to the thread's breaking strength, thus keeping the loop and all fixation/breaking threads at the canopy and reefing line attached. [4]

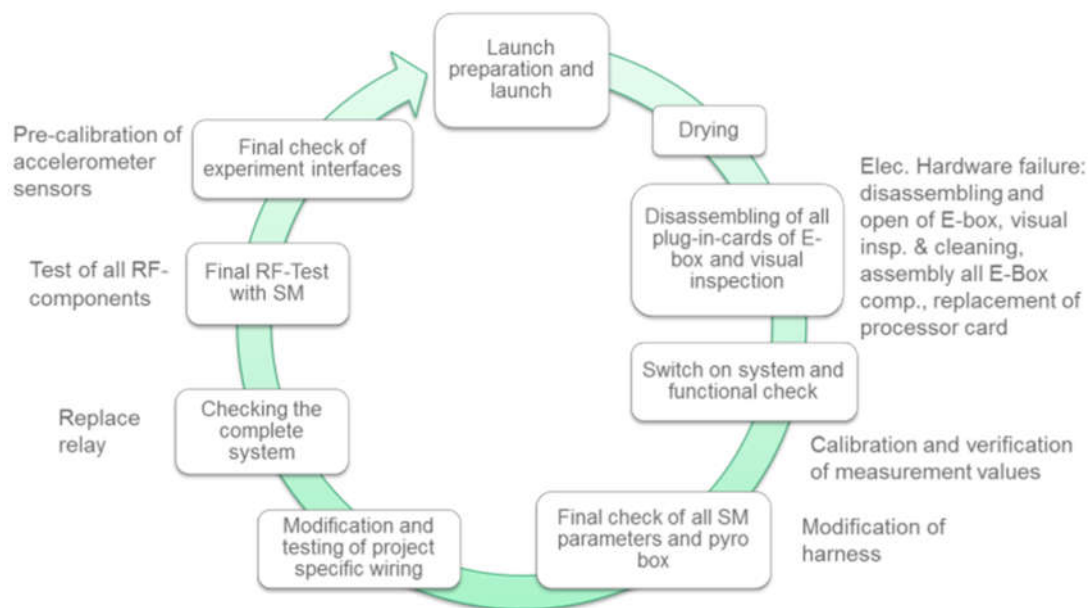
Figure 6. On-range check service system

The duration of the service system check was 3.5 days. The checks are performed in four phases:

- A post-flight analysis based on the telemetry data immediately after the flight to identify anomalies within the various system components, the flight dynamics, etc. This step identifies extra checks and actions within the subsequent steps.
- A visual inspection of the recovered components to find damages and components exposed to loads above the nominal limits.
- Parts of the system will be disassembled and cleaned for more detailed analysis of electrical components, harness, etc., to find potential damages on these components.
- The last test of the reintegrated system concentrates on the implemented functions of data handling, power management and the implemented sensors with the system running. This is basically a function test.

A detailed overview of the service system on-range check is illustrated in figure 6. The inner cycle illustrates the planned actions and the outer description explains the unexpected events during the check.
