Operando and ex-situ investigation of PEMFC degradation

P. Gazdzicki^a, J. Mitzel^a, D. G. Sanchez^a, P. Aßmann^a, K. Talukdar^a, S. Hoffmann^a, T. Morawietz^{a,b,c}, R. Hiesgen^{b†}, F. Häußler^d, J. Hunger^d, G. Schlumberger^d, K. A. Friedrich^{a,c}

^a German Aerospace Center (DLR), 70569 Stuttgart, Germany

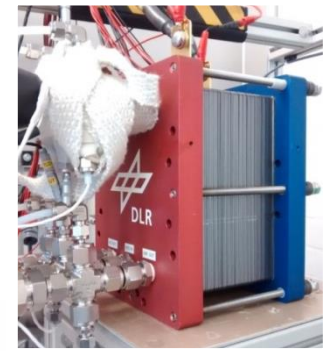
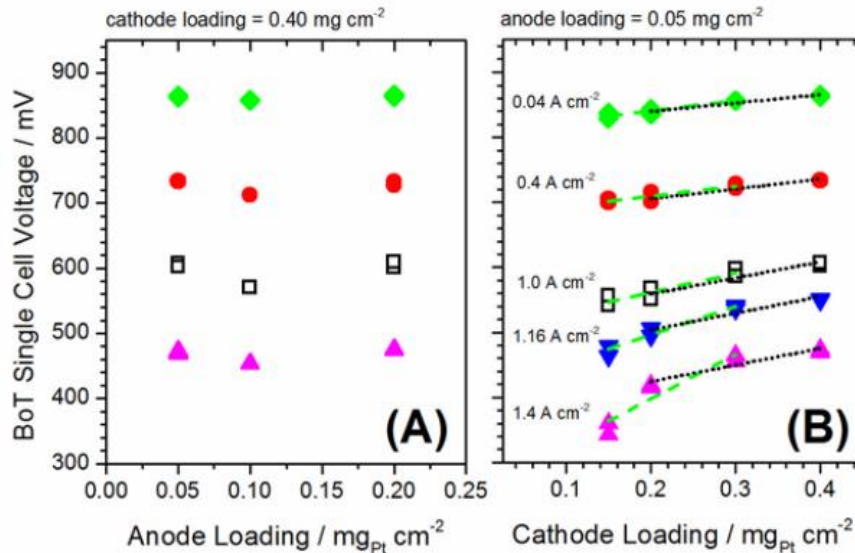
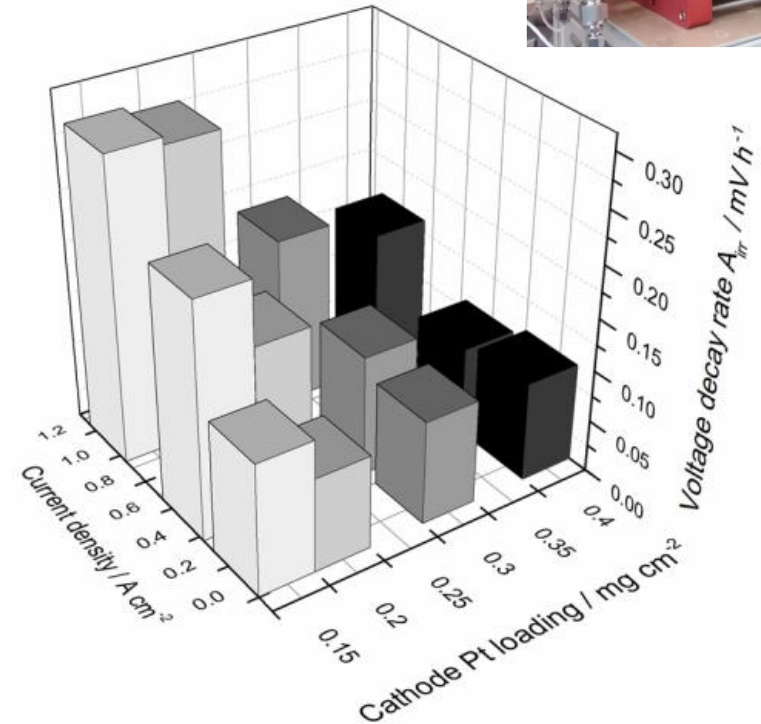
Low Pt loading (Rainbow PEMFC Stack)

Cathode Pt loading of 0.2 mg cm^{-2} is found to be a threshold value; below this value cell performance and durability drop significantly for current densities $>1 \text{ A cm}^{-2}$

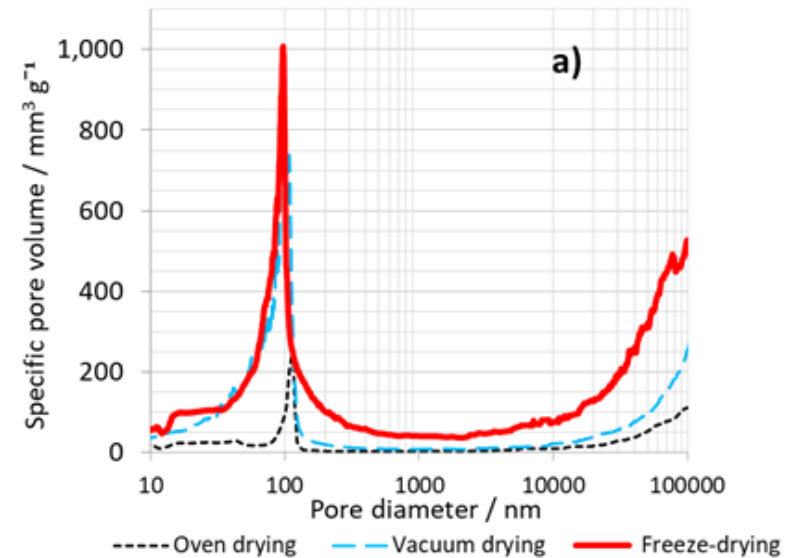
Improving transport losses at low Pt loading

Performance loss at low Pt loading can be reduced by increasing CCL porosity by a freeze-drying step during CCL preparation

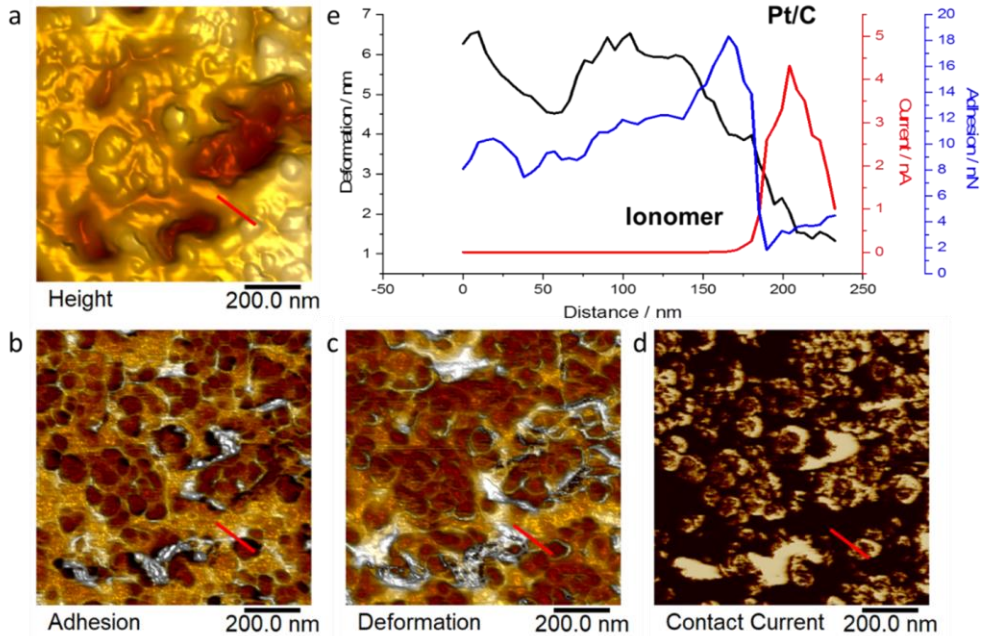
AFM surface analysis of CL

Ionomer visible due to:

- High deformation and adhesion
- No electronic current

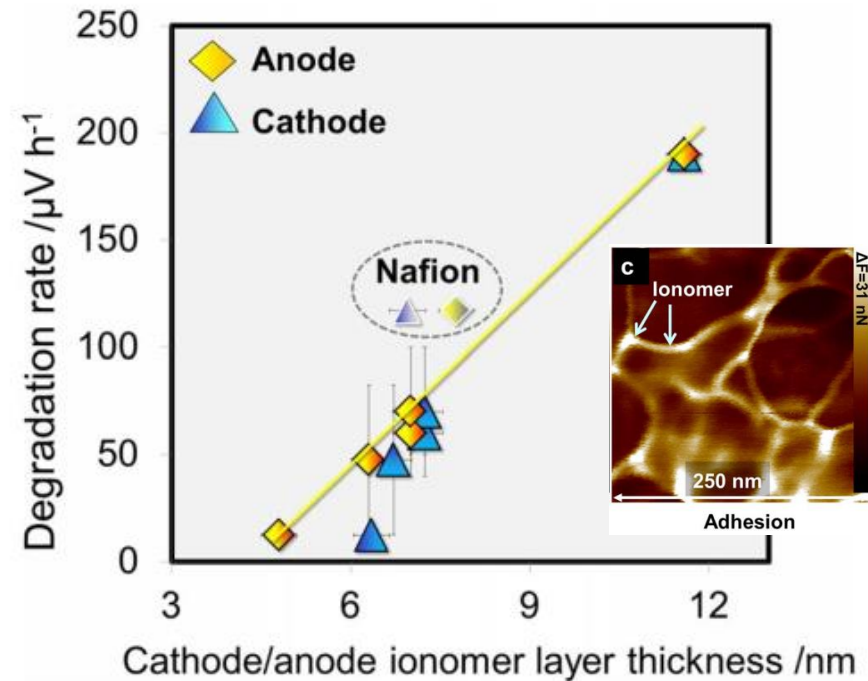
AFM cross-section analysis of CL

Differently prepared Aquivion-based MEAs:

- Advantage of thinner ionomer films regarding durability

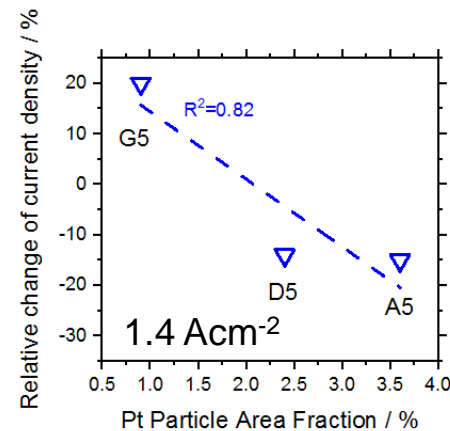
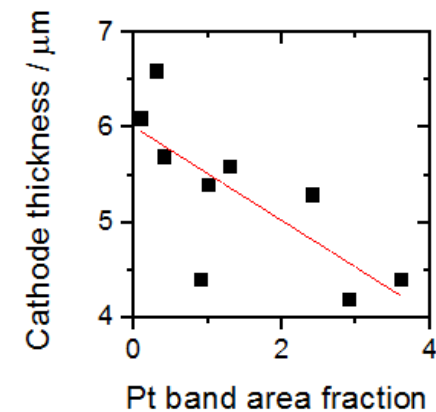
Local degradation analysis

- Stationary operation is stressing condition leading to heterogeneous operation
- Local Pt band formation linked with CCL degradation

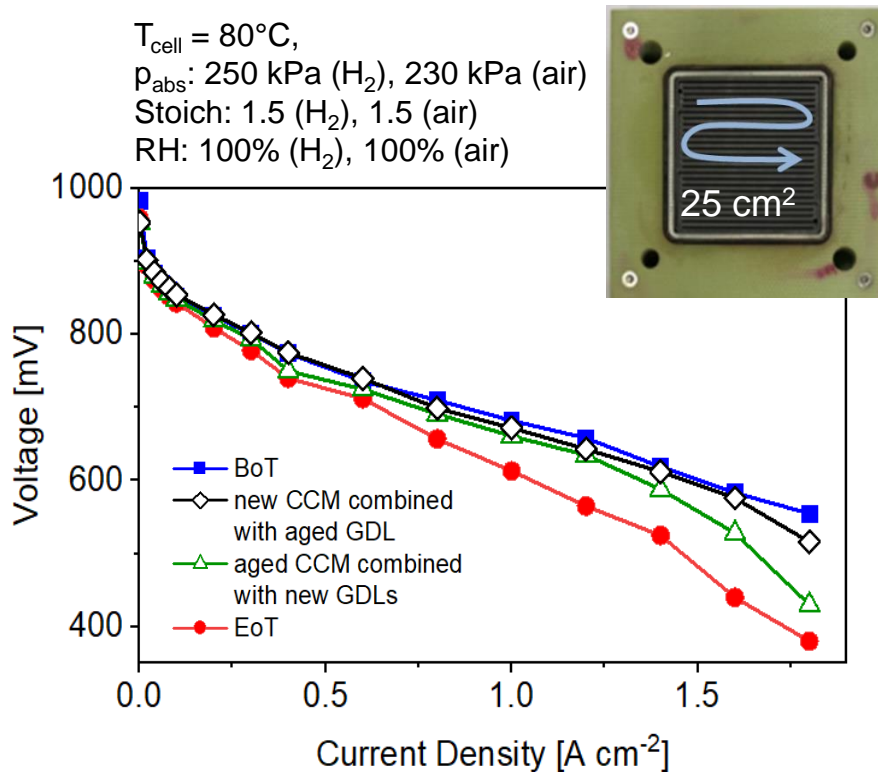
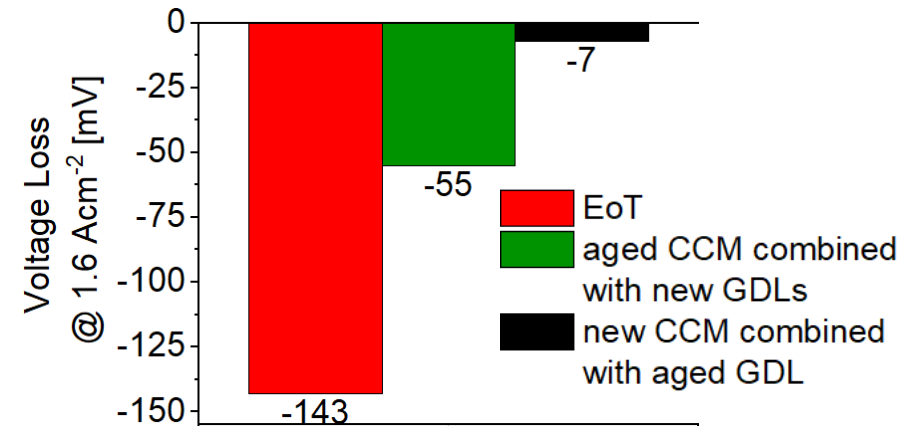
Stressor: $T = 95^{\circ}\text{C}$ at 50%RH (219 h at 1 Acm^{-2})

Separate analysis of GDL and CCM degradation does not explain all performance losses → possible coupling effect

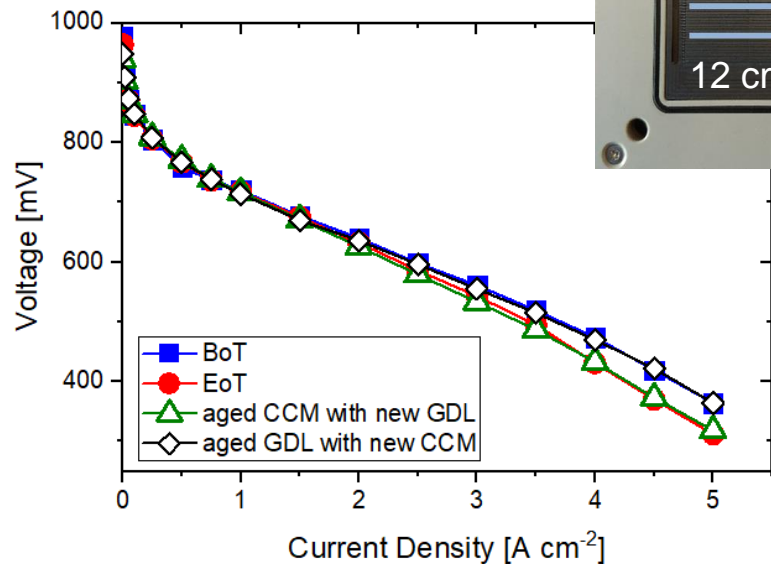
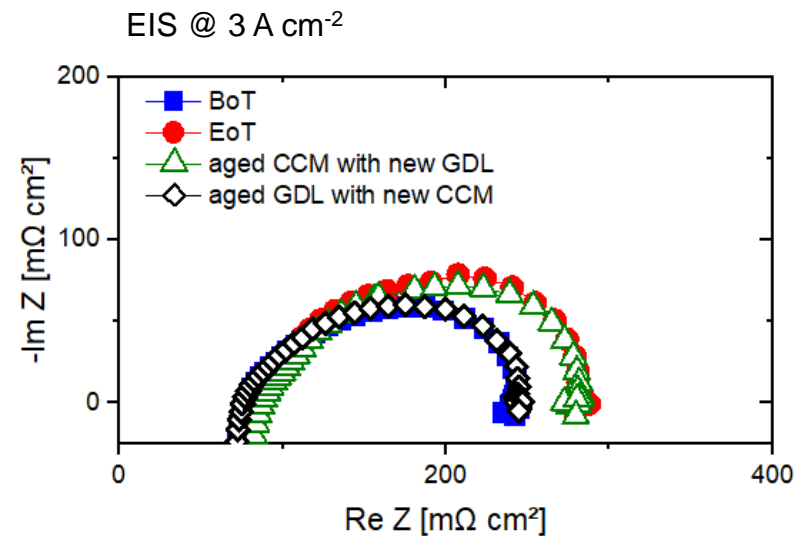
Stressor: High water flux (300h, 100%RH, $j = 4 \text{ A cm}^{-2}$)

$T_{\text{cell}} = 65^\circ\text{C}$,
 $p_{\text{abs}}: 250 \text{ kPa (H}_2\text{)}, 230 \text{ kPa (air)}$
 Stoich: 8 (H₂), 10 (air)
 RH: 100% (H₂), 100% (air)

- Degradation due to CCM responsible for 100% of losses
