# Durability of Anti-Reflective Coatings for Parabolic Trough Receivers

**Abstract.** Anti-reflective coatings are employed on both sides of the glass envelope tube of evacuated parabolic trough receiver tubes to minimize reflectance losses. This paper reports the measured initial transmittance values of seven different receiver tube manufacturers as well as the degradation rates after accelerated aging, outdoor exposure and in-service testing. The presented data represents a summary of measurements carried out in the *OPAC* laboratory at Plataforma Solar de Almería in the period between 2013 and 2019.

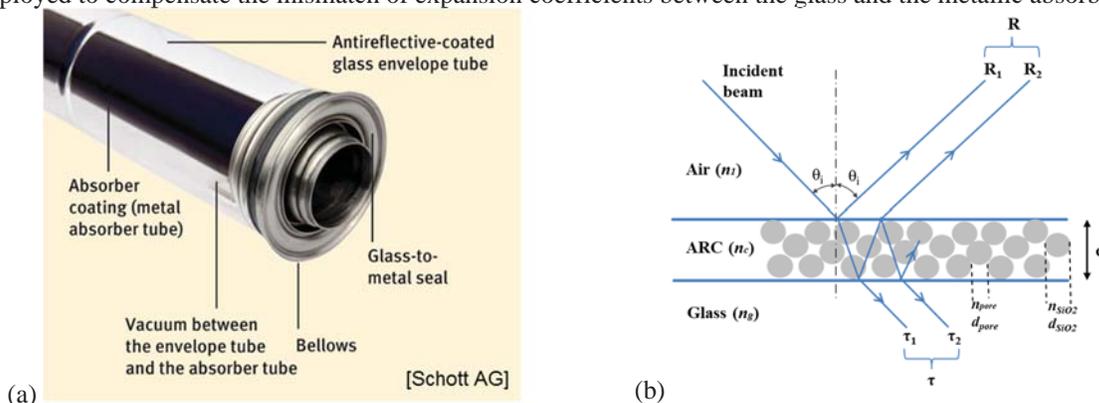
**FIGURE 1.** a) Typical receiver tube for parabolic trough technology. b) Optical path at surface of glass envelope tube with ARC.

The 3 mm thick borosilicate glass tube has a solar-weighted hemispherical transmittance  $\tau_{s,h}$  of 0.91-0.93, which is significantly higher compared to standard soda-lime glass ( $\tau_{s,h} = 0.82-0.86$ ). In order to minimize optical reflectance losses further, the inner and outer surface of the borosilicate glass are coated with an ARC, which typically increases  $\tau_{s,h}$  to 0.96-0.97.

1. The reflected rays at the air-coating and coating-glass interfaces  $R_1$  and  $R_2$  need to have the same amplitude (see **FIGURE 1b**), therefore

$$n_c = \sqrt{n_1 \cdot n_g} = \sqrt{1 \cdot 1.52} = 1.23 \quad (1)$$

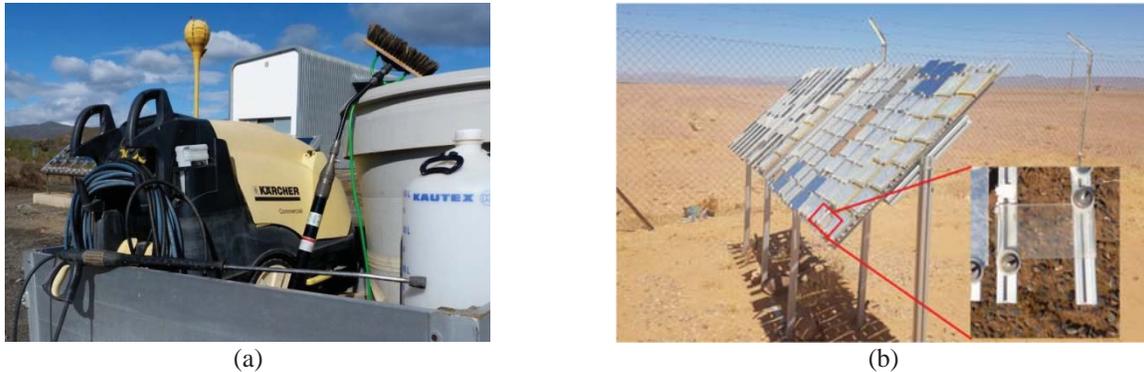
**FIGURE 2.** Outdoor exposure testing a) Cleaning devices used for the exposure experiments in Tabernas, Spain. b) Exposure of sample from manufacturer B in Zagora, Morocco.

- **Outdoor exposure at Plataforma Solar de Almería in Tabernas, Spain:** four samples were weathered for a total exposure time of 12 months. An intermediate optical characterization was performed after 6 months of exposure. The samples were exposed on an exposure rack at 1.5 m above the ground. Two of the four exposed samples were cleaned every two weeks with pressurized water using the spray gun Kärcher HDS 10/20-4M (see FIGURE 2a). The pressure was 100 bar, the distance between nozzle and sample

was 50 cm, the nozzle angle was 25° and the diameter was 0.54mm. Cleaning was always performed the same way with five strokes per sample (about 3 seconds in total).

- **Outdoor exposure at Zagora, Morocco:** one sample was exposed for 1.8 years. No intermediate measurements were conducted. The sample was exposed at a height of about 1m from the ground (see FIGURE 2b). Zagora is known to be an aggressive site in terms of sand erosion and has caused erosion damage on several exposed glass mirror samples [11].

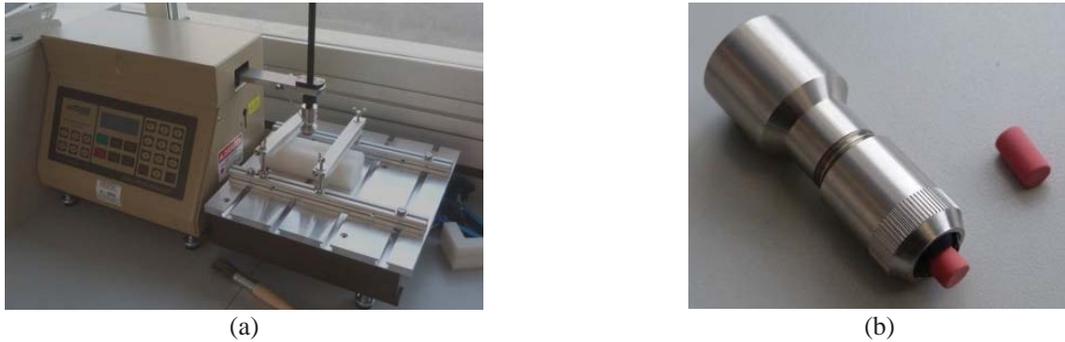
**FIGURE 3.** a) Taber Linear Abraser used to conduct the abrasion resistance test. b) Abradant according to MIL-E-12397

The Taber Linear Abraser – Model 5750 was used to carry out the test (see **FIGURE 3a**). The test consists of an abrasion head, which is moving with low pressure on the glass surface in a straight line back and forth. The abrasion head material consists of abrasive inside a rubber matrix. One cycle is defined as the movement of the grinding head once forth and back. The movement of the abrasion head produces grinded stripes on the glass surface, where the light transmittance is affected by the scratches. The normal force acting on the sample is constant throughout the test, the mass of arm and abradant pushing on the surface of the sample is 350g. The velocity of the moving arm is 7 cycles per minute at a stroke length of 38.1mm. Samples have been rotated several times to increase the abraded area necessary to perform transmittance measurements. The abradant used is the MIL-E-12397 which is very mild abrading action. Its diameter is 6 mm (see **FIGURE 3b**). Before each test the surface of the abradant is shaped by performing 5 cycles using an abrasive paper glued to a glass envelope tube sample. The abradant is cleaned carefully with a brush after being reshaped. That way homogeneous contact between sample and abradant across the entire diameter is assured. Transmittance was measured after 20, 50 and 100 cycles of testing.

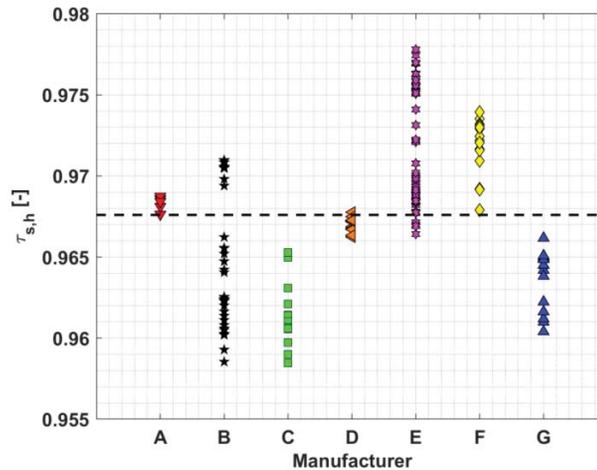
**FIGURE 4.** Solar-weighted hemispherical transmittance  $\tau_{s,h}$  of the ARC samples of seven manufacturers in pristine state before aging. The dashed line indicates the average  $\tau_{s,h}$  from the different manufacturers.

**FIGURE 4** shows the solar-weighted hemispherical transmittance of glass envelope tubes of seven tube manufacturers as deposited in pristine condition. It can be seen that all manufacturers achieve transmittance values  $\tau_{s,h} > 0.955$ . The highest transmittance measured is  $\tau_{s,h} = 0.978$ . The average transmittance of the different manufacturers is  $\tau_{s,h} = 0.968$  (indicated by the dashed line). This value can be considered as the state of the art.

Note that samples from manufacturer E have been deposited on different glass substrates, which can explain the high standard deviations.

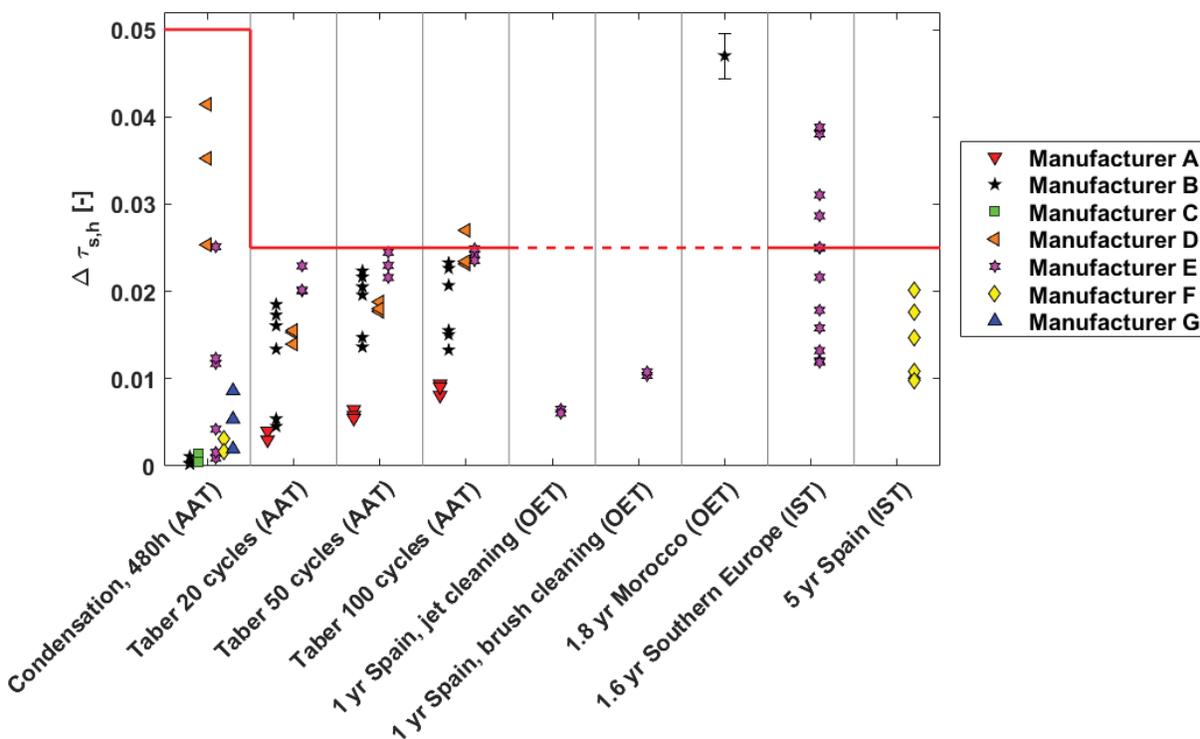
**FIGURE 5.** Summary of measured transmittance losses  $\Delta\tau_{s,h}$  during AAT, OET and IST from seven manufacturers A-G. Each dot corresponds to the average value of one measured sample at 3 different spots.

**FIGURE 5** shows a summary of the measured degradation of solar-weighted hemispherical transmittance  $\Delta\tau_{s,h}$  after the conducted aging tests. As described in the introduction, the 3 mm thick borosilicate glass tube achieves a solar-weighted hemispherical transmittance  $\tau_{s,h}$  of typically 0.92 and the ARC boosts the  $\tau_{s,h}$  to 0.968 as seen in the previous section. Hence, the ARC is responsible for a transmittance gain of approximately 0.05. Since both sides (inner and outer surfaces) of the glass tube are coated with ARC, one can estimate that each ARC is responsible for a transmittance gain of 0.025. This needs to be taken into account for interpretation of the results. The red line in **FIGURE 5** represents the transmittance gain caused by the ARC of 0.05 (for samples tested from both faces) and 0.025 (for samples tested from only one face). Degradation beyond those limits means that either the glass substrate is being damaged throughout the test or that a non-coated borosilicate sample would perform better. This is the case for the OET in Morocco and partly for the IST in Southern Europe, while abrasion testing up to 100 Taber cycles also approaches the 0.025 degradation limit. For all the other tests, the measured degradation is below the red line, meaning that the ARC is still contributing to a transmittance gain after the conducted aging tests.

The red line is dashed for the OET experiments since those samples were exposed from both sides to the climatic conditions of Tabernas and Zagora but only the front side is subjected to the predominant degradation mechanism. In Tabernas, the samples are only cleaned from the front side in 2 week intervals and in Zagora the predominant wind direction is southwest, meaning that the sand particles will only degrade the front side of the coating. However, a minor degradation of the AR back coating cannot be excluded and this is why the line is dashed.

**FIGURE 5** shows that four out of six manufacturers pass the condensation test with transmittance losses below  $\Delta\tau_{s,h} = -0.01$ . The highest degradation measured is  $\Delta\tau_{s,h} = -0.041$  for manufacturer D. During condensation testing, both coated sides of the glass tube are exposed to the conditions of the accelerated aging chamber. After 480 hours of testing, all tested samples show a higher transmittance than a bare glass tube. The measured degradation is smaller than  $\Delta\tau_{s,h} = -0.05$  in any case.

The Taber abrasion test shows the expected increment of transmittance losses with growing cycle number (see **FIGURE 5**). Complete removal of the ARC on one side of the sample would result in a transmittance loss of  $\Delta\tau_{s,h} = -0.025$ . After 100 cycles of testing, most of the coating from manufacturers D and E is removed, while coatings from manufacturers B and especially A show higher abrasion resistance. **FIGURE 9** shows a comparison of samples from manufacturers A and D up to 100 cycles of Taber testing. While samples from manufacturer A lost  $\Delta\tau_{s,h} = -0.009 \pm 0.001$ , the ARC samples from manufacturer D lost  $\Delta\tau_{s,h} = -0.025 \pm 0.002$ . The microscopic images confirm that the ARC has almost been completely removed in the case of manufacturer D.

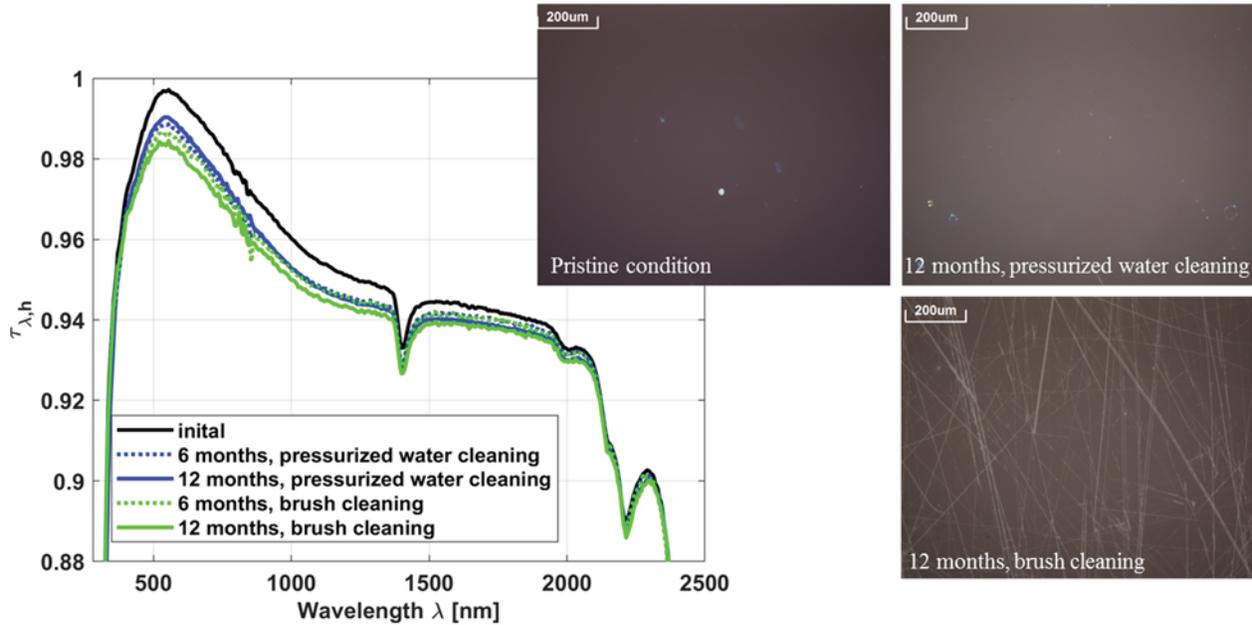
**FIGURE 6.** Spectral hemispherical transmittance of ARC samples from manufacturer E in initial state and after 6 and 12 months of outdoor exposure in Tabernas, Spain, as well as corresponding microscope images.

The conducted outdoor exposure tests in Tabernas, Spain demonstrate the influence of the applied cleaning method on the ARC degradation rate. **FIGURE 6** shows the measured transmittance spectra in initial state and after

6 and 12 months of exposure of ARC samples from manufacturer E. The samples, which were cleaned by pressurized water in two week intervals, degraded by  $\Delta\tau_{s,h} = -0.006 \pm 0.001$ , while the samples, which were cleaned by brush, showed a higher degradation rate of  $\Delta\tau_{s,h} = -0.010 \pm 0.002$ . The microscopic analysis revealed several scratches in the ARC, showing that the applied contact cleaning method is not applicable. The glass substrate was not affected by the brush cleaning.

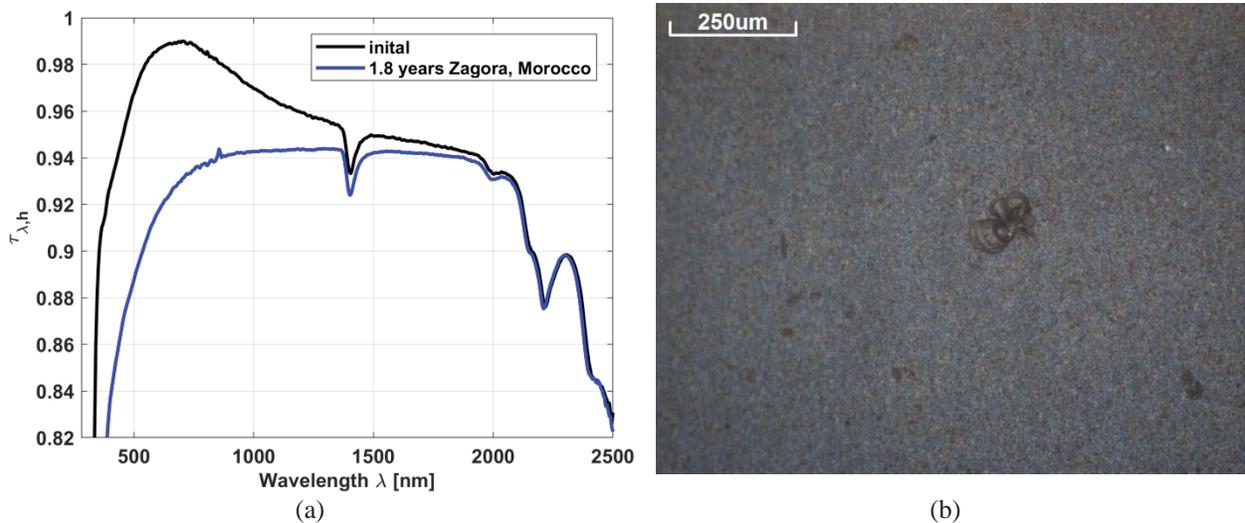
**FIGURE 7.** ARC sample from manufacturer B after 1.8 years of OET in Zagora, Morocco. a) Spectral degradation of hemispherical transmittance. b) Microscopic image of ARC coating degradation and glass erosion.

The sample tested in Zagora, Morocco shows a degradation close to  $\Delta\tau_{s,h} = -0.05$ . The strong reduction in transmittance is not only related to ARC degradation. The exposed sample also shows signs of erosion of the borosilicate glass substrate due to the aggressive sand impacts in Zagora (see **FIGURE 7b**).

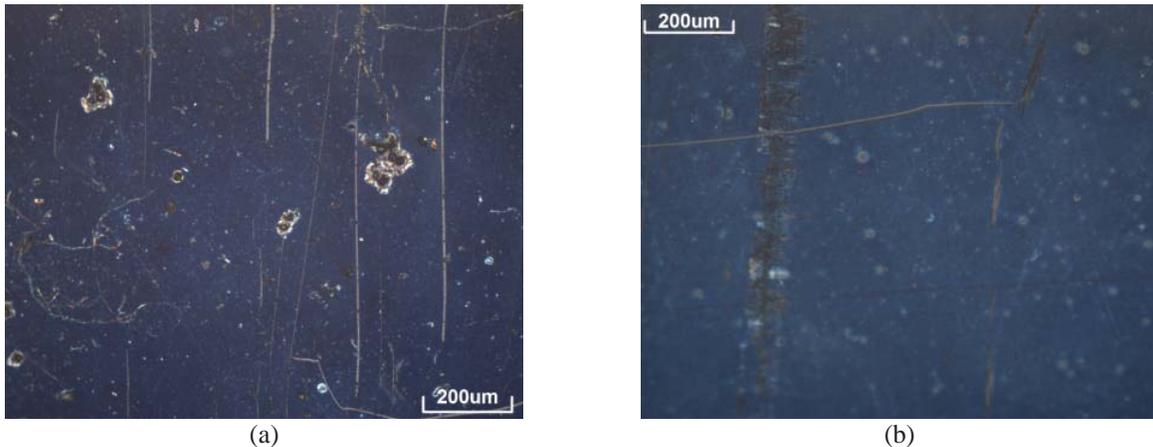
**FIGURE 8.** a) Abrasion and scratching on sample from manufacturer E after 1.6 years of IST in Southern Europe. b) minor defects on samples from manufacturer F after 5 years of IST in Spain.

The in-service tested samples also show abrasion as main degradation mechanism, although the risk of sand erosion is considerably low in European exposure sites. Scratching of the anti-reflective layer of these samples is probably caused during the cleaning process. Samples from manufacturer E have been cleaned 2.7 times per month with pressurized deionized water. The average transmittance loss of the samples exposed in the demo plant for 1.6 years was  $\Delta\tau_{s,h} = -0.023 \pm 0.008$ , meaning that some samples exceeded the 0.025 degradation limit (compare **FIGURE 5**). This can also be explained by degradation of the glass substrate. **FIGURE 8a** shows signs of erosion craters in the glass substrate which might have been caused during the cleaning process or due to small rocks hurled during passing of the cleaning vehicle.

After 5 years of in-service testing in a Spanish CSP plant, the measured degradation on the tubes from manufacturer F was below 0.025 ( $\Delta\tau_{s,h} = -0.014 \pm 0.002$ ), meaning that after 5 years of operation the ARC is still contributing to a transmittance gain of the receiver (**FIGURE 8b**). No information regarding the cleaning procedure is available.

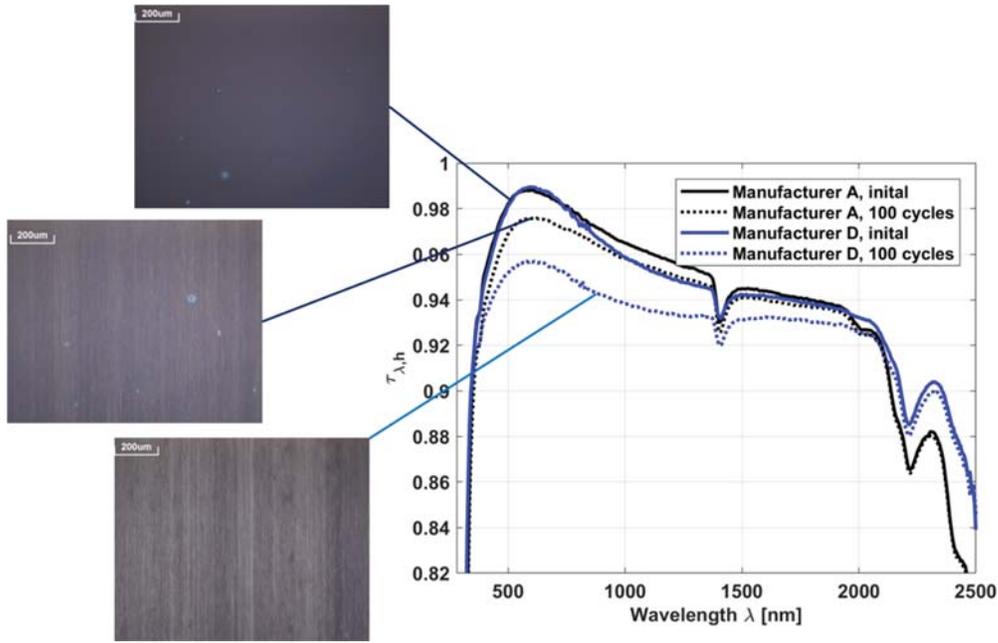
**FIGURE 9.** Spectral hemispherical transmittance of ARC samples from manufacturer A and D in initial state and after 100 cycles of Taber abrasion testing, as well as microscope images.
