Degradation behavior of MK35x stacks with chromium-based interconnects in steam electrolysis operation

Matthias Riegraf^a, Patric Szabo^a, Michael Lang^a, Rémi Costa^a, Stefan Rothe^b, Stefan Megel^b, Mihails Kusnezoff^b

SOFC-XVIII, June 1, 2023

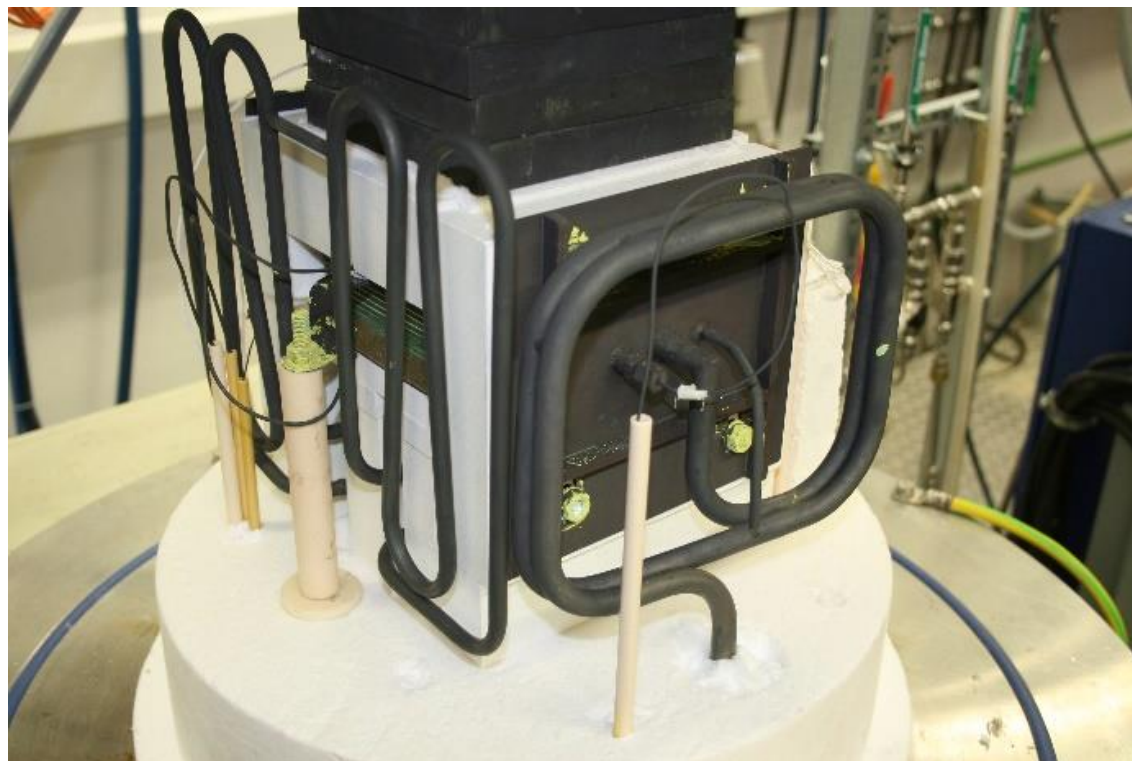
- Long-term stack testing at DLR
- Operating conditions: 80 % H₂O, 20 % H₂, -0.6 A cm⁻², 75% steam conversion, oxygen side outlet temperature of 816°C
- Oven environment with constant temperature
- Before and after durability test: Electrochemical impedance spectroscopy at all individual RUs

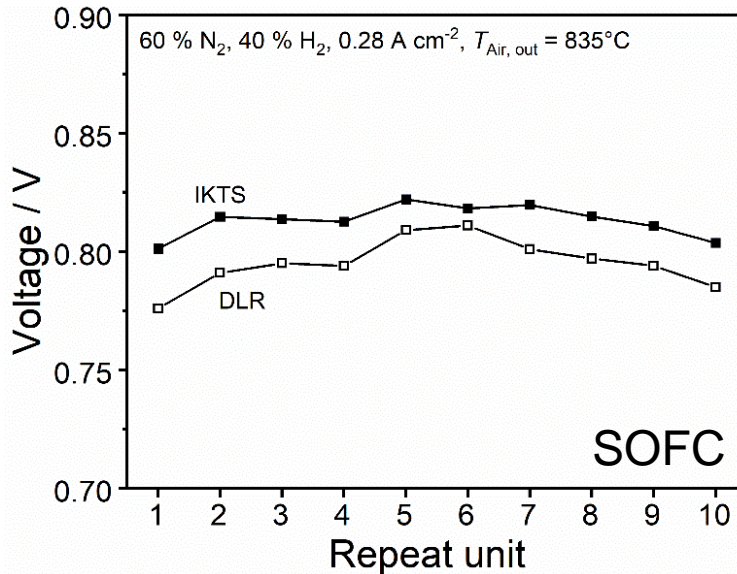
60% N₂, 40% H₂, 0.275 A cm⁻², 75% FU,
oxygen side outlet temperature of 835°C

- Similar behavior at IKTS during joining and at DLR during initial characterization
- 15-30 mV difference, probably due to lower air preheater temperature at DLR
- Initial state: P = 0.28 kW, $\eta_{el} = 53.4\%$

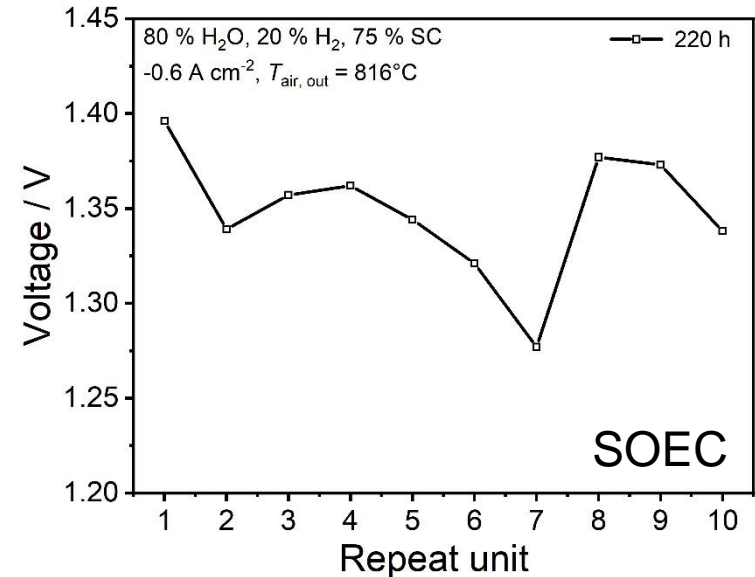
80% H₂O, 20 % H₂, -0.6 A cm⁻², 75% SC,
oxygen side outlet temperature of 816°C

- Less pronounced edge effect
- Initial stack performance: P = 1.03 kW, $\eta_{el} = 92.9\%$

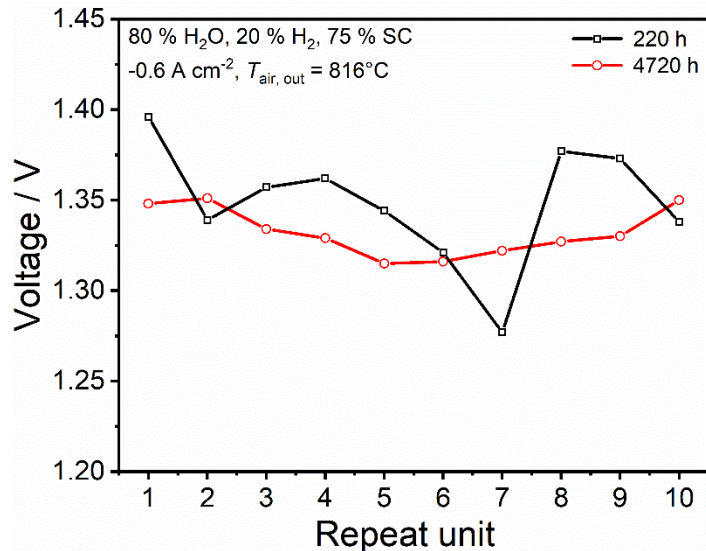
Voltage degradation over time

- Inhomogeneous degradation behavior
- Improvement of most RUs led to a negative overall degradation rate
- No reliable quantification of EIS data at operating point of long-term test due to low-frequency scattering

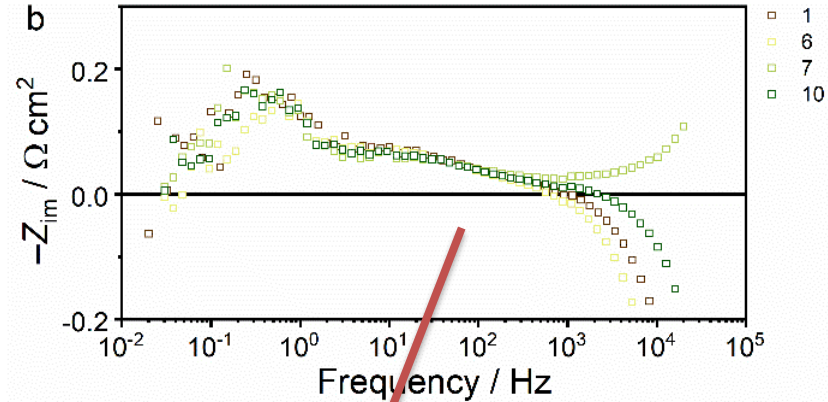
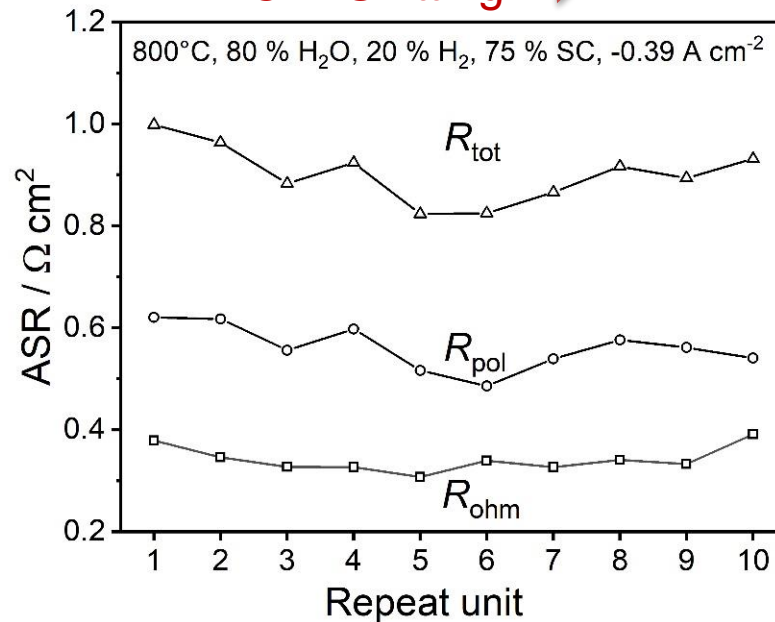
EIS analysis of initial SOEL stack performance

+ CNLS fitting

- Usage of -0.39 A cm^{-2} , 800°C as reference point
- Increased ohmic resistance at top and bottom layer
→ Contacting/temperature effect?
- Decreased low-frequency polarization resistance at 0.5 Hz → Increased gas supply?

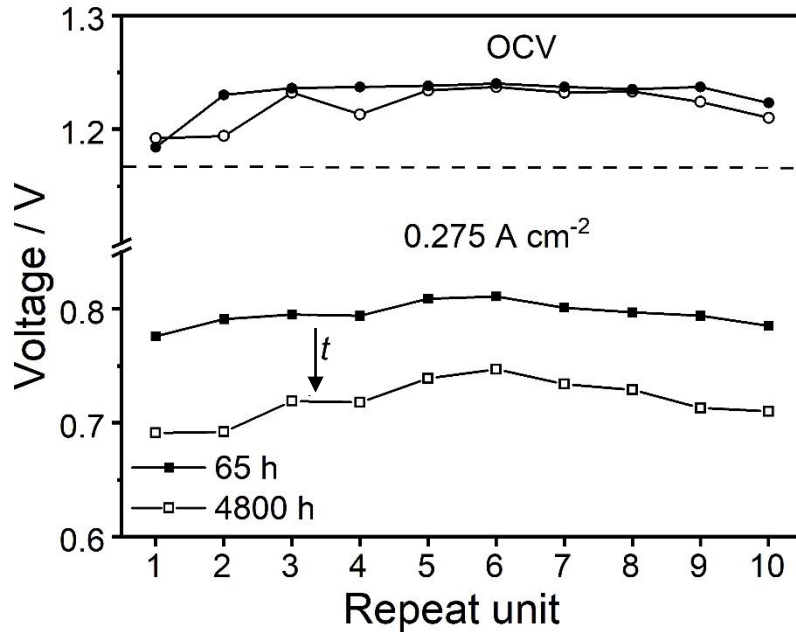
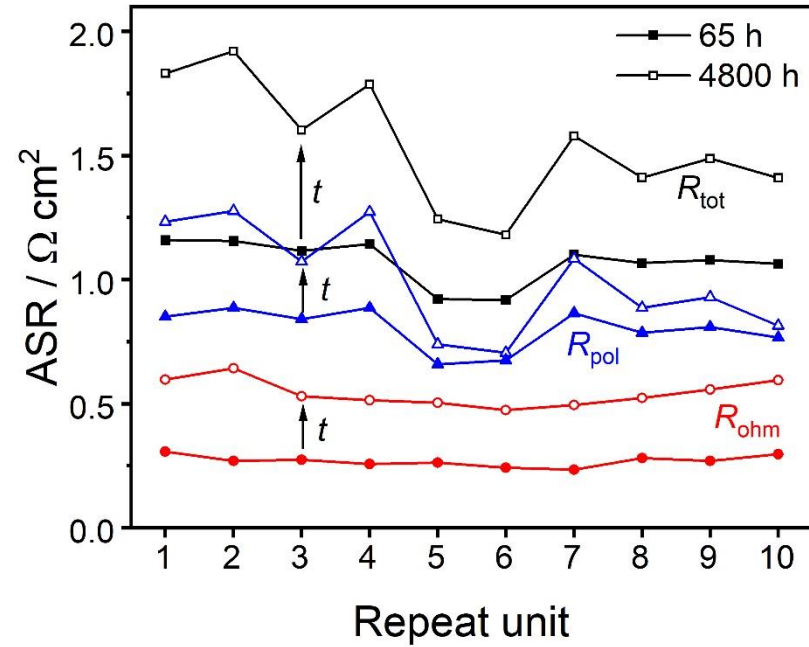
Degradation analysis in SOFC operation

$i = 0.275 \text{ A cm}^{-2}$, $T_{\text{air, out}} = 835^\circ\text{C}$, 60% N_2 , 40% H_2 , FU = 75%

- Small decrease of OCV in some RUs → Negligible gas leakage
- Voltage decrease and ASR increase of all layers
- Increase of R_{ohm} and R_{pol}
