# Performance Estimation of Copper-Free Solar Reflectors

**Abstract.** Copper (Cu) has been an essential ingredient in the production of silvered-glass reflectors used in the concentrated solar power (CSP) systems. However, due to added material cost and the environmental burden induced by Cu mining, researchers have started to look for ways to develop copper-free coating systems for reflectors used in solar thermal applications. In this study, we employed accelerated aging tests to obtain the aging characteristics of reflectors with and without Cu and exposed reflectors outside for natural aging. Samples were subjected to Copper Accelerated Acetic Acid Salt Spray (CASS), Ultraviolet-Humidity (UVH) and UV tests, and the changes in the hemispherical and specular reflectance were measured and compared.

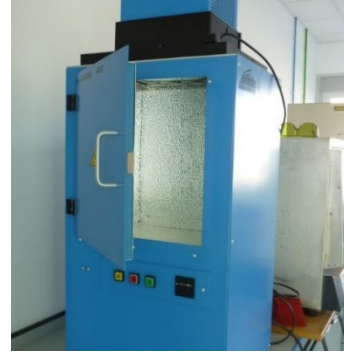
**Figure 2.** UVA-Cube Dr. Hönle UV radiation chamber.

The resistance to UV radiation was tested by exposing the samples during 1000 hours to UV radiation under ambient temperature and humidity. The test was performed in the UVA-cube radiation chamber from Dr. Hönle (Figure 2). The samples were placed with the glass side facing upwards inside the chamber.

The acceleration factor compared to the global ASTM G173 spectrum [4] depends on the considered wavelength range. In the wavelength range from 270 to 400 nm, the intensity of the ASTM G173 spectrum is 92.7 W/m<sup>2</sup>. The intensity of the Dr. Hönle UV radiation chamber in the same wavelength range is 301.3 W/m<sup>2</sup>. Therefore, an acceleration factor of 3.3 is obtained. If the wavelength ranges from 270 to 300 nm is considered, a much higher acceleration factor of 1925 is obtained (the intensity of the UV chamber in this wavelength range is 6.70 W/m<sup>2</sup> compared to 3.48 mW/m<sup>2</sup> of the reference spectrum).

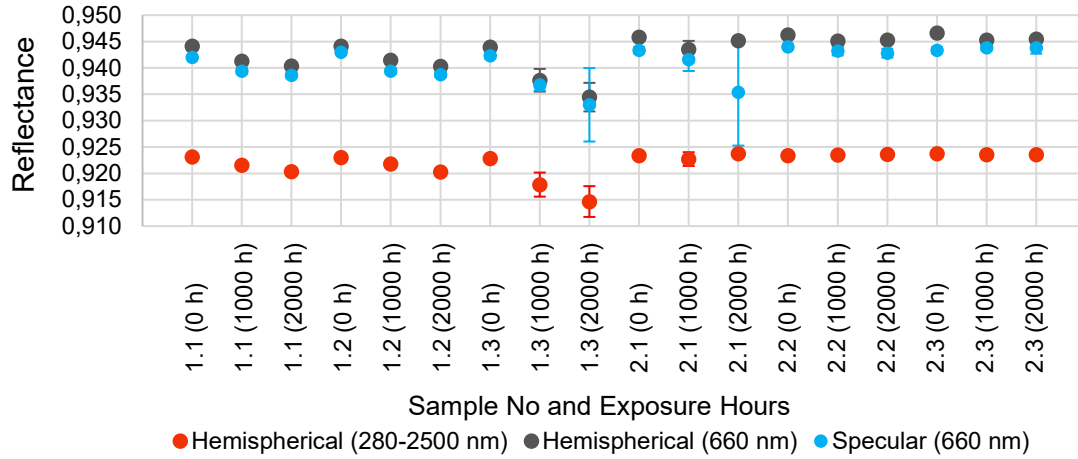
**Figure 6.** Reflectance measurements before and after UVH.

Six of the samples were subjected to UVH tests and their reflectance is measured before the test and after 1000 and 2000 hours in the chamber. The reflectance measurements of samples placed in the UVH chamber is shown in Figure 6.

In Figure 6, it is observed that, after 2000 hours, the average hemispherical reflectance decreases as much as 0.005 for Type 1 and no change was observed for Type 2 samples. On the contrary, the reduction in the specular reflectance of both types are of the same order of magnitude, 0.006 for Type 1 and 0.003 for Type 2. In specular reflectance measurements, it is seen that most of the degradation happened during the first 1000 hours except for samples 1.3 and 2.1. However, the error margin in these particular measurements exceeds the reflectance drop. On the basis of UV-Humidity test, reflectors without Cu appear to be more resilient than their counterparts with Cu, but there needs to be further investigations to arrive a conclusion.

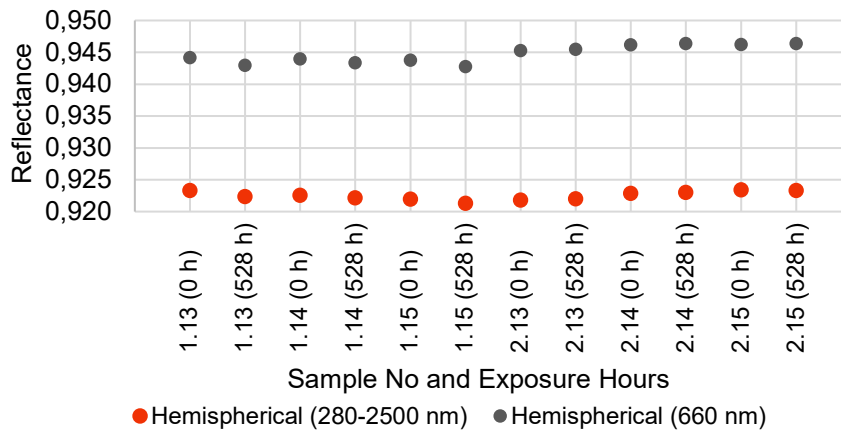
**Figure 7.** Reflectance measurements before and after UV

Reflectance measurements before and after UV test is presented in Figure 7. It is seen that Type 1 reflectors showed a reflectance loss around 0.001, while Type 2 reflectors did not show any degradation. Due to the UV protective feature of Cu layer, the opposite is expected. It can be concluded that the effect of coatings is more significant than Cu for UV protection.
