Pre-collapse spaceborne deformation monitoring of the Kakhovka dam, Ukraine, from 2017 to 2023

The Kakhovka Dam on the Dnieper River in Kherson Oblast, Ukraine, was completed in 1956 as the final dam in the Dnieper reservoir cascade. On the morning of June 6th, 2023, a substantial portion of the dam suffered a collapse while under Russian control. This incident was documented through satellite optical and radar images, providing valuable evidence of the dam's condition. Here we present the results of multi-temporal Interferometric Synthetic Aperture Radar (MT-InSAR) monitoring of the Kakhovka dam. The dam is vital for water management and hydroelectric power generation. Utilizing multi-temporal InSAR (MT-InSAR) data, we assessed the dam deformations prior to the collapse. Our findings indicate movements of the south side, facing the Dniprovska Gulf, compatible with several possible damage mechanisms. This study highlights the significance of employing spaceborne advanced monitoring techniques to detect signs of distress and ensure the stability of critical infrastructure.

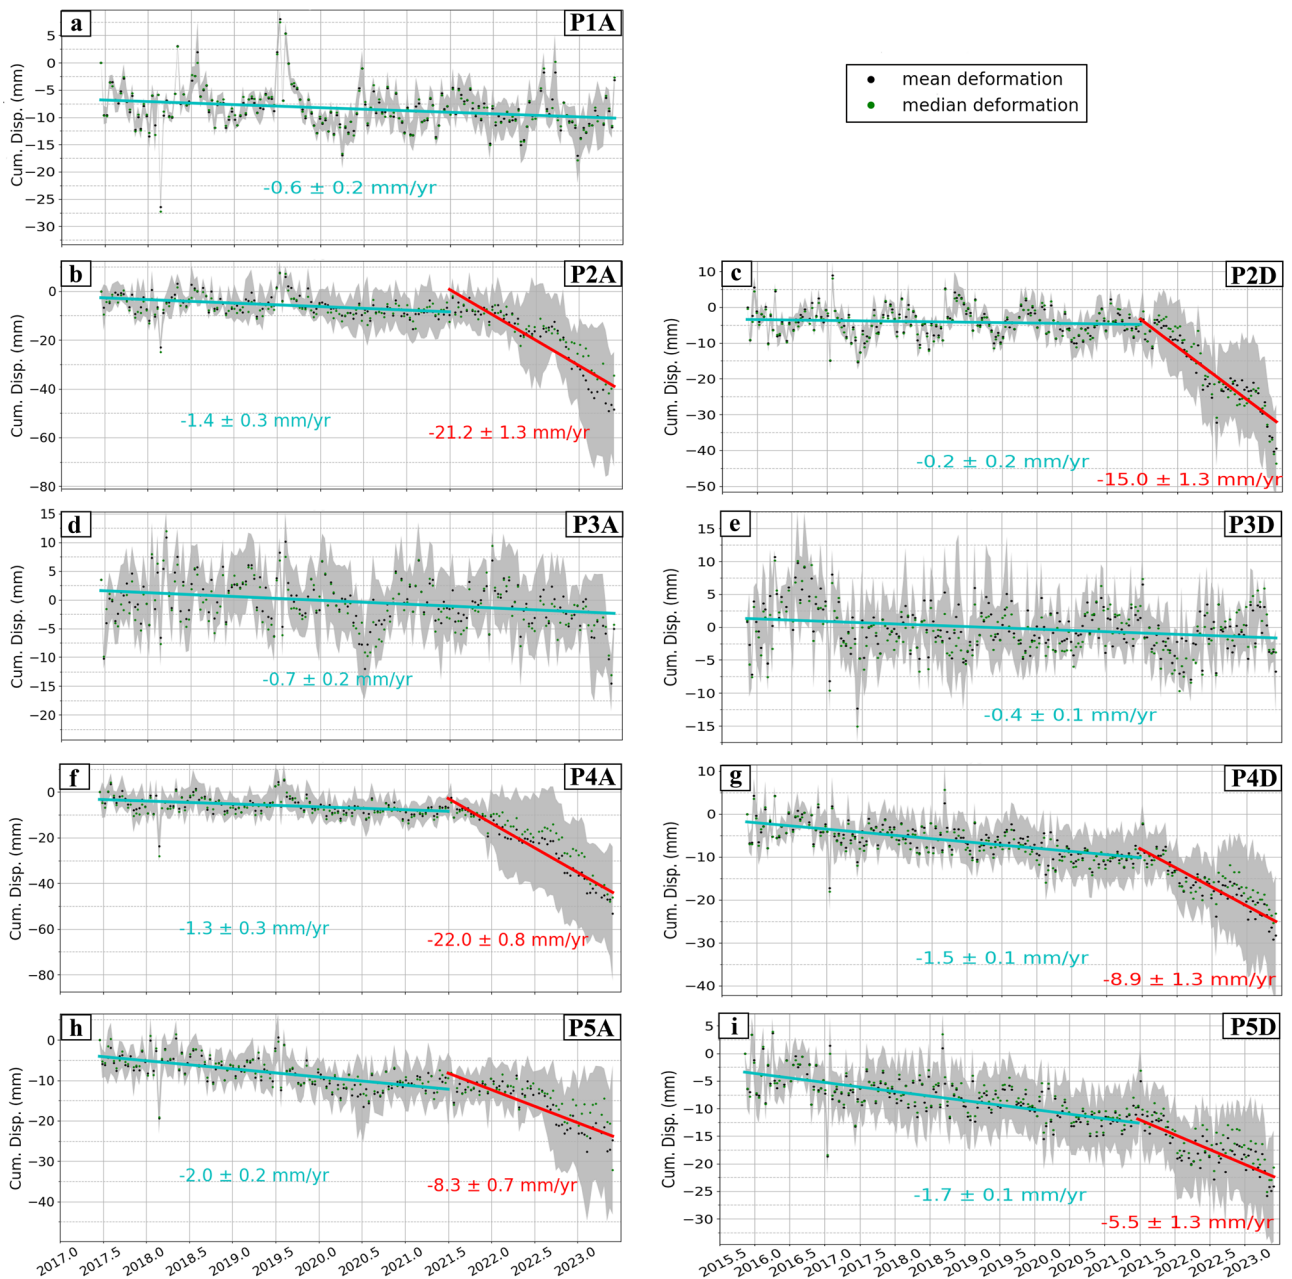
Fig. 2 | Average line of sight deformation time-series for polygons I, II, III, IV, and V extracted from Fig. 1. Images a, d, f and h represent the ascending deformation time-series and images c, e, g and i are the descending deformation time-series, respectively. Positive values point to moving toward the satellite. The Cyan line represents trends between the beginning of each time-series and June 2021 while the red lines indicate trends observed during the period July 2021–2023. Mean and median deformation is represented as black and green dots respectively. Grey

error bars represent limits indicating one standard deviation. The titles of the panels have been abbreviated for clarity, following the pattern: Px(A/D), where “P” represents “Polygon”, x is the number indicating the polygon number, and “A” or “D” stands for “ascending” or “descending” geometry, respectively. Just one measurement point has been found for polygon I descending (PID) and therefore has not been displayed in this figure.

We used two Sentinel-1 InSAR dataset comprising both ascending and descending tracks. The ascending (ASC) track included a total of 180 images acquired by Sentinel-1A and Sentinel-1B, spanning from July 2017 to June 2023 (Table 1). Similarly, the descending (DSC) track dataset consisted of 226 images acquired by Sentinel-1A and Sentinel-1B, covering the period from November 2015 to June 2023. By analyzing the time-series of deformation over each of the five polygons (Fig. 1), five distinct patterns of deformation were observed in both the ASC and DSC geometries, indicating the presence of displacement in different directions, including vertical (up/down) and horizontal (east/west) (Fig. 2 and Table 2). It is noteworthy that upon analysing the data, it becomes apparent that polygons I and III remained remarkably stable, with no substantial deformation observed throughout the entire period. In contrast, polygons II, IV, and 5 exhibited the most pronounced changes, particularly starting from June 2021. Polygon V, which is situated above a nearby dam facility, shows a linear deformation trend starting in 2015. This trend reached a rate of nearly 2±0.2 mm per year, amounting to a cumulative displacement of 10 mm over the 5 years prior to the collapse (Fig. 2h). Starting in June 2021, the rate of deformation in polygon V accelerated by 4 times, reaching a trend of 8.3±0.7 mm year⁻¹ until the dam’s collapse (Fig. 2h). Conversely, polygons II and IV, which are positioned over the section of the dam that experienced breaches, exhibit an average deformation of 21.5±1.5 mm year⁻¹ and 12±1.8 mm year⁻¹ for the ascending and descending geometries, respectively (Fig. 2b, c, f, g). Figure 3 illustrates the distribution of selected persistent scatters (PSs) along with their respective mean velocities, including both ASC and DSC geometries. The ascending track perspective is observed from the southern side of the dam (see Fig. 2a, c), characterized by a smaller look angle compared to the descending (Table 1). Consequently, the chosen PSs are primarily located in the southern portion of the dam. Conversely, the descending track is characterized by a higher look angle, and it originates from the northern side, resulting in PSs that encompass both the northern and southern regions of the dam. Therefore, for a fair comparison, the observed deformation in these polygons is localized and confined to the southern side of the dam. The DSC dataset reveals slightly lower velocity

values and similar activation dates due to its reduced sensitivity to vertical displacements as the descending is characterized by a larger look angle, (Tables 1 and 2).
