MIXED REALITY FOR AIRCRAFT STRUCTURAL DENT AND BUCKLE NON-DESTRUCTIVE EVALUATION

Ann-Kathrin Koschlik¹, Michael J. Scott², Thore Keser¹, Fiete Rauscher³, Hendrik Meyer¹, Wim Verhagen², Pier Marzocca², Florian Raddatz¹ & Gerko Wende¹

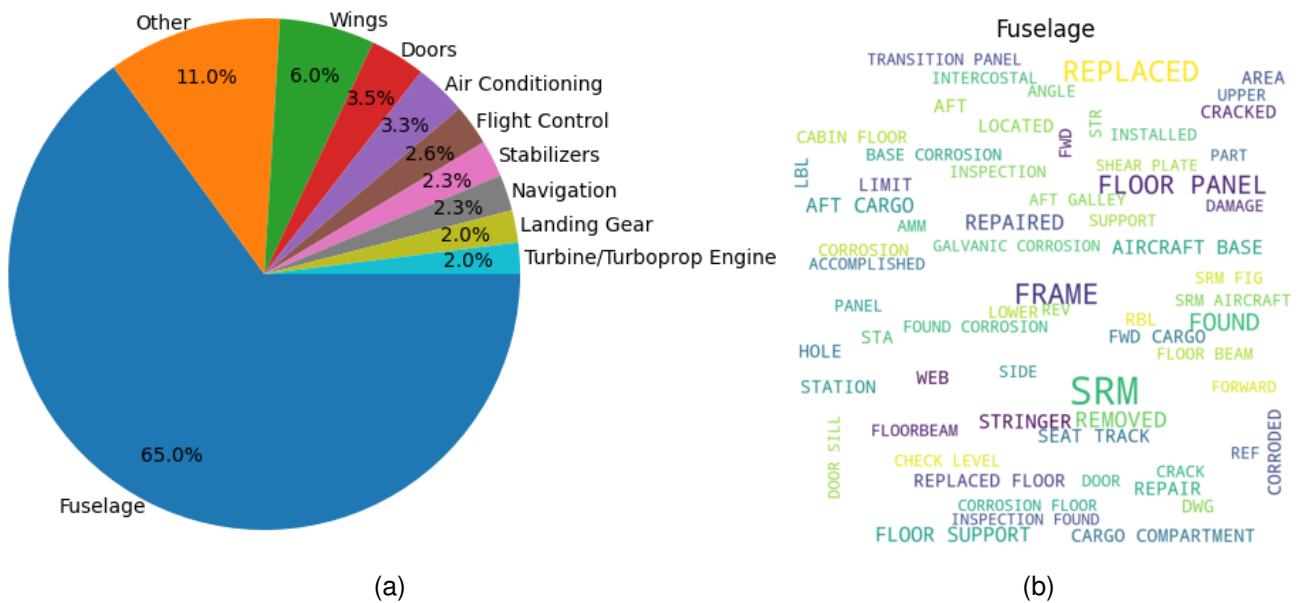
Figure 1 – Based on work by [23], damages of the fuselage are the highest mentioned incidents as illustrated in Figure 1a. The impact of the SRM is indicated by the big font size which equals the overall number of occurrences, represented in the word cloud in Figure 1b.

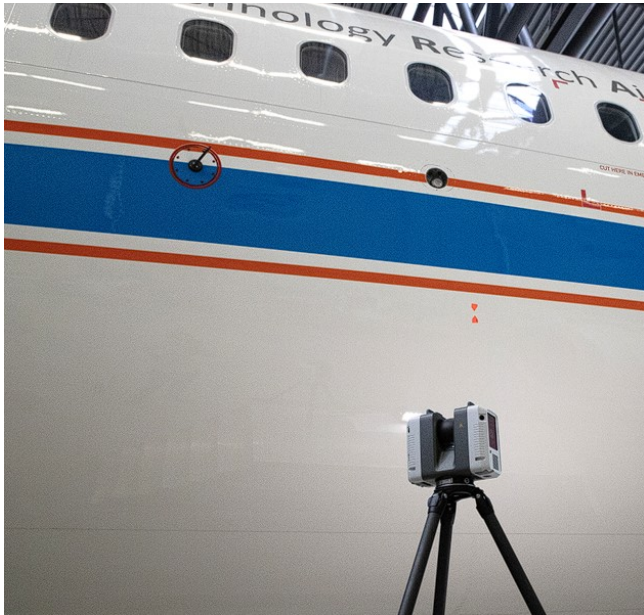
(a) Airbus A320 D-ATRA in Hangar at DLR Braunschweig being scanned by Laser scanner imaging.

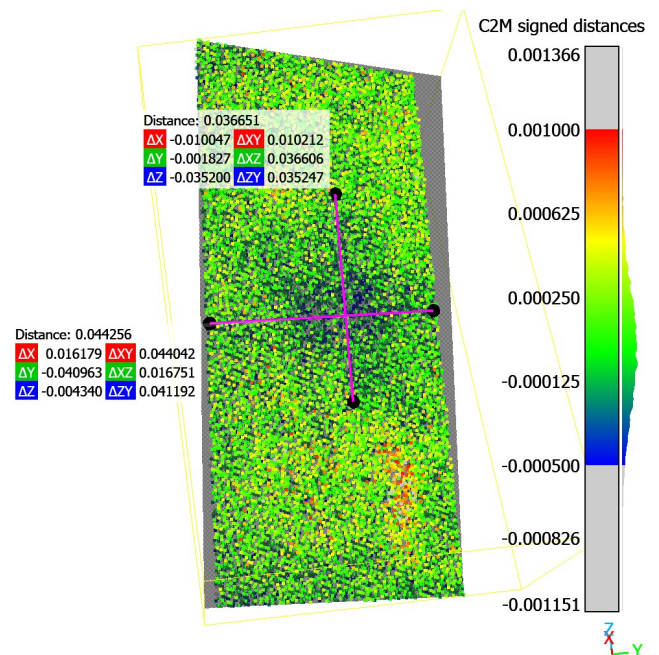
(d) Analysis of point cloud scan using open source CloudCompare 3D point cloud and mesh processing software.
