Acoustic Fault Diagnosis for UAV Propeller Blades

Leon Steinhoff, **Ann-Kathrin Koschlik**, Emy Arts, Maria Soria-Gomez, Florian Raddatz

German Aerospace Center (DLR), Institute for Maintenance, Repair and Overhaul, Hein-Saß-Weg 22, 21129 Hamburg

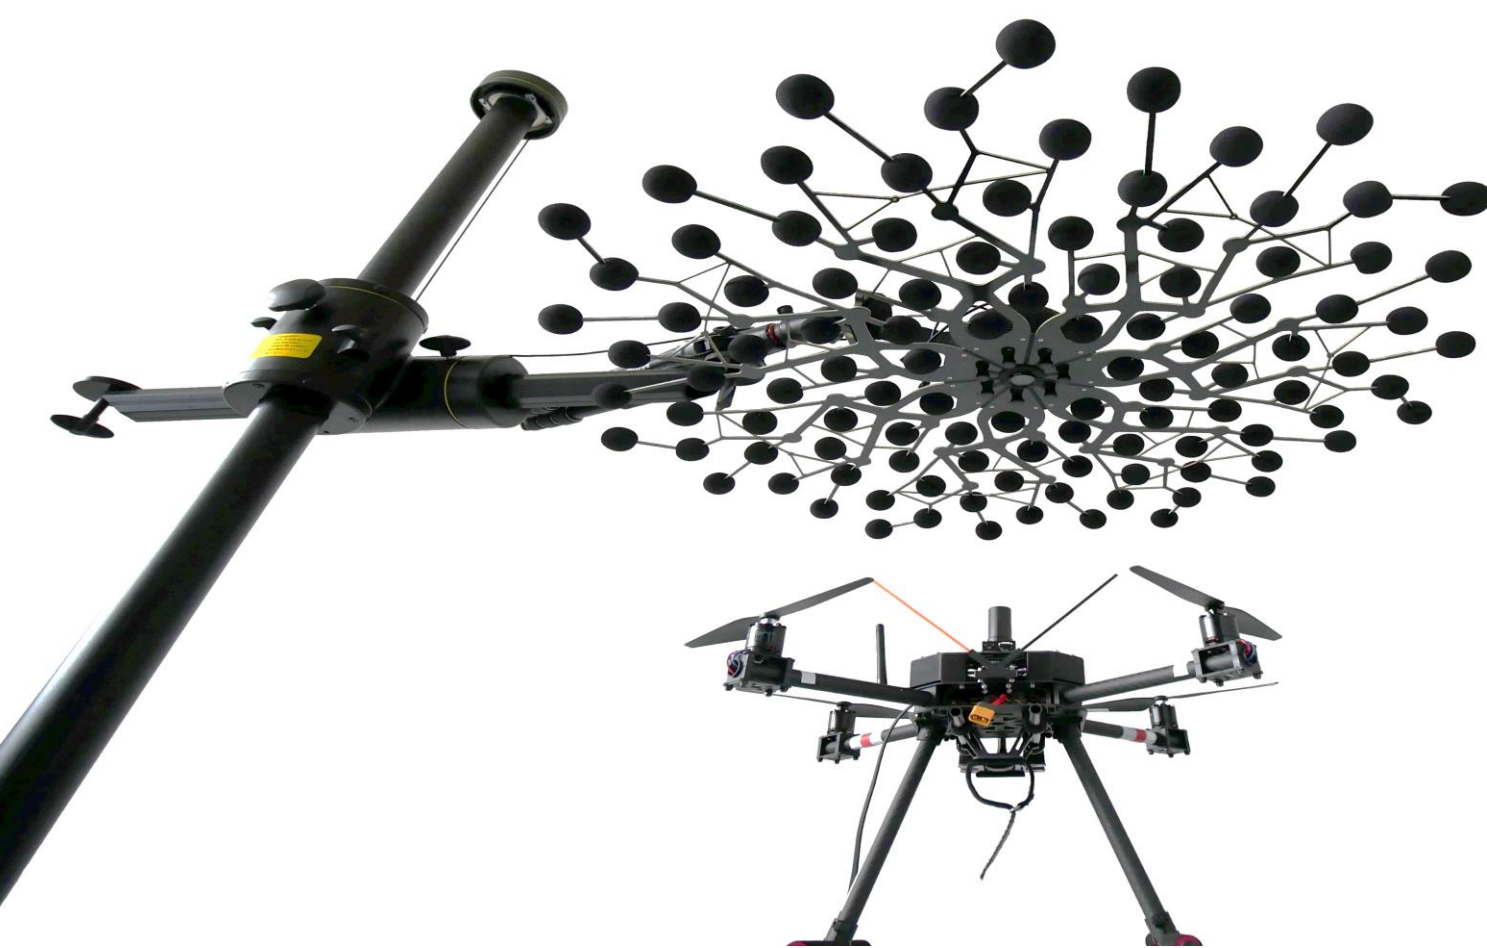
Fig. 3: The acoustic camera is mounted above the UAS, which is in parking position on ground level.

The acoustic camera records the UAV (Fig. 3) in 3 different environments. Functional beamforming creates a sound profile for the individual propeller blades (Fig. 4). The sound profiles are classified as damaged or undamaged using a Convolutional Neural Network (Fig. 5).

The CAE Systems Bionic M112 is used to record the UAV at 12.5 kHz in 3 different environments: laboratory (APZ), anechoic chamber (AC) and echoic chamber (EC).
