**DLR-IB-AS-BS-2025-174**

## **Visualization of flow inside the Fenestron**

# Visualization of flow inside the Fenestron

## Abstract

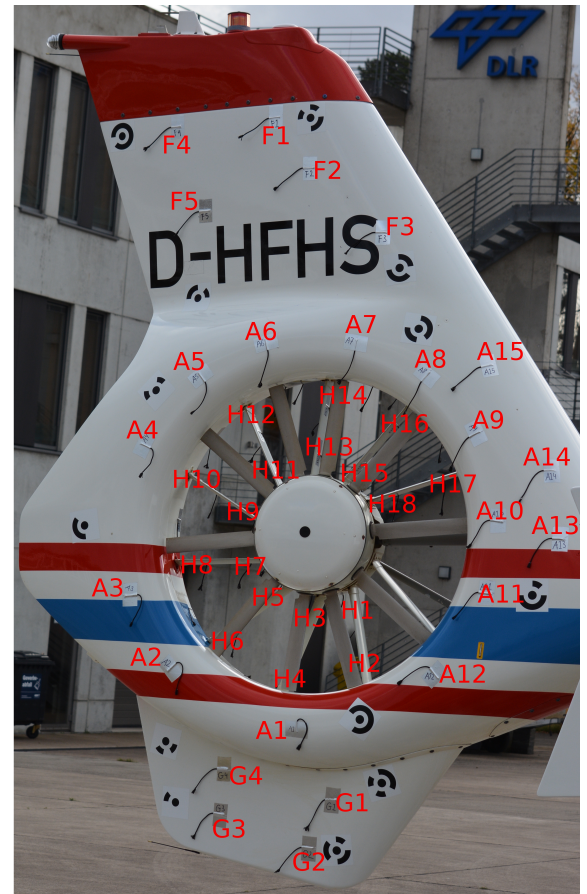
**Figure 2.** Tuft locations with their labels, in and around the Fenestron and tail surfaces. On the left side (a) and on the right side (b). Also shown are circular encoded markers for automatic image processing.

which causes an left/right asymmetric wake development. In addition to the tufts and temperature sensors, circular encoded markers (see figure 2), printed on certified 3M<sup>TM</sup> Exterior Aircraft Graphic Film A7322, were applied to enable automatic image processing techniques. An infrared image of the temperature distribution on a part of the tail is provided in figure 5b of [12], but this only applies to forward flight without side slip.

Tufts were placed in and around the Fenestron, as shown in figure 2. The tufts had a thickness of 3 mm. The thickness of the tufts is a compromise between visibility and dynamic response. Thinner, lighter tufts align quicker and better with the flow, but are more difficult to observe. On the left side (figure 2(a)) tufts were mounted on the upper fin (area D), the lower fin (area E), around the diffuser outlet on the casing (area C), on the outside of the diffuser (area B) and on the inner hub (area I). On the right side (figure 2(b)) tufts were located around the inlet on the casing close to the collector (area A), on the upper fin (area F), the lower fin (area G) and on the stator blades (area H). In total 81 tufts were mounted. In the initial flight test tufts were only placed in areas A, B, C, D, E, F and G. After the initial flight tests additional tufts in the areas H and I were added, as well as the circular encoded markers. Airworthiness of all parts and operations was ensured by certification with the DLR Design Organization and a Permit to Fly.

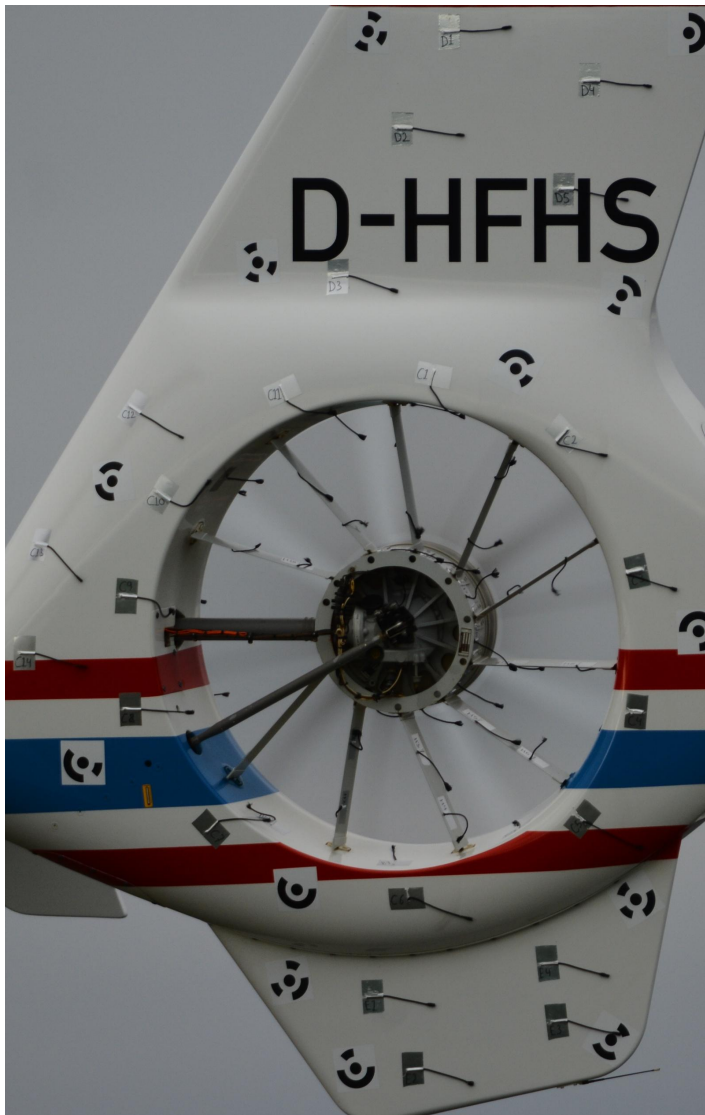
**Figure 13.** Flow inside and around Fenestron at airspeed 70 kt and side slip  $-17^\circ$ . Seen from the left side (a) and from the right side (b). Flow topology marked by purple diamonds in figure 7.

For the region indicated by the purple diamonds a reverse flow (from stator to rotor) is expected. Images of the flow are shown in figure 13 for an airspeed of 70 kt and a side slip of  $-17^\circ$ . This reverse flow is, however, not obvious from the tufts inside the duct. The flow inside the duct appears similar to that of the blue squares region. A very unsteady and unstable flow is observed between the stator blades. Based on the behavior of the tufts inside the duct it is not possible to observe a general flow direction (reverse or nominal). However, tufts in the area A clearly show that the flow there is separated, which indicates that the flow is directed outwards from the inlet lip. Tufts A6 is actually pointing upward and A1 is not sucked into the duct. Tufts A8–A11 also indicate a separated flow and are lifted off the surface. Tufts in the F area indicate some flow separation on the aft part of the upper fin. Tufts in the area G display attached flow. On the left side the tufts in area D and E also display attached steady flow. For a condition with an airspeed of 50 kt and side slip  $-25^\circ$ , a stable vortex appears in the lower part of the duct, indicated by tuft H2, which is rolled up into a spiral shape. This shape is stable over many images for this flight condition. At an airspeed of 40 kt and a side slip of  $-42^\circ$  tufts inside the diffuser are stable and pointing from stator to rotor, which corresponds to reverse flow. However, this conditions was only tested with a reduced number of tufts and was only observed from one side.
