2.1 IMPROVED THUNDERSTORM WEATHER INFORMATION FOR PILOTS THROUGH GROUND AND SATELLITE BASED OBSERVING SYSTEMS

A. Tafferner^{*}, C. Forster¹, Martin Hagen¹, T. Hauf², B. Lunnon³, A. Mirza³, Y. Guillou⁴, T. Zinner⁵.

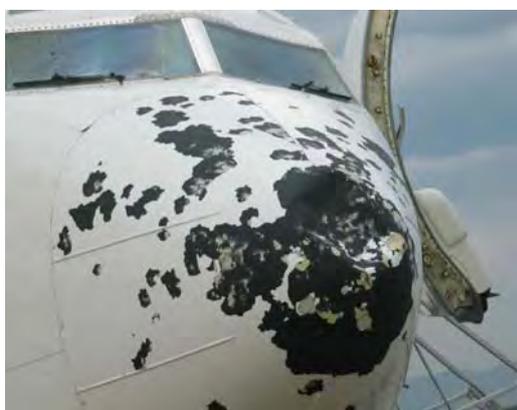
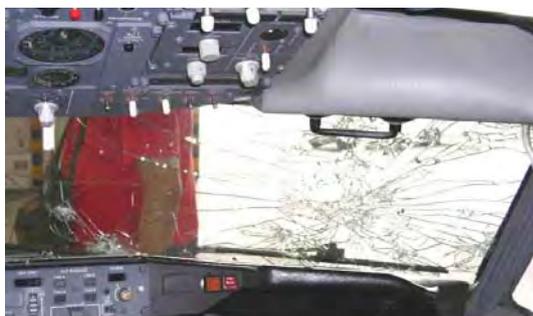
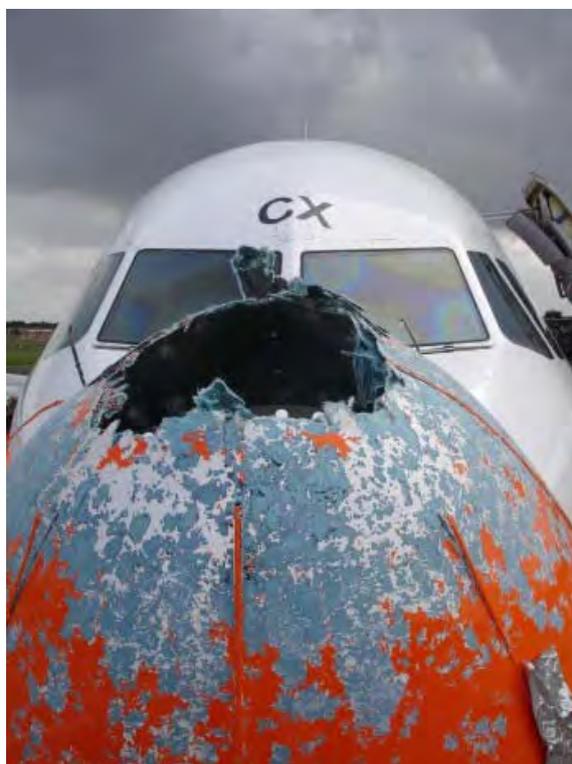
Figure 1: Nose and wind shield damage of two aircraft hit by hail stones during passage of thunderstorms. Left: Easy Jet Boeing 737 after take-off from Geneva, 15 August 2003. Right: WindJet A319 near Catania on Oct 1st 2009 (The Aviation Herald, Photo: ATRDRIVER)

aircraft is passing through it, the duration of exposure, the type of aircraft and the flight phase. Figure 1 shows two examples where aircraft have been hit by hail when passing through a thunderstorm. In both cases the aircraft's nose has been heavily damaged, and in one case also the wind shield has been cracked.

A photograph taken after landing (figure 1, right) shows a hole in the aircraft's radome due to hail encounter. Also it is noted in the Aviation Herald page by referring to a report from a mechanics after landing that *"the airplane experienced wind shear of +50/-50 knots on final approach to Palermo prompting the crew to initiate a go-around. The airplane did not climb until after passing the runway at very low height despite the engines at full thrust"*.

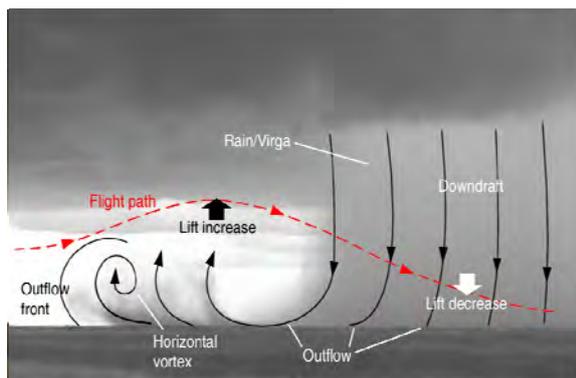
Figure 3: Lift increase and decrease for an aircraft which passes through a thunderstorm at low levels (FLYSAFE)

Wind shear can be a great hazard for an aircraft especially on approach to land when passing through the up- and downdraft regions of a thunderstorm. Figure 3 illustrates the situation. First the aircraft experiences a lift increase when it encounters the outflow boundary of the thunderstorm; thereafter it enters the downdraft region where it encounters a downward force which is of course dangerous on approach to landing.

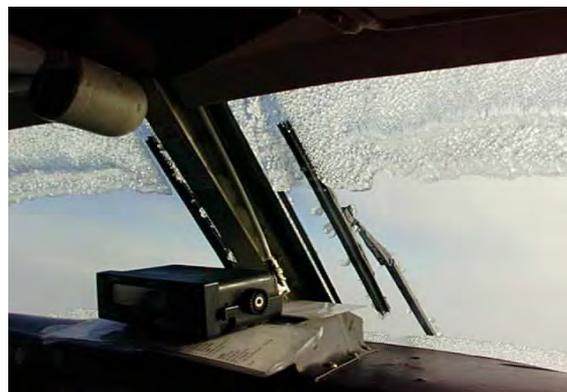
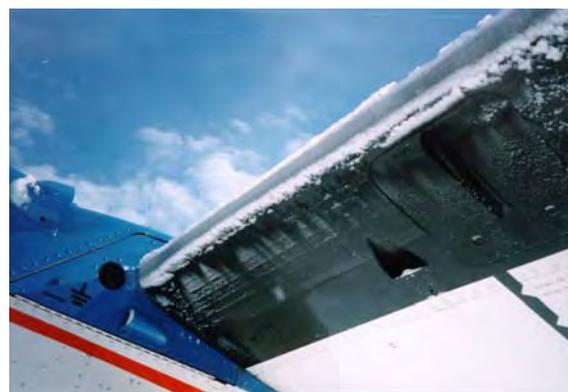
Figure 4: wind shield and wing icing after a flight of the DLR Dornier 228 aircraft in severe icing conditions.

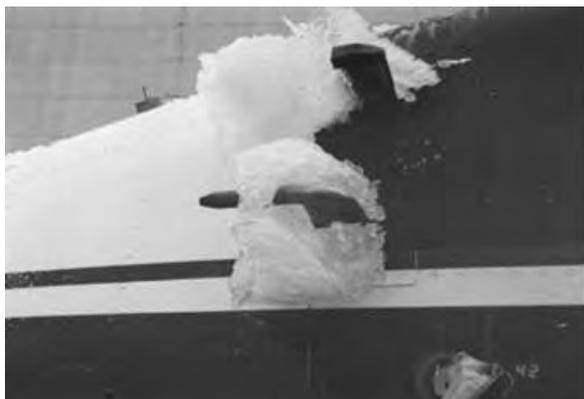
Figure 5: Icing of Pitot tubes, picture taken after landing of a flight of the DLR Dornier 228 aircraft in severe icing conditions.

There have been numerous incidents and also a few accidents due to aircraft icing, e.g the ATR-72 crash near Chicago 1994 (Sand and Biter, 2000). Icing of the Pitot tubes can result in wrong speed indications for the pilots or the onboard computer. In two cases of unintended descent within the upper parts of two independent thunderstorms a complete freezing of the Pitot tubes was observed even though the anti-ice (heating) systems were activated (Hauf et al., 1999). Figure 5 shows icing accretion on the Pitot tubes of the DLR Dornier 228 after landing.

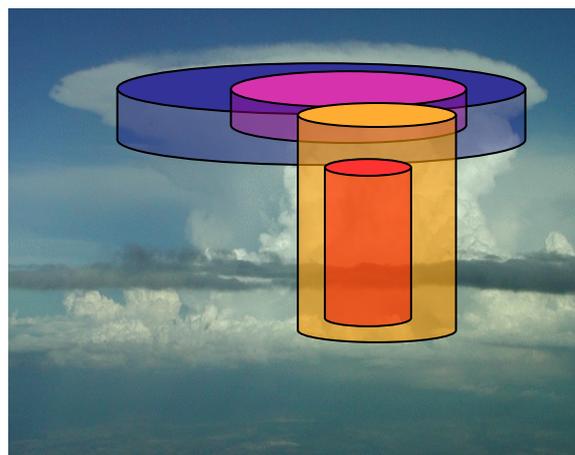
Figure 6: Bottom and top volumes representing hazard volumes for aircraft in two severity levels.

A set of requirements of pilots were obtained from a questionnaire and from discussions held at meetings, Pilots had expressed clearly that they do not wish to be confronted with a picture of the full complexity of a particular thunderstorm, which they would have to interpret themselves with regard to their flight, rather they would have the weather experts to define hazardous regions and tell the pilots where they can or where they cannot go. To fulfil this requirement the thunderstorm forecasts output from CB-WIMS are reexpressed as weather object, which define hazard volumes representing thunderstorm threats for aircraft. The aim of the weather object is to reduce then complexity of the weather feature. Figure 6 illustrates the concept.

In Figure 6, hazard volumes are depicted as cylinders for simplicity, however, in practice polygons are used. A thunderstorm object is composed of a “top volume” and a “bottom volume.” The nested bottom objects define volumes where the thunderstorm hazards of wind shear, turbulence, heavy rain, hail, icing and lightning can occur within the lower tropospheric part of a thunderstorm cell which present a hazard to aircraft flying at low levels, especially during landing and take-off.

The bottom volumes are constructed by use of 3D-radar and lightning data using Météo-France’ CONO algorithm (Hering et al., 2005) with severity defined by radar reflectivity thresholds 33 and 41 dBZ. The volume of each cylinder, in this case, represent the severity levels “moderate” and “severe” respectively.

The top volumes represent the hazards: turbulence, icing, and lightning and are detected from satellite data using DLR’s Cb-TRAM algorithm (Zinner et al., 2008). Here the “severe” threshold is selected based on lightning density, an additional data source from the LINET network (Betz et al., 2004). A detailed description of the thunderstorms objects and their attributes is found in Tafferner et al. (2008).

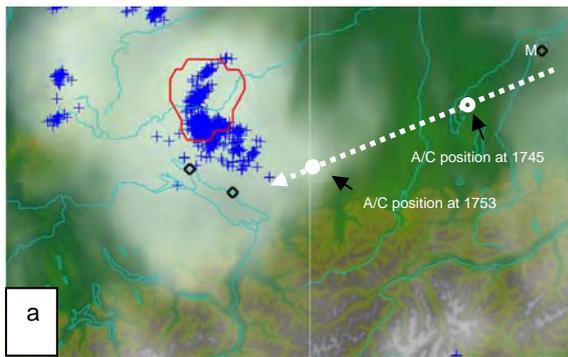
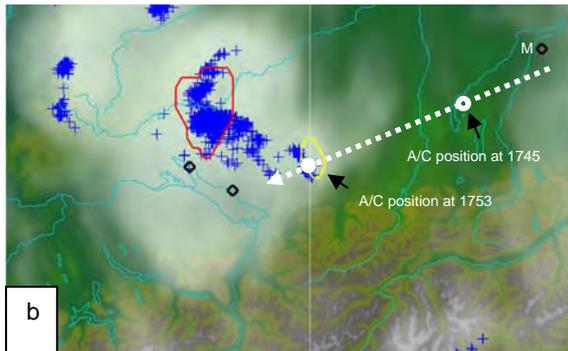
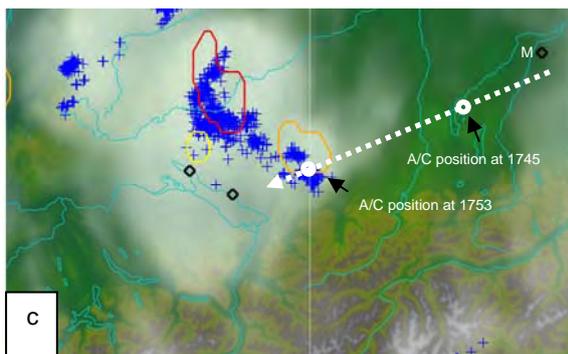
Figure 8: Thunderstorm cell development from 1755 (a) over 1800 (b) to 1805 UT (c). Marked in red: Cb top, yellow: convection initiation, orange: rapid development; blue: lightning observations during past 5 minutes (from LINET, Betz et al., 2004). Infrared satellite image in grey transparent shading. Flight track starting from Munich marked by dotted line, also a/c position at 1753 UT.

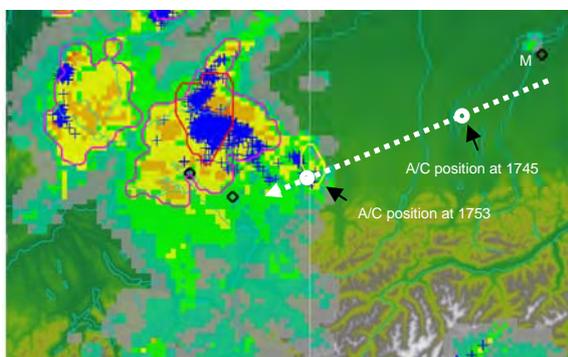
Figure 9: Same situation as in Fig. 8 at 1800 UT, but with radar reflectivity instead of satellite image and with violet contour marking the Cb bottom objects (by use of a 37 dBZ reflectivity threshold) in addition to the top object.

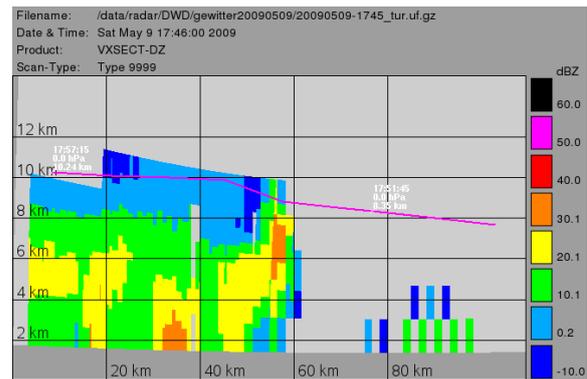
Figure 10: Vertical section through the radar reflectivity field as gained from the Türkheim radar at about 1748 UT along the flight path (pink line). Aircraft positions marked for 1751 and 1757 UTC.

below the lowest scan line of the radar. It is also possible that the gain switch was set at a too high value because of the strong thunderstorm cell to the north which the pilots wanted to avoid, again with the consequence that the small cell beneath did not show up on the screen. Finally, whilst flying over the cell, there were indications of precipitation to the pilots (perhaps on the wind shield). In accord with this note the vertical cross-section of the reflectivity pattern which indicates precipitation particles intersecting with the aircraft track (Fig. 10). At about the same time, the convective initiation is noticeable by lightning detections in that region (Fig. 8b). Note that these figures present lightning observations during the past 5 minutes before 1800 UTC.

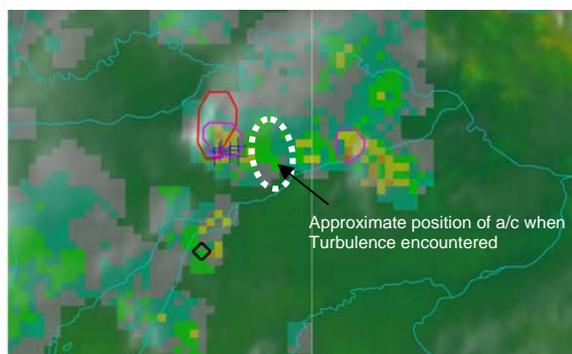
Figure 11: Radar reflectivity and Cb bottom volumes (pink contours) over southern Germany at time 1645; MSG rapid scan HRV image (transparent grey) and Cb top volume (red) at time 1640; approximate aircraft position indicated when turbulence encountered at 1637 UT. The black diamond marks the position of Munich airport.

On 5 June 2008, an Airbus A319 aircraft during the descent to Munich experienced turbulence about 3 nm north of the way point LANDU at flight level 110 at 1637 UTC (BFU 2008). The approximate position is indicated in figure 11 by the dotted white oval.

According to the BFU report, the pilots saw two cumulus clouds left and right of the flight path which were also apparent on the navigation display. In the figure, these are obviously the two cells marked by coloured contours on both sides of the aircraft position.

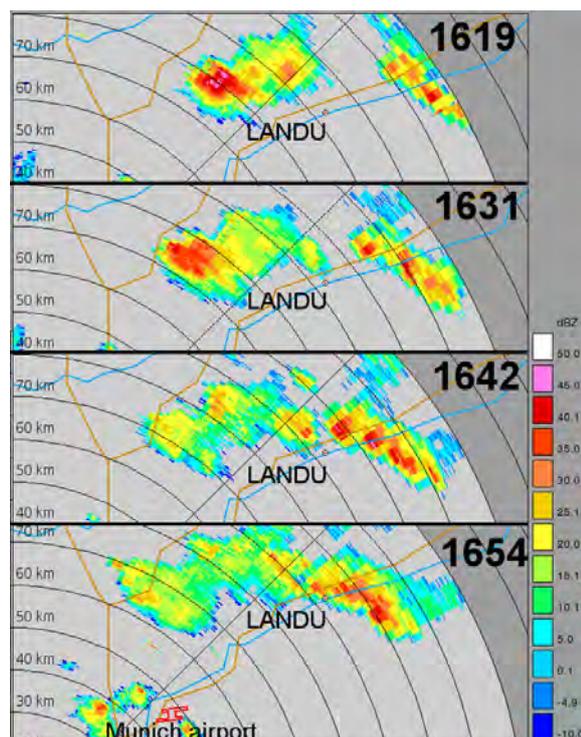
Figure 12: Radar reflectivity at four different times on 5 June 2008 from DLR polarimetric radar at a height of 3100m AMSL. The little dot at the crossing of the river Isar and the 80 km range circle marks the way point LANDU.

Like in the previous case, the intensity values in the radar composite are below 37 dBZ in the region of the aircraft. However, a detailed inspection of radar data from the DLR operated polarimetric radar POLDIRAD in the form of a constant altitude plan position indicator (CAPPI) at 3.1 km, somewhat below the height where the descending aircraft was at that time, shows the growth of small cells of high reflectivity up to 40 dBZ just north of waypoint LANDU between 1631 and 1642 UTC (figure 12). It is plausible that the aircraft approaching from north hit one of these cells with the turbulence encounter.

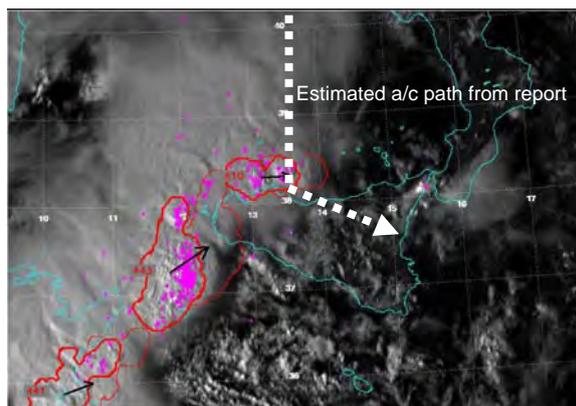
Figure 13: High resolution visible satellite image in grey transparent shading and mature thunderstorm cells at 1455 UT marked by thick red contours, thin red contours indicate one hour nowcasts of the cells. Lightning observations recorded during past 5 minutes before 1455 UT marked by pink dots (from LINET observation system). Dotted line segments mark direction from Forli to Palermo and from Palermo to Catania.

The METAR from Palermo, available around the time of the incident, reports at 1450 UT a 20° Wind with 26 knots with lowest visibility of 4000m, thunderstorm as present weather. The Cb-TRAM analysis for about this time is shown in figure 13.

The satellite image from Meteosat in the high resolution visible channel shows an approaching thunderstorm front towards the island of Sicily. The heavy convection cells, marked in red, and the lightning activity in the frontal line, observations from the LINET network, can be traced back for more than three hours before this time. Most probably the aircraft flew into the foremost convective cell (labelled with 410) just off the coast of Palermo, where the black arrow indicates its progression. Note also that the one hour nowcast of that cell indicates propagation to the east. There are also lightning observations in that cell.

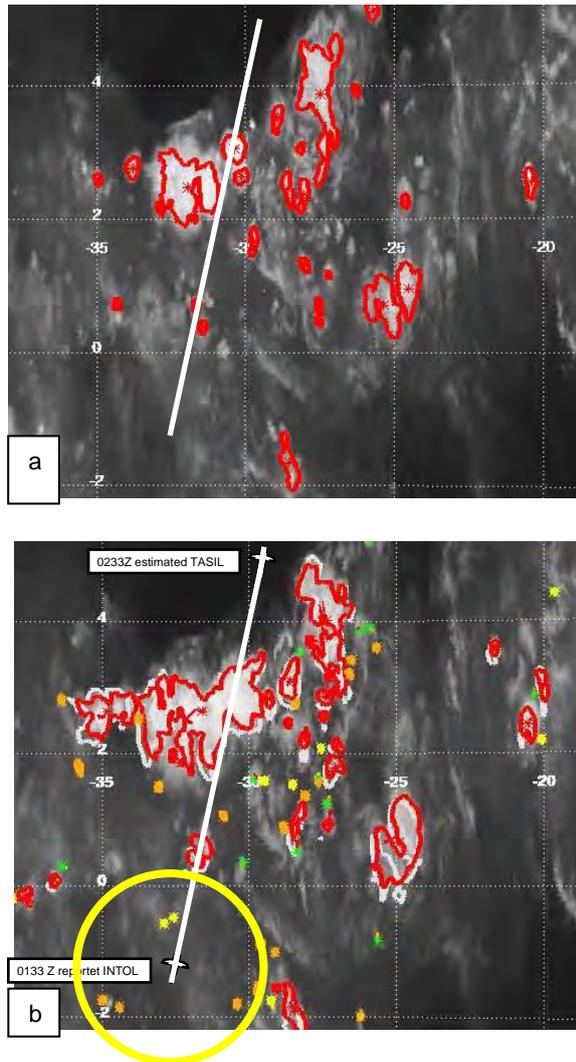
Figure 14: Meteosat infrared image over the Atlantic east of Brasil together with convective clusters (red contours) as identified from the Cb-TRAM cloud analysis on 1 June 2009 for time 000 UTC (a) and 0130 UTC (b). Also marked is the flight route between the way points INTOL and TASIL. The yellow circle indicates a radar range of about 80nm. Yellow, orange and green little patches mark initial developments not relevant for this analysis and not discussed.

Figure 14 shows the convective situation over the Atlantic at two different times, i.e. 0000 and 0130 UTC, from the satellite cloud analysis. Red contours mark again the convective updrafts as detected by Cb-TRAM. The flight track is indicated by a white line combining the way points INTOL and TASIL. The convective cloud feature which is traversed by the flight route is seen to grow remarkably during this time span of ninety minutes. For the time 0130 UTC when the aircraft reported waypoint INTOL to ATC an approximate radar range of 80 nm is drawn as a yellow circle around the aircraft. This is to demonstrate that at this time the pilots could not foresee the strong convective activity on their future track from the on-board radar detection (also a longer range would not change the situation). Also, just from looking out of the window it was probably impossible for them to recognize the thunderstorm complexes in the far distance due to the midnight darkness. Furthermore there are no lightning discharges observed from the networks for this region at this time (noted by Vasquez' report) which could have warned the pilots. Half an hour later, at 0200 UTC, when the aircraft was close to the major convective complex (figure 15a), the onboard radar should have detected the cells, but now indicating convective activity almost everywhere in front of the aircraft which makes it

difficult for the pilot to decide whether to penetrate the system or to go around and in which direction. This is complicated by the fact that the onboard radar signal is strongly attenuated by precipitation, due to its short wave length of 3cm (as compared to ground based radars) with the effect not being able to render the real extension of the storm. In this case the pilots obviously chose to go through the convective complex. Figure 15b shows the aircraft in its last known position when it had almost crossed the major storm cell at 0210 UTC.

sequence of figures 14 and 15 makes clear that the ground based information is able to represent the real situation about the convective activity and that this information, when brought to the cockpit, would help pilots in making decisions, especially when the planned route is impacted by thunderstorms. Ideally an alternative route in a given situation would be proposed by the ground based systems, e.g. as indicated by the dotted line in figure 16. This is not to say that the indicated route would have been possible for flight AF447. There might be restrictions due to ATC, prescribed air routes or fuel uptake which would not allow such a detour. Furthermore, it is known that often aircraft fly through these storms without any problems. Obviously, it is not only the mere presence and location of these storms that is relevant but also their evolution; whether they are growing in size or depth, their movement and possibly more elaborate attitudes like height, precipitation rate and type, lightning activity and turbulence level. Some of which have been addressed in the FLYSAFE Cb WIMS.

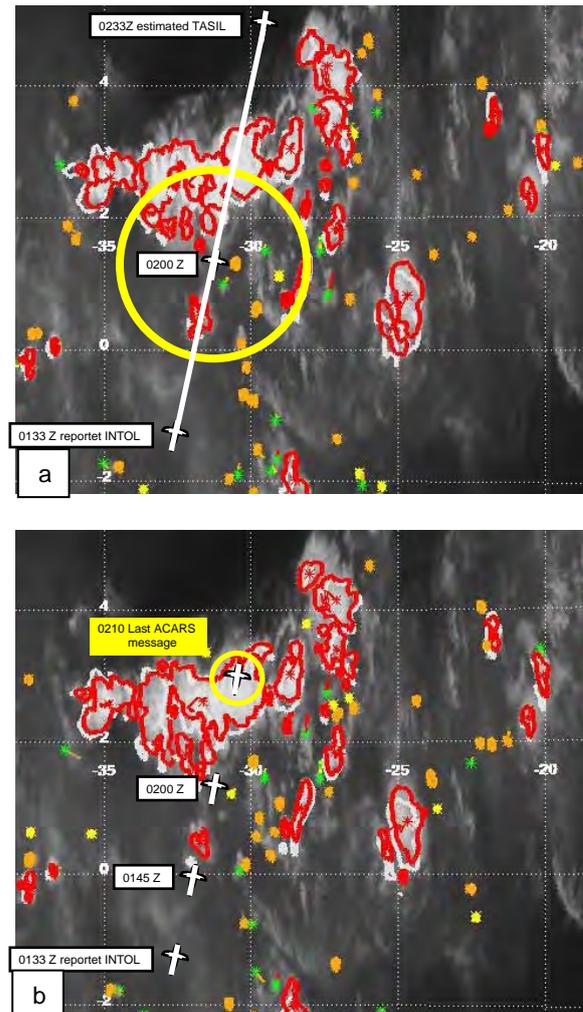
Figure 15: as in figure 14, but for 0200 UTC (a) and 0210 UTC (b)

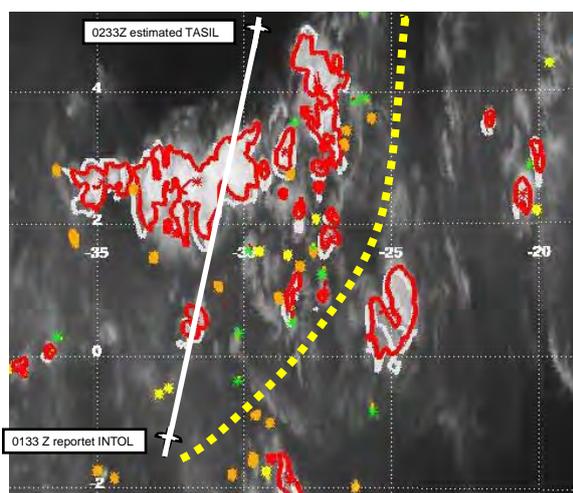
Figure 16: As in fig. 14b, with indication of alternative route marked by dotted line.

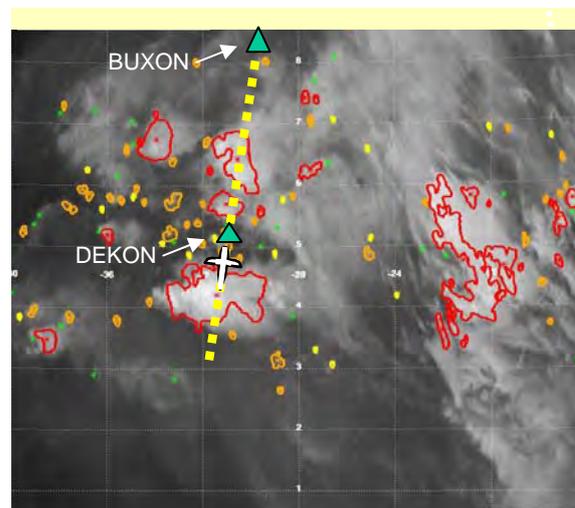
Figure 17: IR Meteosat 9 image on 30 November 2009 at 0350 UTC with mature convective cells (red contours) from Cb-TRAM analysis. Airway UN866 marked by yellow dotted line together with position of aircraft.

Later in the report it is noted that the airplane was at FL380 about 60nm ahead of DEKON on airway UN866 at time 0350 UTC. The Cb-TRAM analysis for this date and time is shown in figure 17

together with the airway and the approximate position when Mayday was called. Apparently the aircraft flew right through a major thunderstorm as seen clearly in the satellite image and marked by the red contour. From inspection of the development before and after this time (not shown) it is apparent that the convective cluster in this location originated around 0100 UTC and was still growing at the time of encounter. Also one can notice that additional convective clouds are on the

flight path further to the north between DEKON and BUXON way points (fig. 17). According to the report the turbulence lasted for about 30 minutes. It is not clear whether it would have been possible for the pilot to choose another route. The French Bureau d'Enquêtes et d'Analyses (BEA) reports that according to the air safety report weather forced the crew to divert from the airway and descend to FL360 employing oceanic contingency procedures after being unable to obtain clearance from ATC.
