FEM-analysis of de-bonding behaviour between stringer and skin

Institut of
Composite Structures
and Adaptive Systems

TESTING AND ANALYSIS OF OMEGA STRINGER DE-BONDING

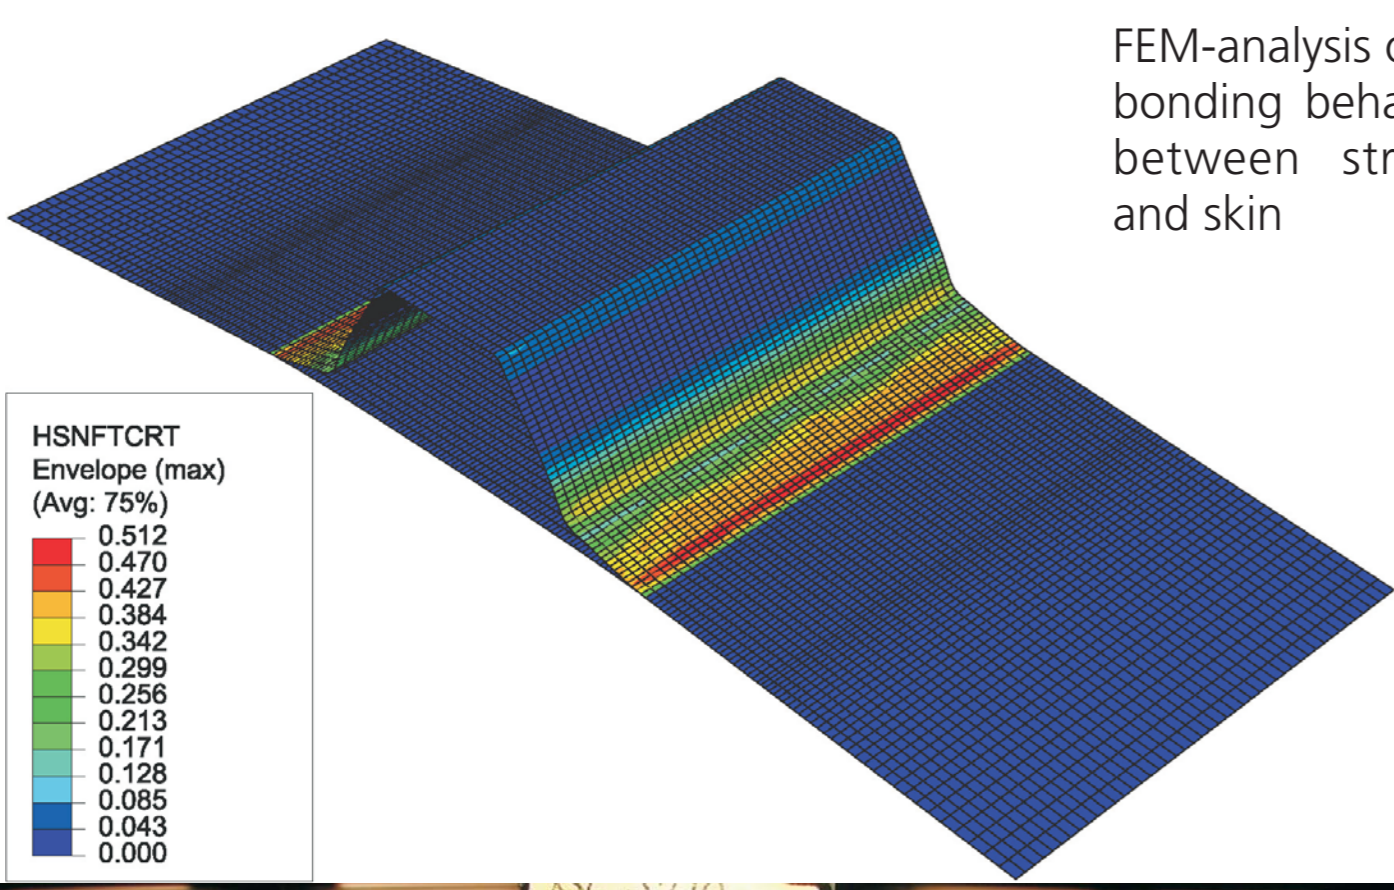
HSNFTCRT
Envelope (max)
(Avg: 75%)

The interface strength between omega stringers and the skin was tested at DLR Braunschweig. Therefore the stringer is teared-off with a new test device using a standard test machine. Pull angle can be varied from 0° to 45°. With the help of this device omega stringers can be tested according to stresses dominated by fracture Mode I and stresses from combined fracture Mode I and Mode II. This allows to compare different omega stringer geometries and bonding technics. In parallel a de-bonding analyses was made using different numerical approaches (e.g. 3D continuum damage model).

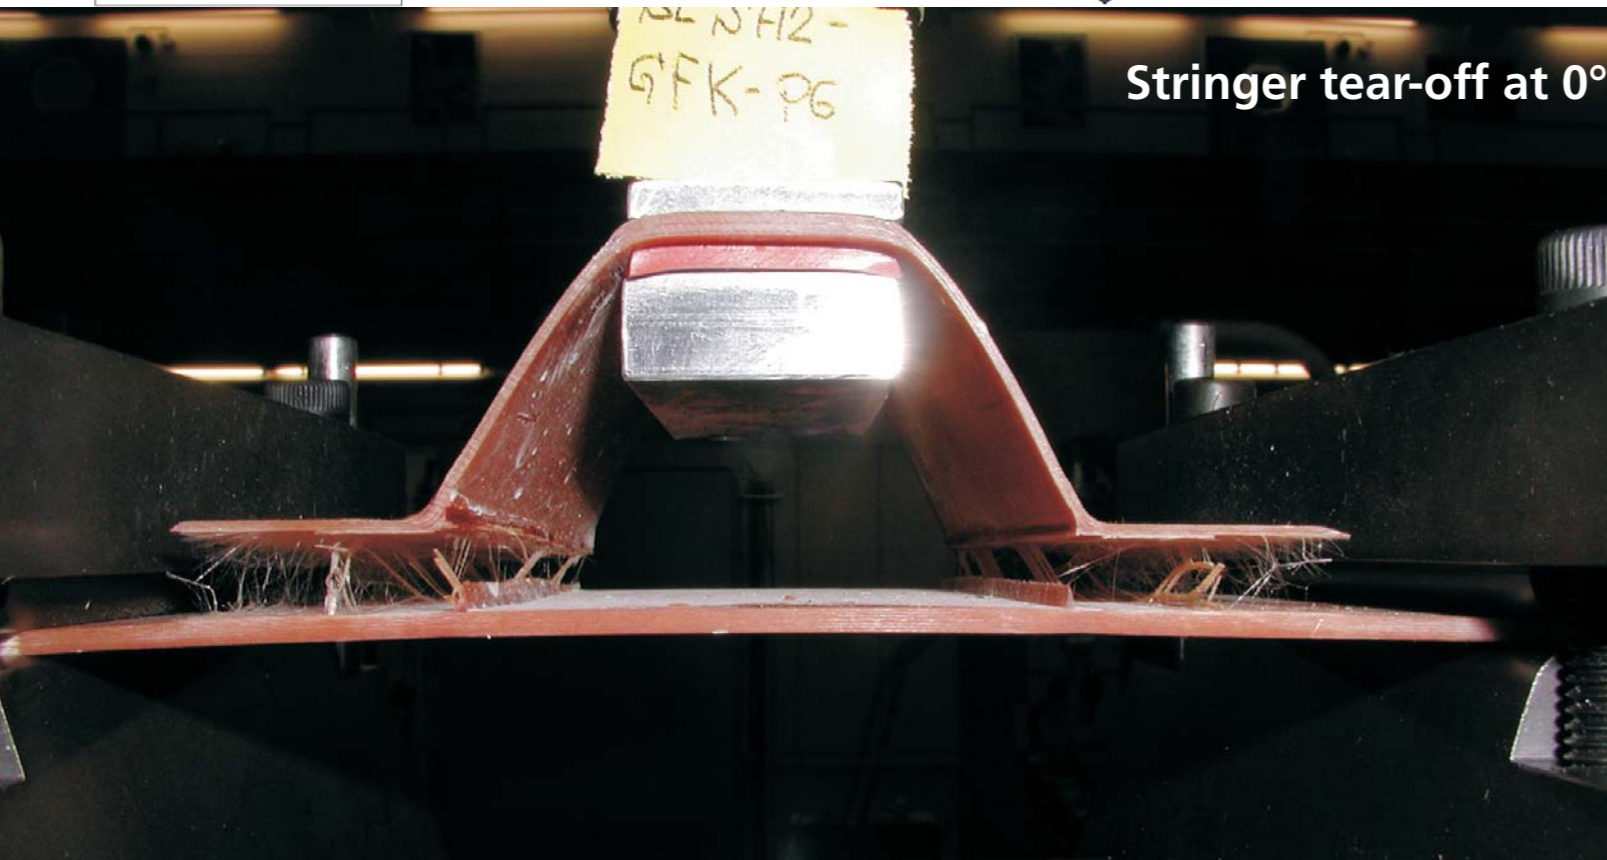
Stringer tear-off at 0°

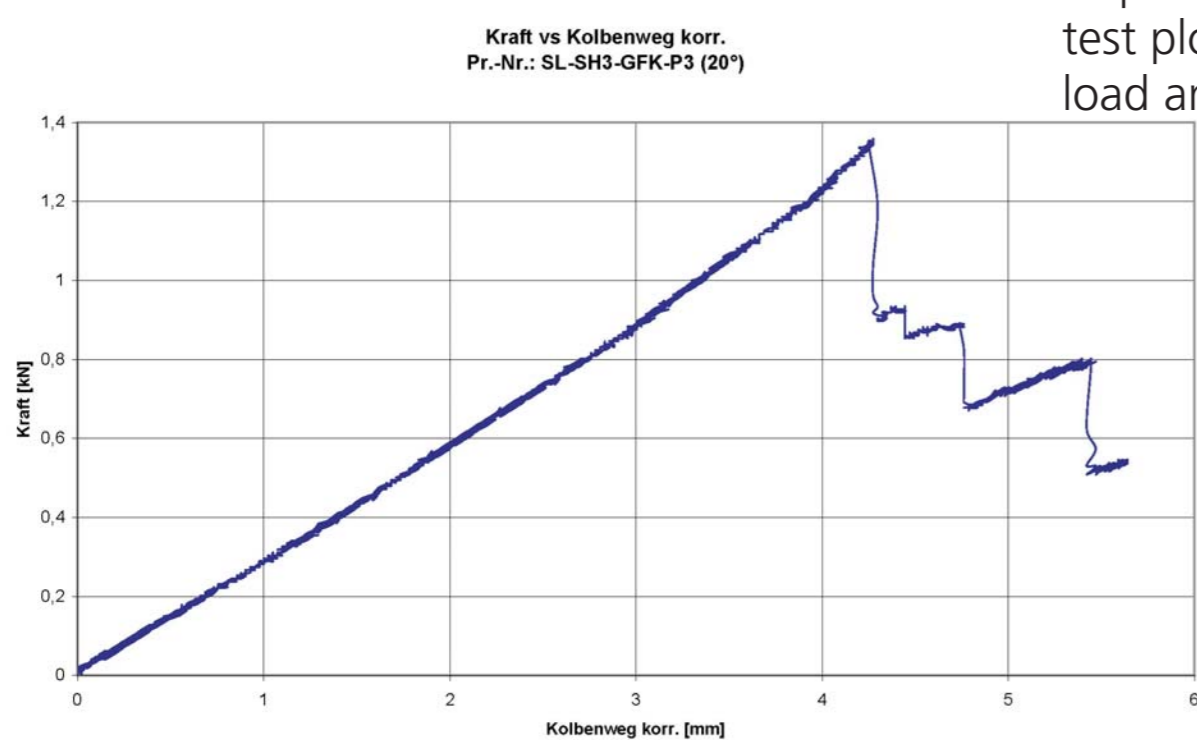
Experimental test plot for 20° load angle

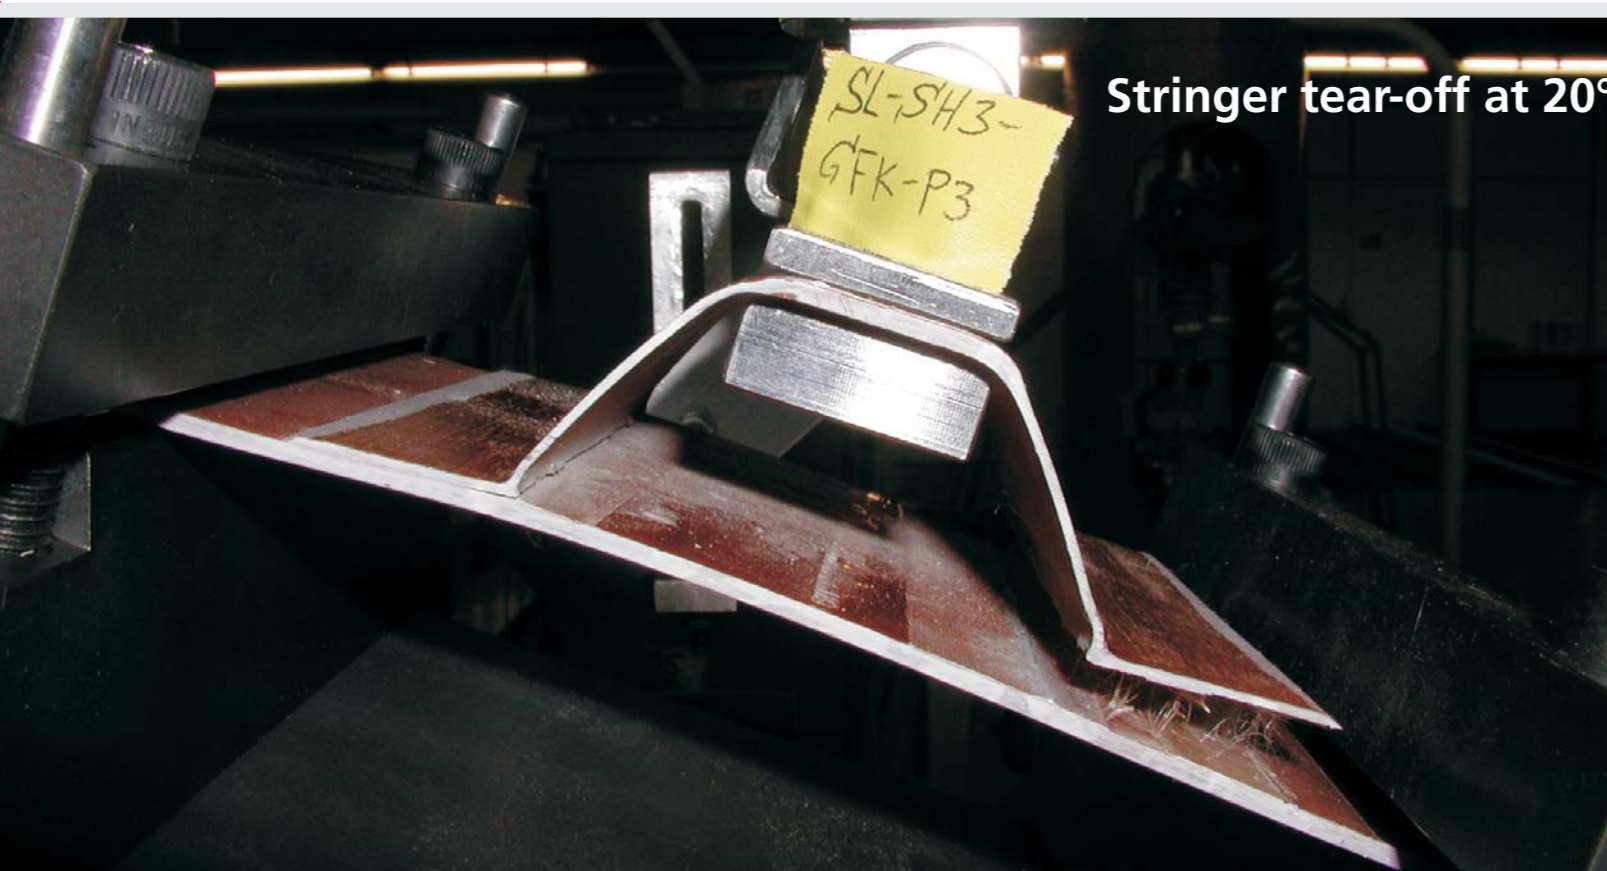
Stringer tear-off at 20°

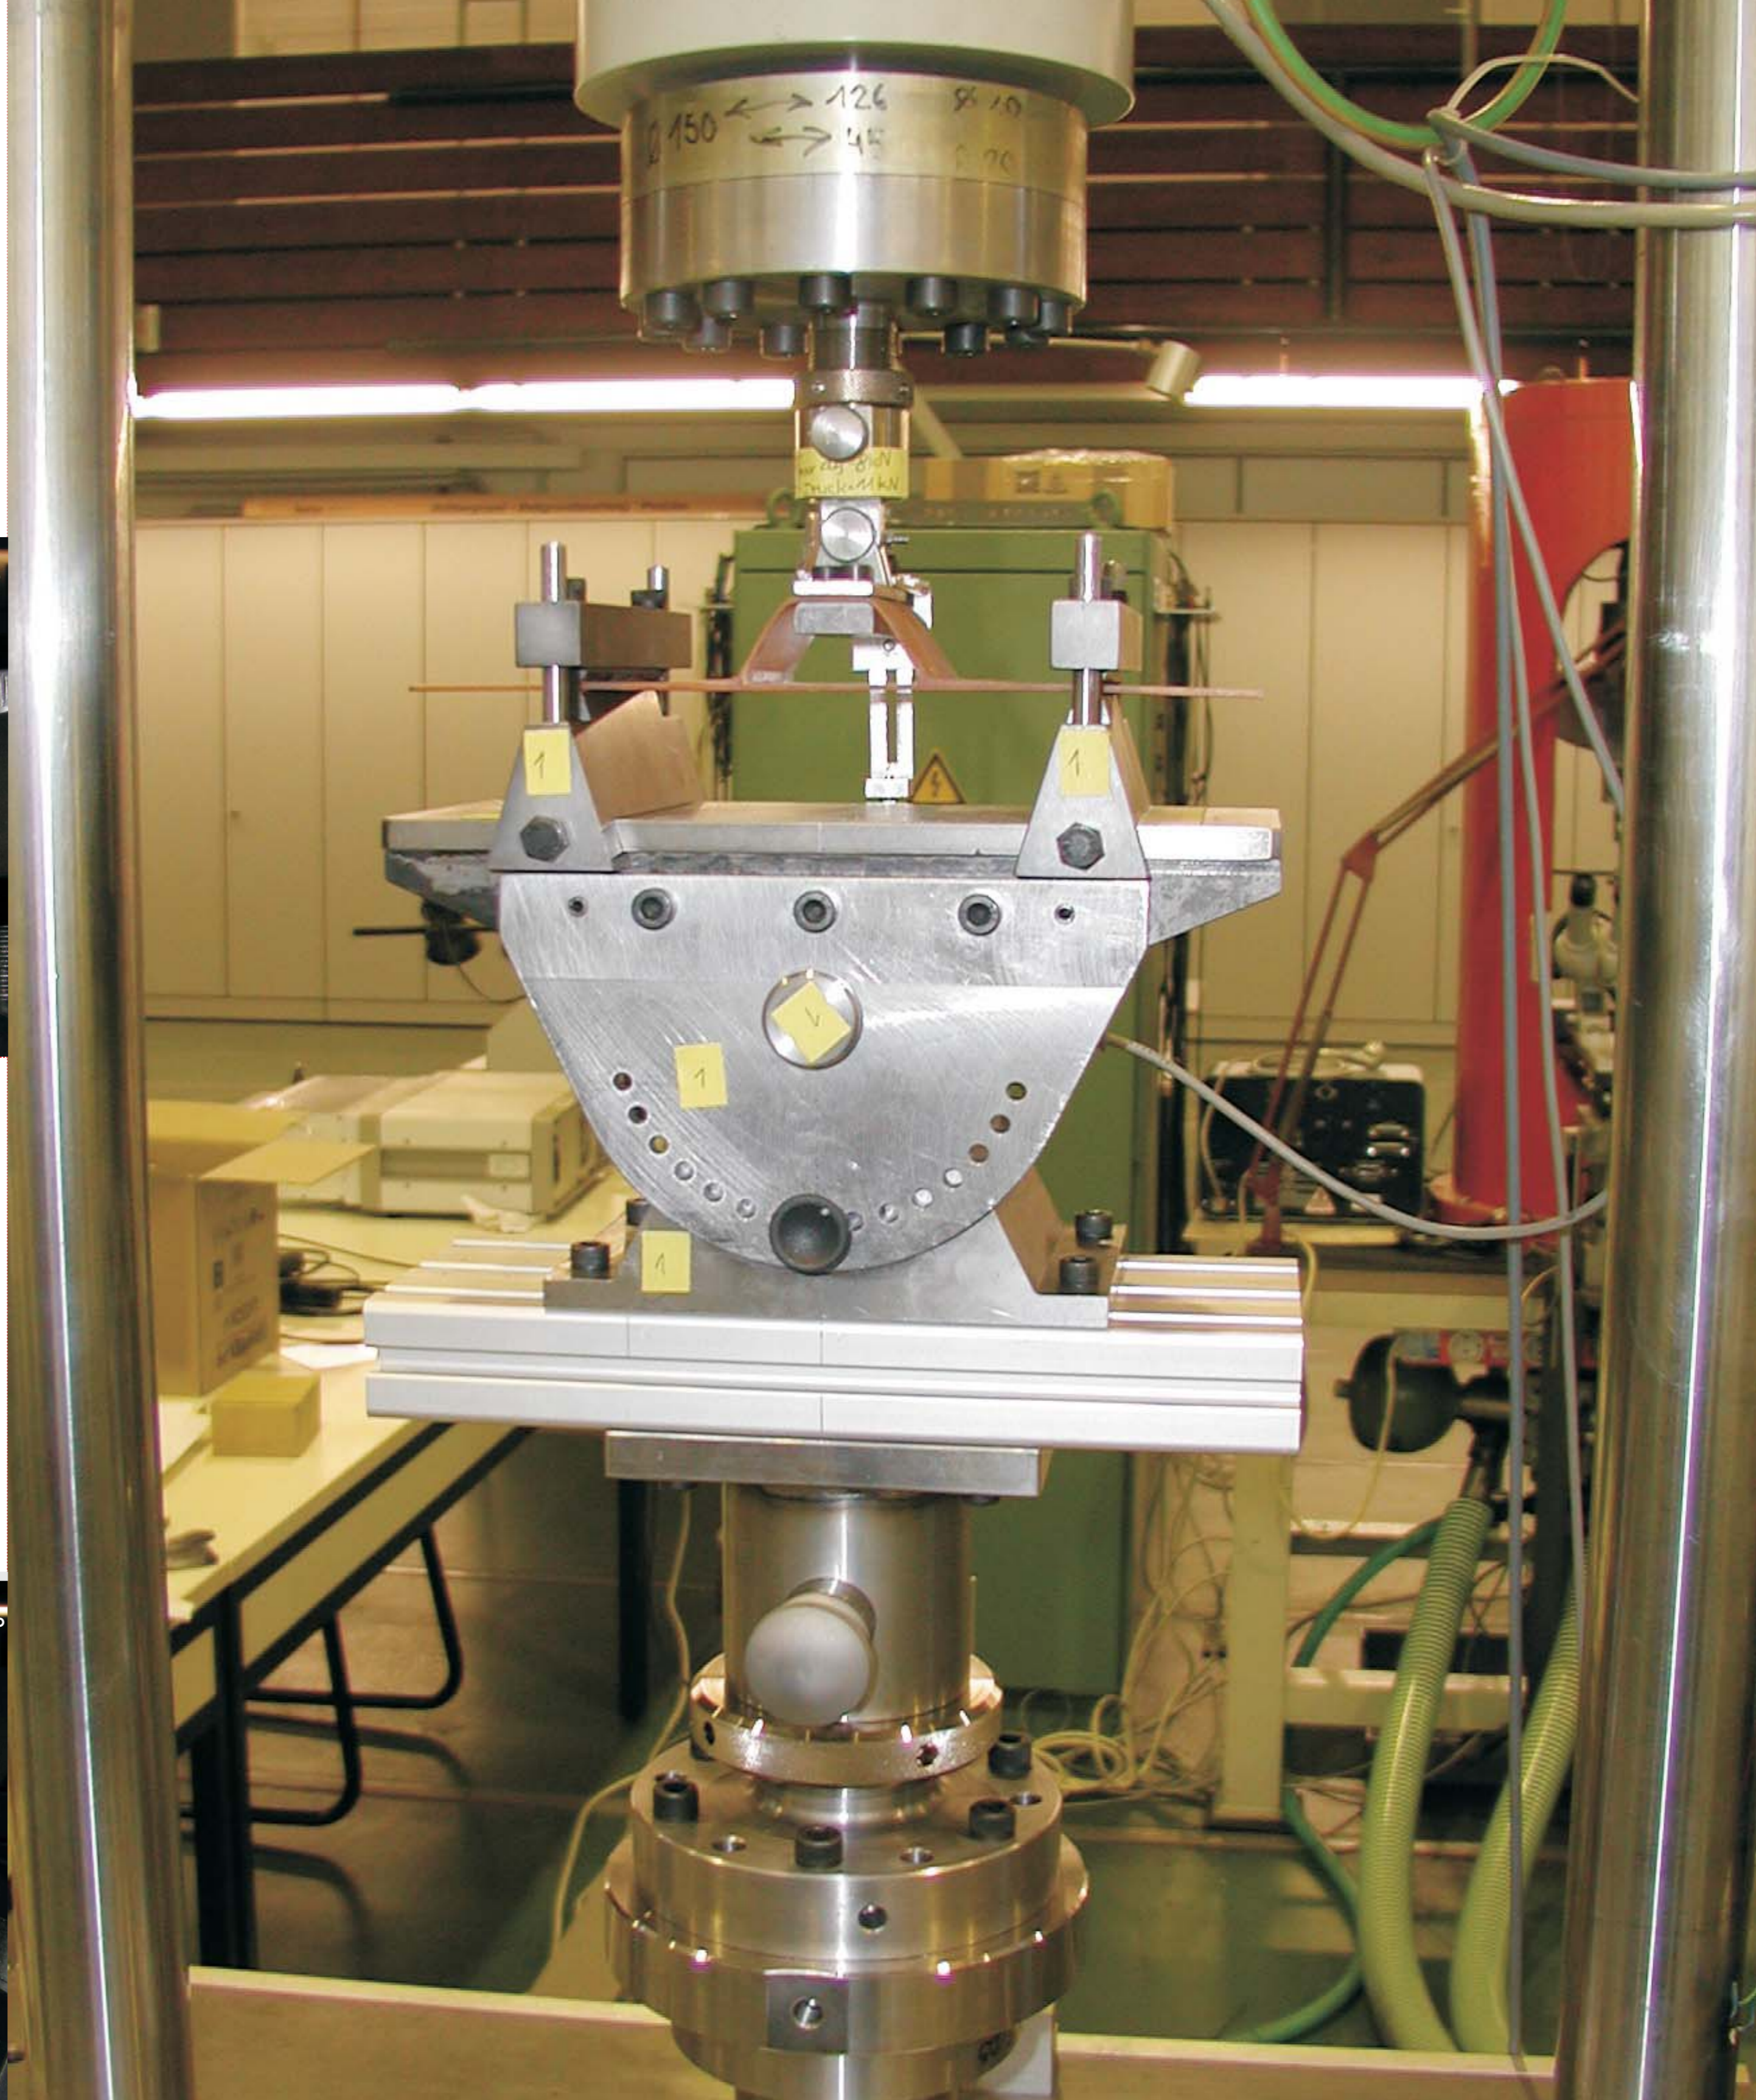
Picture:
Omega Stringer Tear-off Test Device with Specimen
