In-situ laser-induced contamination monitoring using long-distance microscopy

ABSTRACT

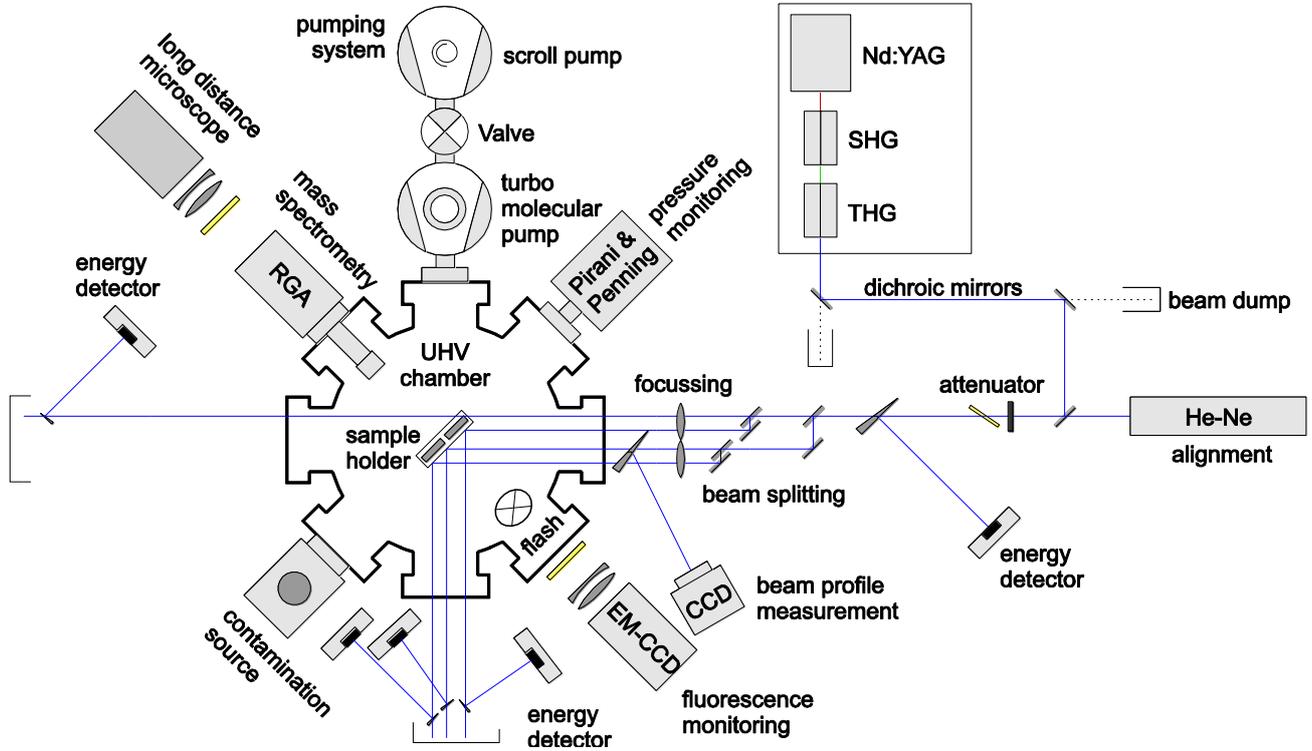
Fig. 1 shows the setup which was used to perform laser-induced contamination tests for space optics. Space conditions are simulated in the ultra-high vacuum (UHV) chamber. The contamination process is enforced by evaporating an organic contaminant into the UHV chamber. As contaminant naphthalene was chosen due to its high vapor pressure, and easy handling. The contamination chamber can be heated from outside by electrical heating bands for acceleration of the outgassing. By a needle valve the mass flow into the main chamber can be regulated and a temporally constant pressure can be adjusted. A partial pressure in the range of 10^{-5} mbar was used for LIC tests.

Figure 1: Laser-induced contamination test bench for testing HR coated optics.

As UV laser source a pulsed Nd:YAG laser with subsequent frequency doubling and tripling unit is used at 355 nm. The pulse frequency is 1000 Hz with a pulse width of 10 ns and pulse energy up to 1.9 mJ. The beam is split into four identical beams to allow tests of three different samples simultaneously under identical conditions. One beam is used for reference. A moveable sample holder allows performing several tests successively without breaking the vacuum.

Focusing lenses ensure that on the chamber windows the beam diameter is larger and consequently the energy density is considerably lower than on the optical samples. This ensures that contamination is mainly formed on the optical samples and not on the windows. The beam diameter is about 260 μm on the sample plane.

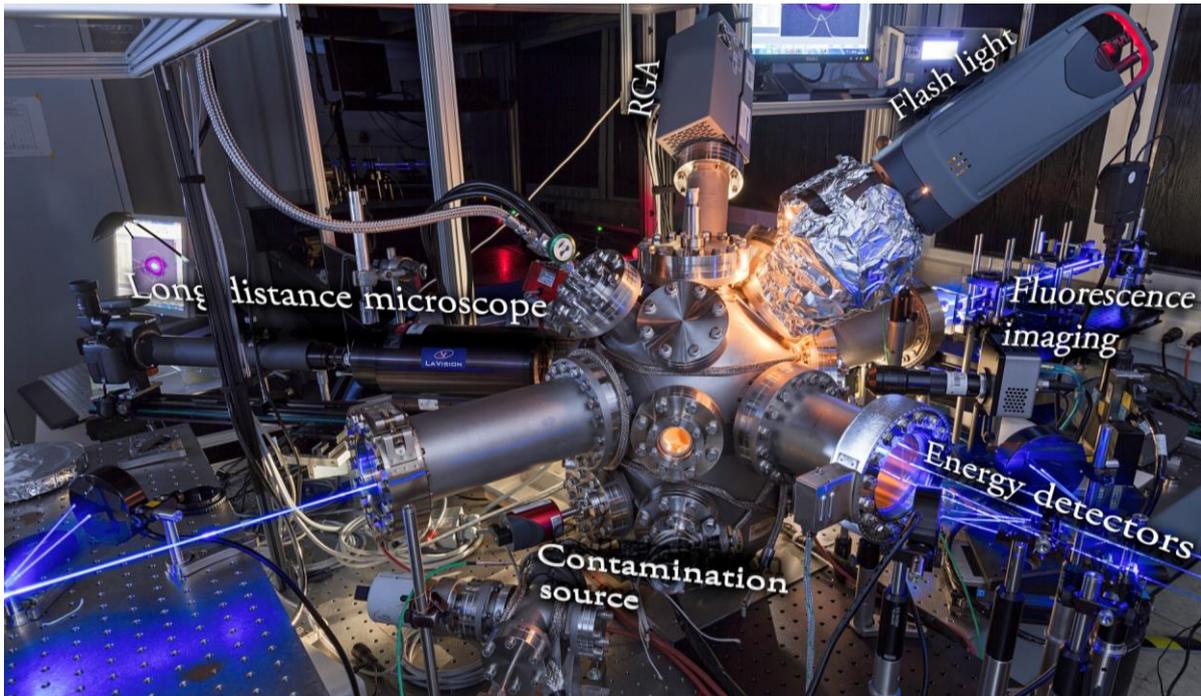
Figure 2: UHV chamber equipped with various sensors for process monitoring.

Different monitoring units are available for investigation of contamination and damage occurrence. Energy detectors record the reflectivity of each sample. To investigate damage formation a long distance microscope is installed to monitor the sample inside the UHV chamber during irradiation. It consists of a Maksutov-Cassegrain Catadioptric lens design in combination with a single lens reflex camera. To resolve even small damage under sufficient contrast the optical sample needs to be illuminated. A flash is triggered by the camera and illuminates the sample from the back. The long distance microscope is mounted in front of the UHV chamber window. By an appropriate filter unwanted, scattered

UV light from the laser source is blocked. The microscope is focused onto the front side of the HR coated samples and the images are recorded in-situ during LIC tests. An optical resolution down to 10 μm is possible with this setup.

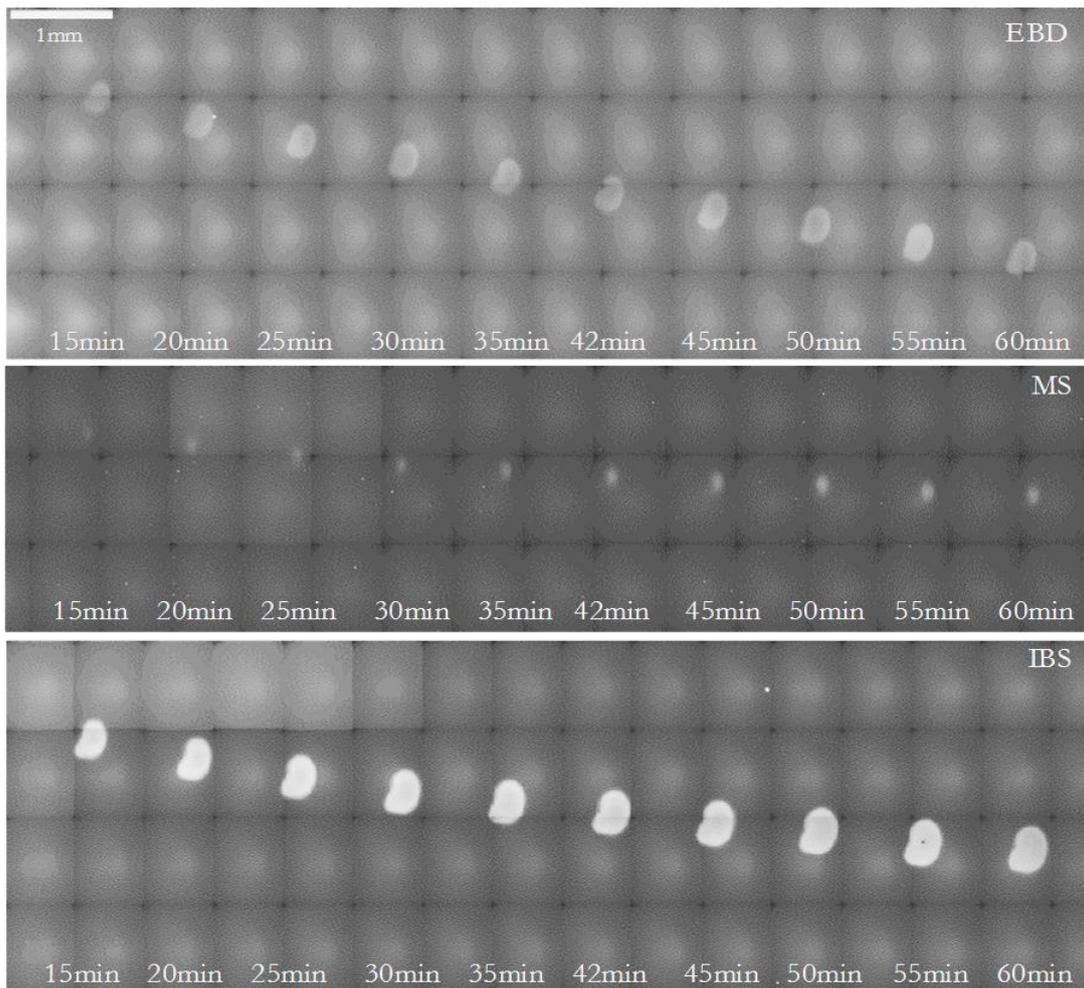
To investigate the deposit growth as a function of time the laser radiation time was varied for tests on different sample positions by moving the sample holder and while keeping same contamination conditions. Top image on Fig. 3 shows fluorescence for EBD, middle for MS and bottom for IBS samples. From left to right the laser irradiation time increases from 15 min up to 60 min. Laser fluence was 300 mJ/cm^2 and contamination pressure was 2×10^{-5} mbar naphthalene. No contamination induced damage was observed during these tests due to short laser irradiation time. The line scans in Fig. 4 are taken from FM images across the center of deposits. These profiles show the fluorescence level after laser irradiations of 15 min, 45 min and 75 min on EBD, MS and IBS samples.

Figure 3: Fluorescence micrographs after LIC tests show deposit formation. Laser irradiation time varied from 15 min up to 60 min. Fluence was 300 mJ/cm² with contamination pressure of 2×10^{-5} mbar.

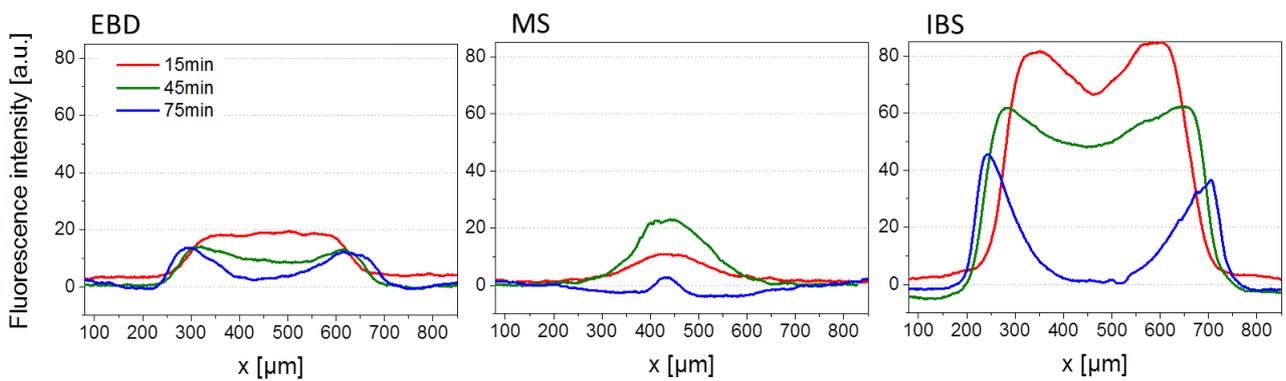
Figure 4: Fluorescence line scans of LIC tested samples after 15, 45 and 75 min.

For IBS sample fluorescence intensity is considerably higher than for EBD and MS samples. For all three samples the fluorescence intensity decreased in the center of the beam for higher irradiation time, indicating that there is a competitive ablation or transformation to non-fluorescent material. For IBS and EBD samples doughnut shaped deposits are clearly visible, but for MS sample the shape remains Gaussian like for investigated irradiation time up to 75 min. The surface covered by contamination on MS samples is smaller with a diameter of about 150 μm than on EBD samples with about 300 μm and IBS samples with about 400 μm .

The MS coated optic was tested at a fluence of 660 mJ/cm^2 and a contamination pressure of $1 \times 10^{-5} \text{ mbar}$. MS samples show a different contamination shape than IBS and EBD samples (see Figure 4). But the damage morphology is similar to EBD samples, seen in Fig. 7. Damage starts to occur with a couple of small spots within an area of $200 \mu\text{m} \times 250 \mu\text{m}$ after 8 h of irradiation. The reflection decreased just slightly by 1 %. These spots are about $10 \mu\text{m}$ in diameter and are holes like those found at EBD samples. They are getting larger by time until they merge after 22 h resulting in a decrease of the reflectivity down to 85 % (Fig. 8).

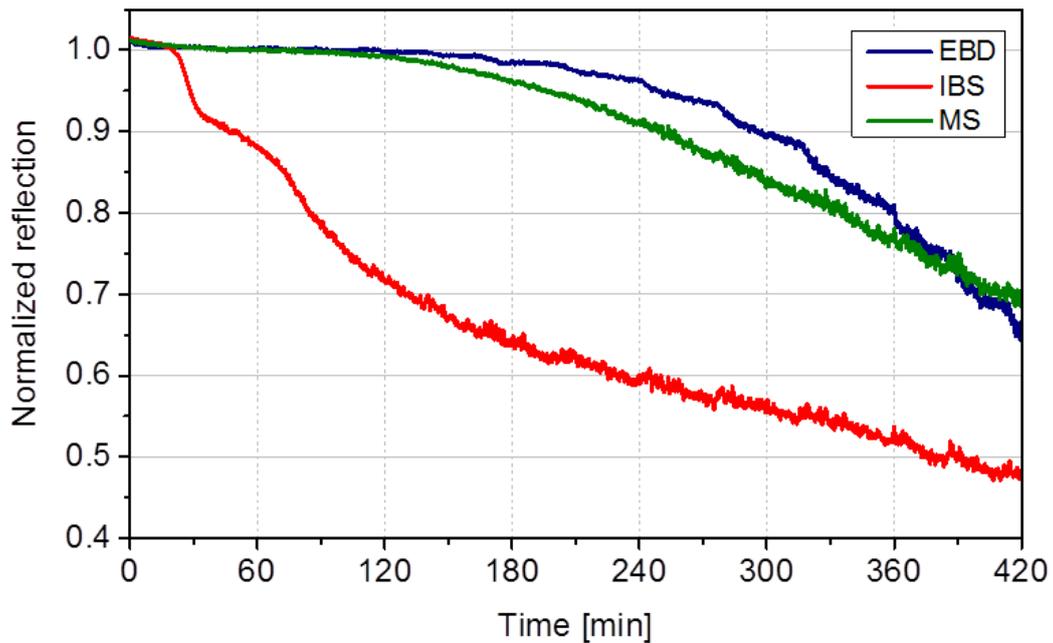
During several long term tests, which were run up to 30 hours, contamination induced damage was investigated in dependence on fluence and contamination pressure. Figure 5 shows as an example the reflectivity of the HR samples coated by EBD, MS and IBS in dependence on irradiation time for a test with a fluence of 900 mJ/cm^2 and a contamination pressure of 4×10^{-5} mbar. For IBS sample the reflectivity decreases much earlier than for EBD or MS samples. Ex-situ investigations verified that damage occurred. The comparison of the breakpoints shows that EBD samples always performed best followed by MS and IBS samples (Fig 6).

Figure 5: Normalized reflection measurement of the EBD, MS and IBS samples during a LIC test. Test conditions are $H_{\text{peak}} = 900 \text{ mJ}/\text{cm}^2$, with a contamination pressure of $p = 4 \times 10^{-5}$ mbar.

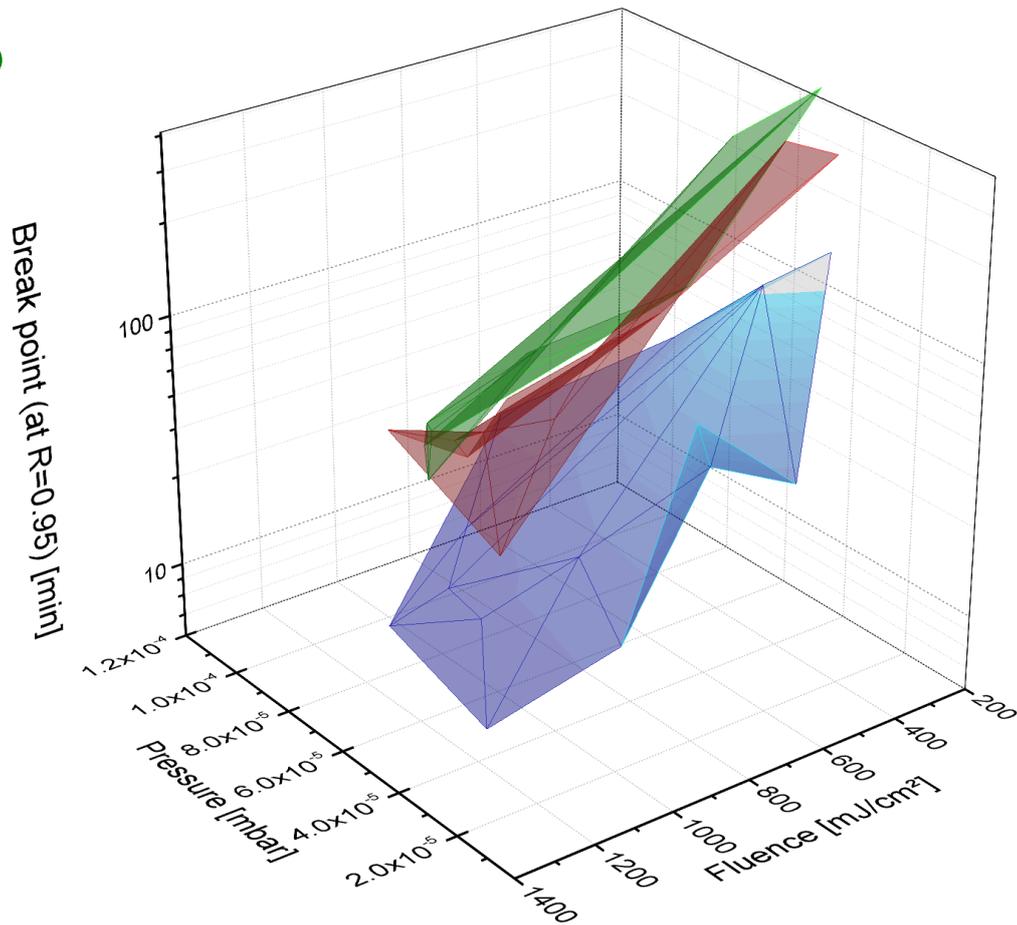
Figure 6: 3D-plot of the break point in dependence on fluence and contamination pressure for EBD (green), MS (red) and IBS (blue) samples.

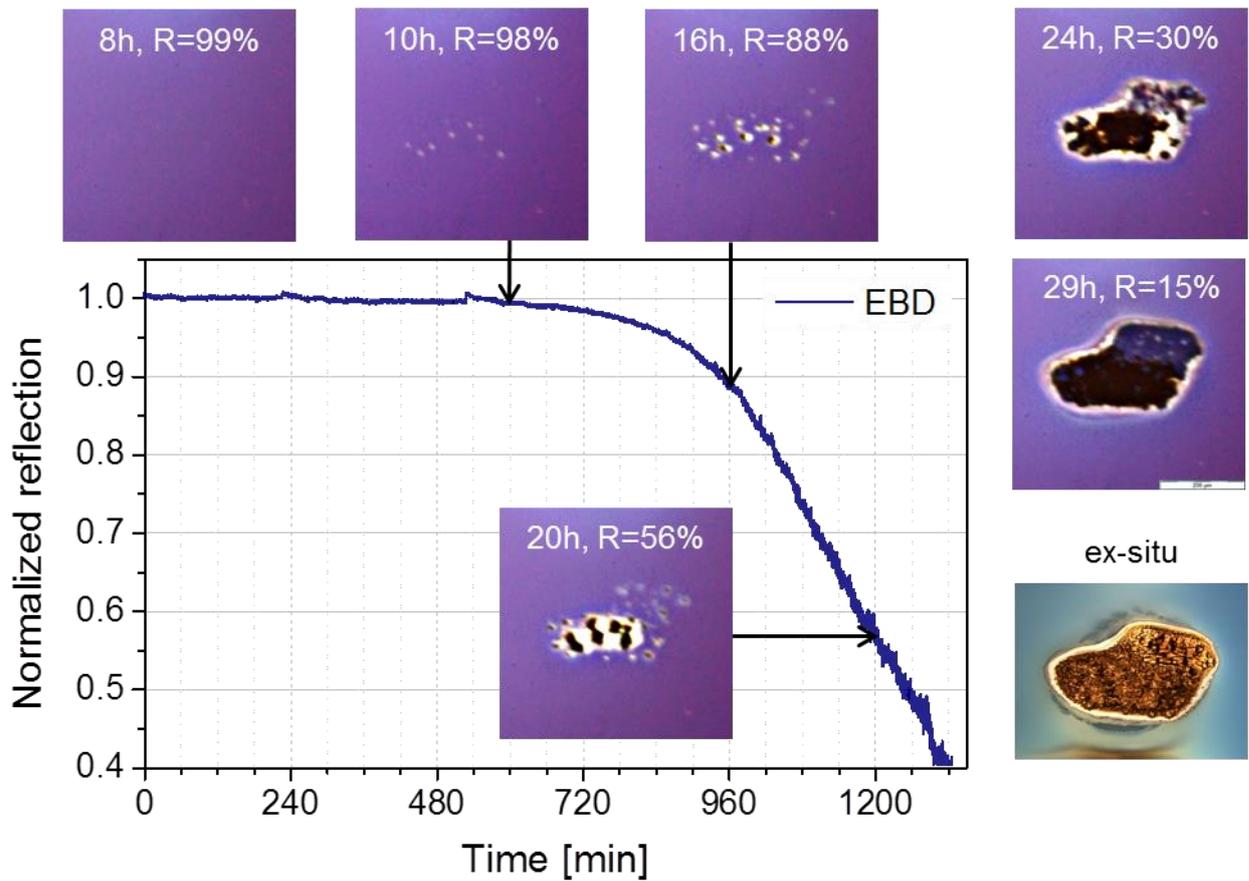
For in-situ monitoring of damage formation and dynamic the long distance microscope was used. Figure 7 shows the relation between LDM micrographs and reflectivity for a test with EBD coated HR sample. It was tested with a fluence of 400 mJ/cm^2 and a contamination pressure of $p = 3.1 \times 10^{-5} \text{ mbar}$. After 10 hours damage becomes visible. A couple of locally spread spots appear with a size of about $10 \mu\text{m}$ each. This has only a slight effect on the reflection loss, which decreased to 98 %. By ex-situ investigation with atomic force microscopy it was demonstrated that these damages are small holes in the coating. These small damages appear to start at almost the same time and are spread within the area of the beam spot. By further these small spots merge until they form a large damaged area after 24 h.

Figure 7: Normalized reflection measurement of the EBD sample during a LIC test. Test conditions are $H_{\text{Peak}} = 400 \text{ mJ/cm}^2$ with a contamination pressure of $p = 3.1 \times 10^{-5} \text{ mbar}$. After 10 h (36 mio. shots) of irradiation the reflection starts to degrade and in-situ long distance microscope images show damage growth. In addition ex-situ DIC micrograph is shown.

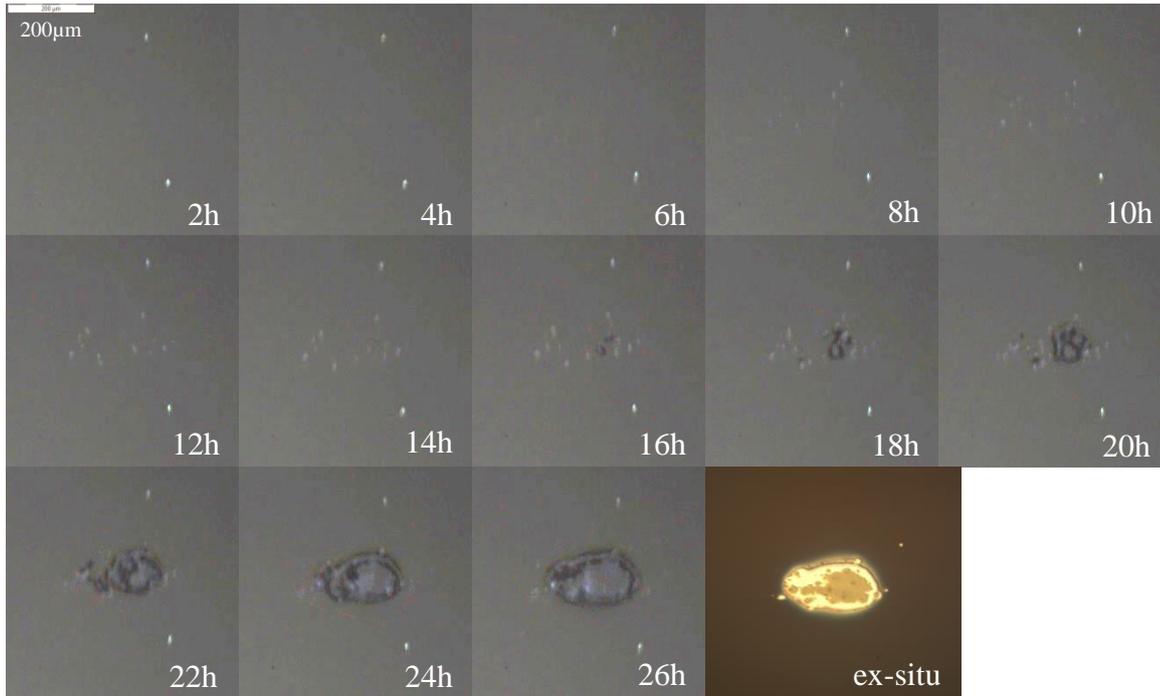
Figure 8: In-situ long distance microscope images of MS sample during LIC test and ex-situ DIC micrograph made after the test. Sample tested at a fluence of 660 mJ/cm^2 and a contamination pressure of $1 \times 10^{-5} \text{ mbar}$.
