Risk assessment of war wrecks –a comprehensive approach investigating four wrecks containing munitions in the German Bight/North Sea

Abstract

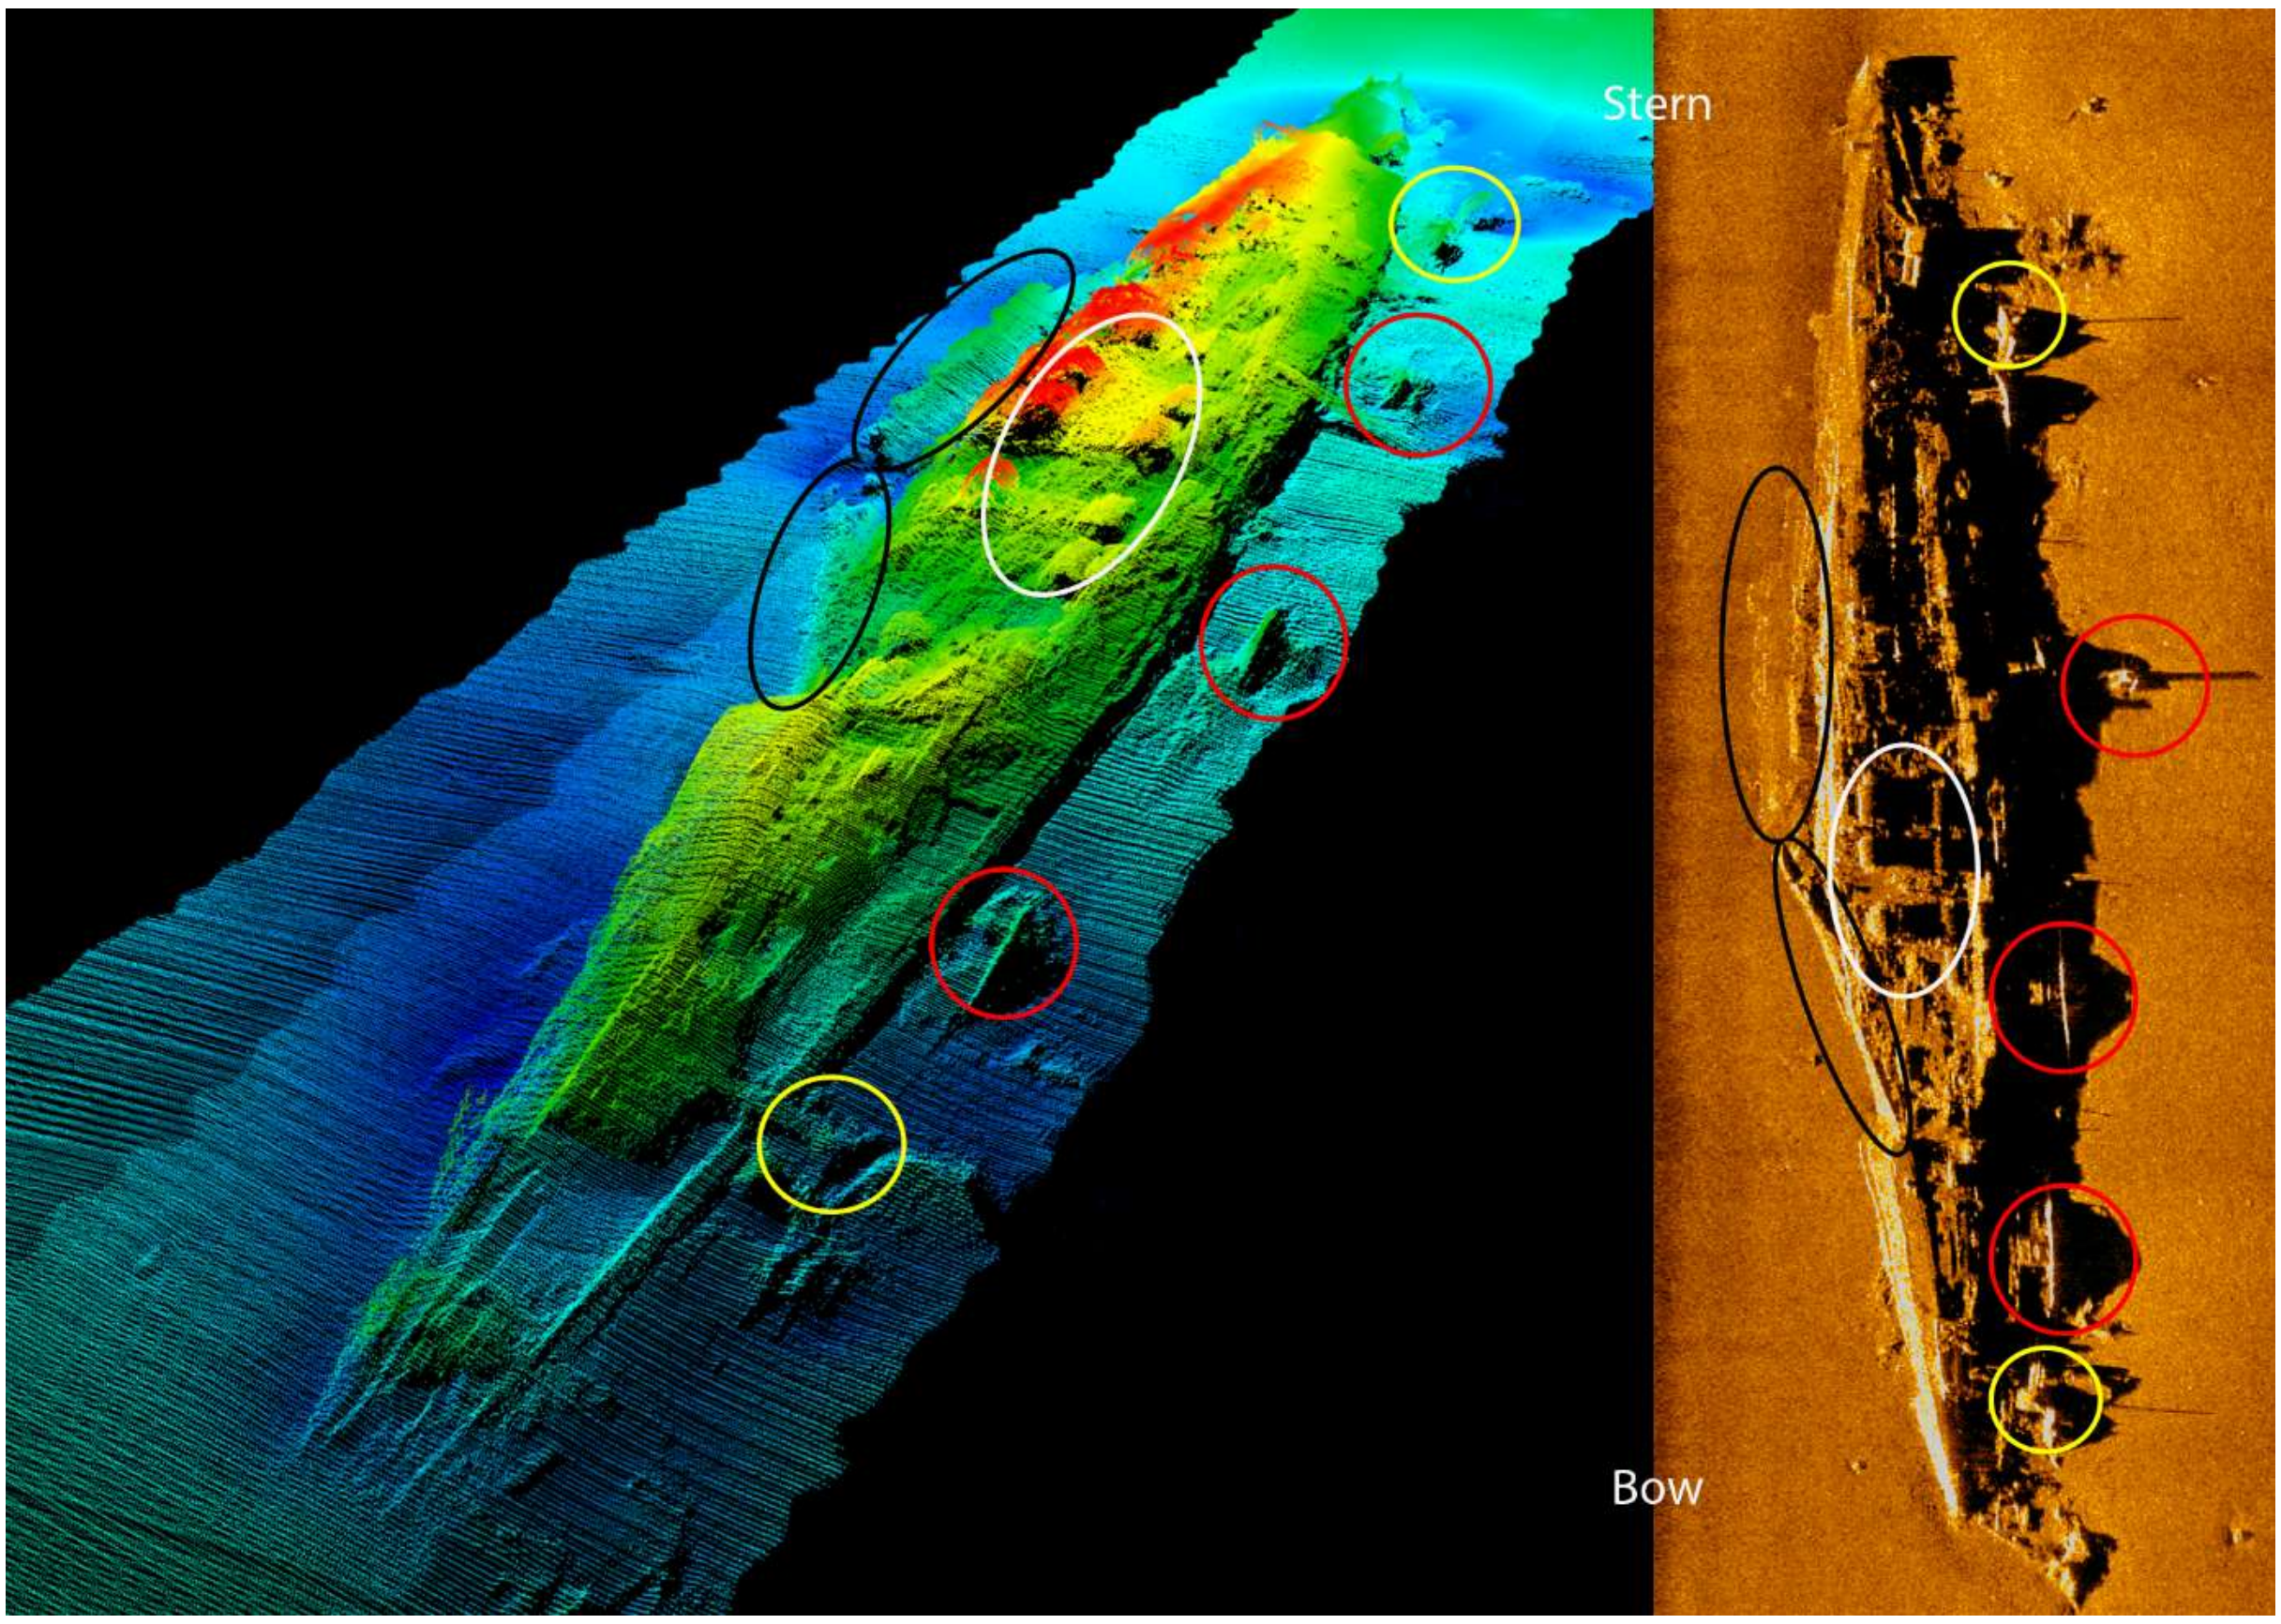
The wreck is situated c. 25 nautical miles (nm) north off the island of Borkum and c. 40 nm west-southwest off Heligoland in nearly 30 m depth. (see Fig. 1) It lies on keel, is slightly inclined to the portside and, with the exception of some smaller protruding parts, preserved up to the level of the former armoured deck. The wreck is preserved over a length of about 114 m. However, the entire bow area is badly damaged and only preserved up to the level of the front chain locker. Therefore, c. 16 m of the total length of c. 130 m are missing in the bow area. The width of the wreck is 14 m and it protrudes from the surrounding sediment to a height of c. 5 m.

Some massive objects lie in the immediate vicinity on portside (Fig. 5). The bow is completely damaged, whereas the stern is well preserved. On the starboard side of the ship, a huge part of the preserved hull has collapsed over a large area. In the central area, with the former boiler rooms, some steam collectors of the former boilers are preserved. Furthermore, many small parts such as pipes, sleeves, hand wheels and cables can be found here. A similar situation is observable in the area of the former engine rooms. Many arm-thick pipes with flanges and sockets are preserved here, as well as some larger parts that may belong to the former turbines or condensers. The massive objects on portside are some of the QL guns cal. 10.5 cm that have fallen off or broken out from the wreck. Remains of the former ammunition hoists in the fore ship and aft are clearly visible in the ROV data. Blasting or salvage actions on the wreck are not assignable in the wreck biography so far. The ammunition chambers and the torpedo room seem to be preserved beneath the partly collapsed armoured deck.

Fig. 5: 3D animation of AUV multibeam echosounder (left), and 2D animation of AUV side scan sonar (right), from the wreck site of the SMS MAINZ. Black circle = collapsed hull areas starboard, white circle = boiler room area with steam collectors, red circle = remains of QL guns, yellow circle= unidentified objects (probably QL gun remains) (Scans provided by DLR).

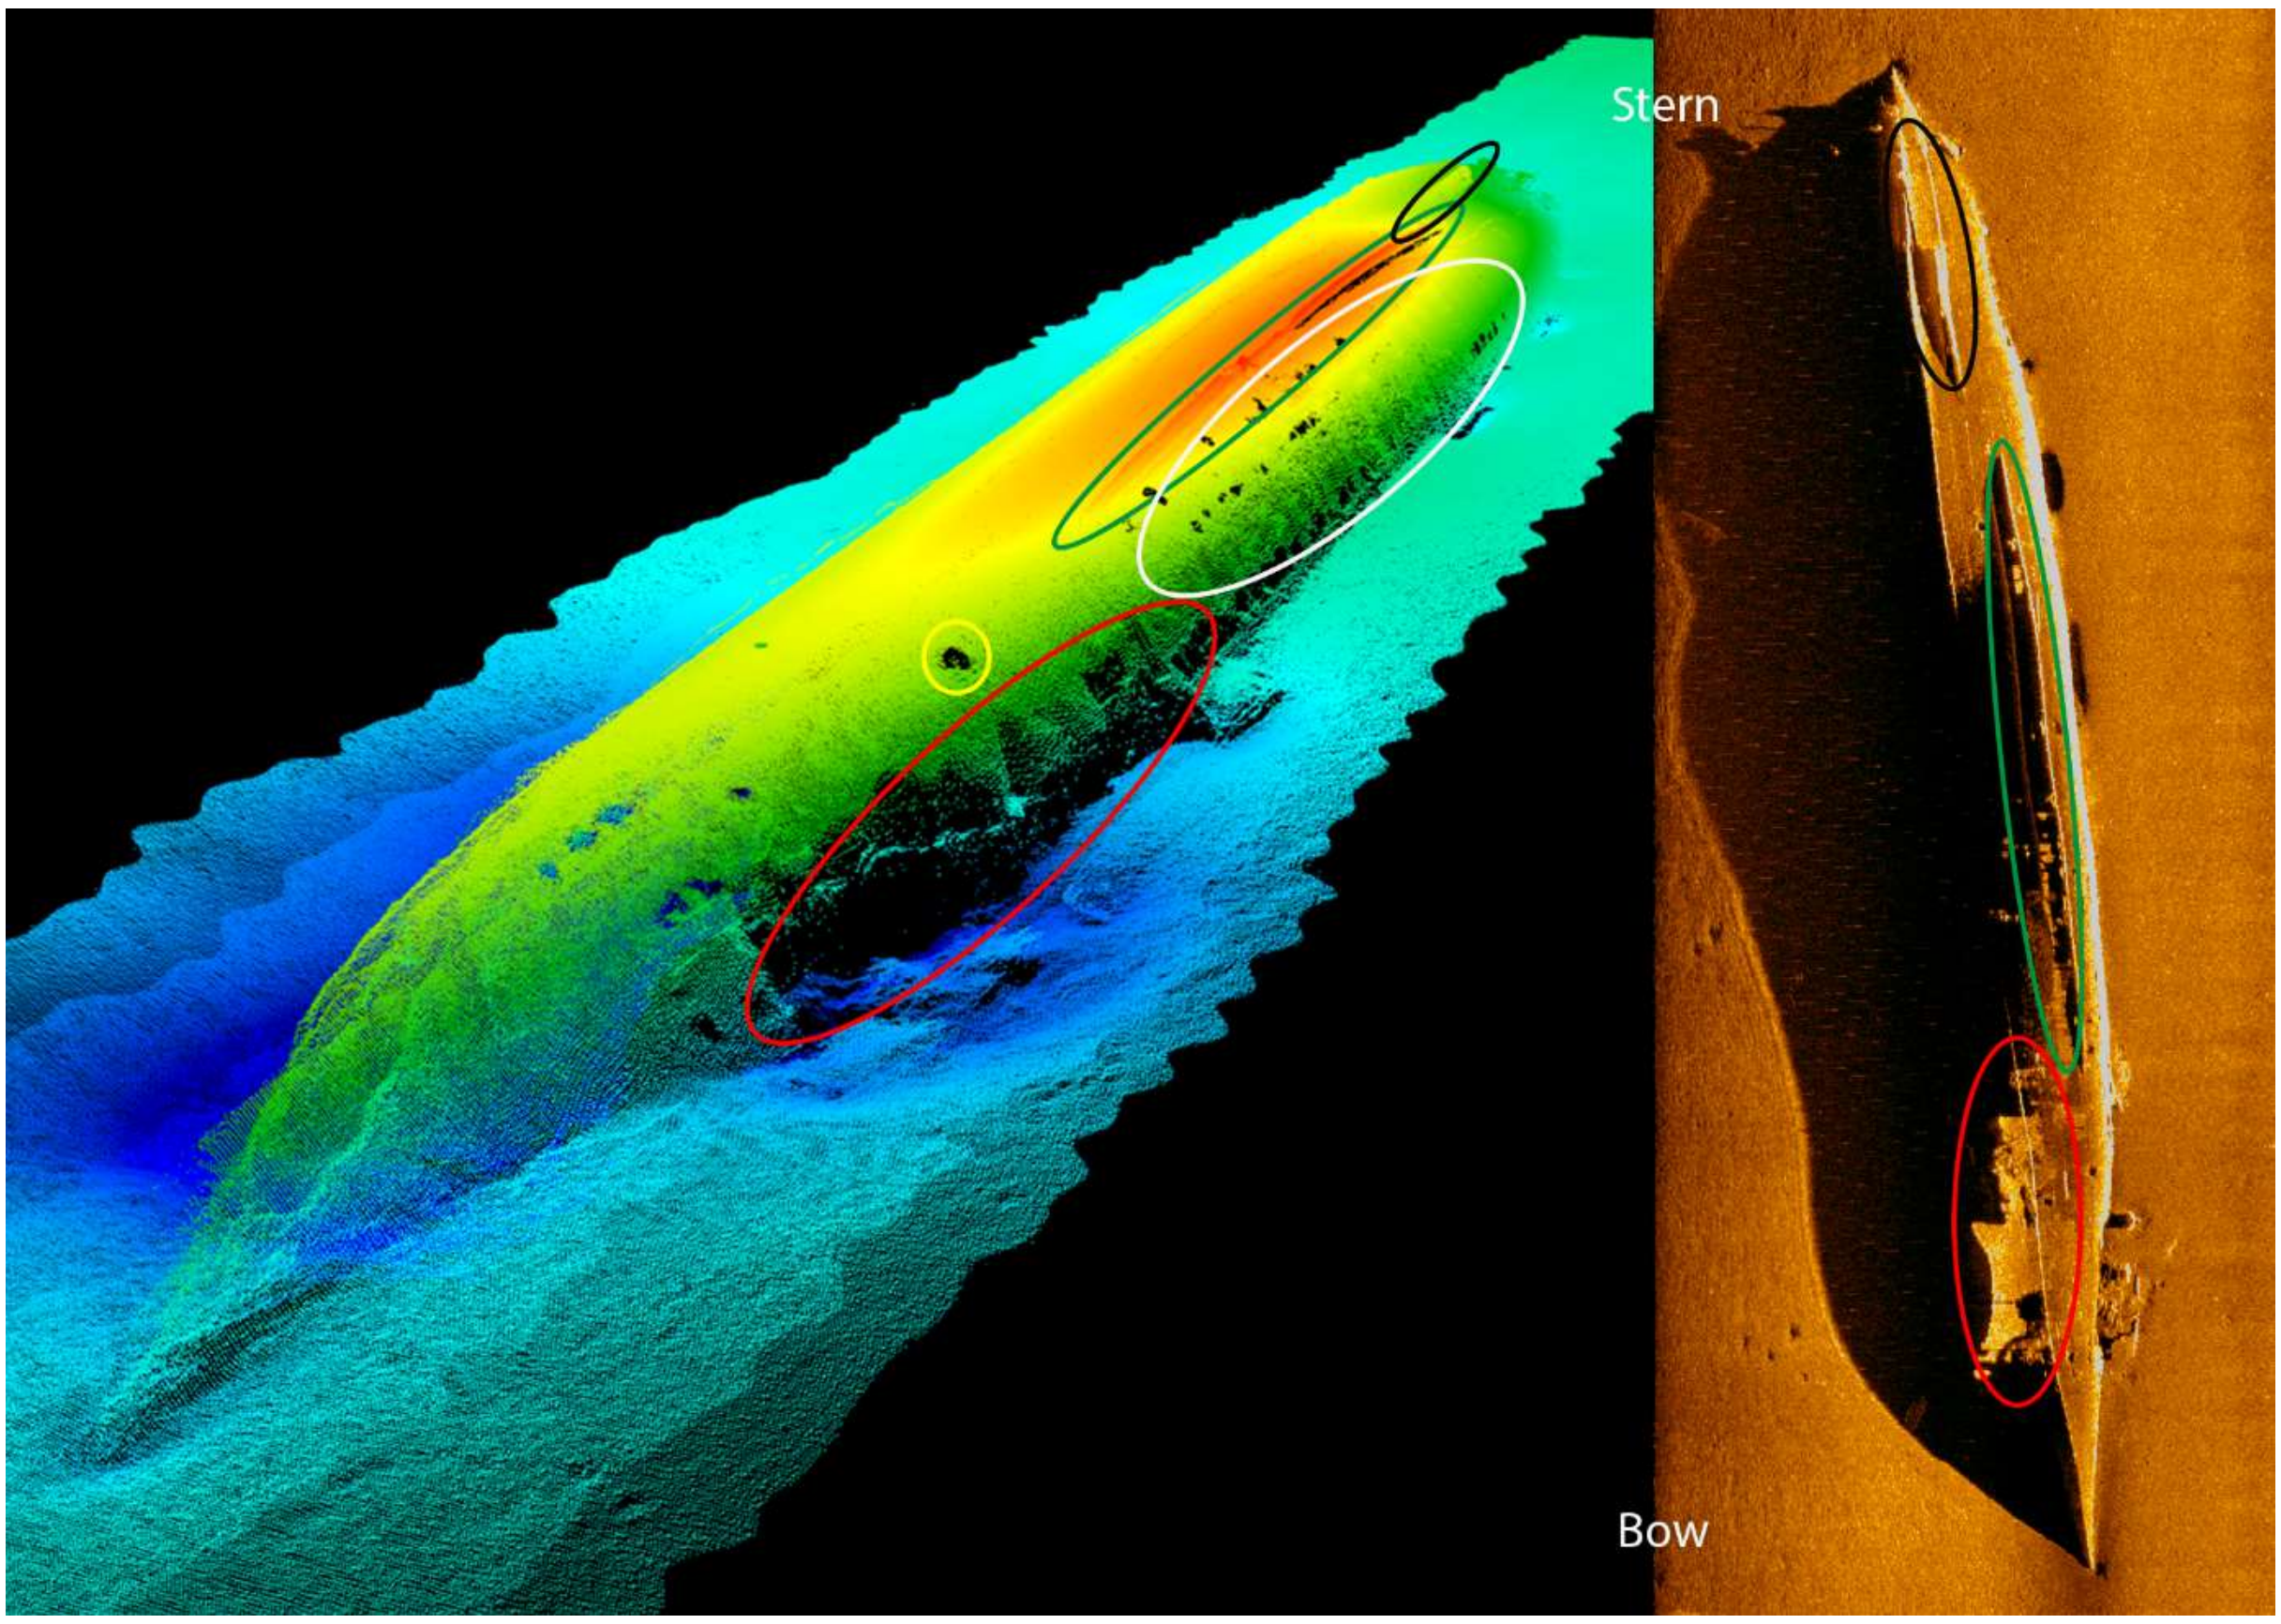
The wreck is situated c. 23 nm north-northeast off the island of Norderney and c. 20 nm west-southwest off Heligoland in nearly 37 m depth. (see Fig. 1) It lies keel up on the ground and is slightly inclined to portside. The wreck is preserved in total length of 105 m and a width of 12 m. It protrudes from the surrounding sediment to a height of about 4 m. The stern and the bow with the prow are clearly visible. The hull is well preserved, but perforated in some places. Whether this is natural rust or artificial intervention or both is not clear yet. Both the keel and the starboard gulper keel are completely visible. The propeller shaft, shaft block and shaft hose on starboard are preserved as well. The propeller shaft on portside is also visible but slightly snapped off. The shaft block and shaft hose on portside also seem to be preserved, but do not protrude as far as on starboard; both propellers are missing. In the fore ship area, a double tube with an open hatch can be seen on the starboard. This appears to be the open starboard torpedo tube. Furthermore, in the fore ship area on starboard, a large hole in the hull with a scour in front of it can be seen. The view through this hole shows various small parts, chains and not yet clearly identified objects. On the opposite side, there seems to be a smaller hole as well.

Remains of the superstructure and armament of the ship cannot be identified (Fig. 6). However, this is not surprising, as the ship lies keel-up. Before the 1970s, blasting actions appears to have been carried out on the wreck. For example, the propellers were blown off.

So far, it can be said that the ammunition chambers and the torpedo room could be widely intact inside the wreck as the hull is quite good preserved. That could mean on one side that the preserved ammunition inside these areas could be relatively sealed off from outside influences. Although the big hole in the fore ship and the small holes in the hull may allow, on the other side, a good water flow through the whole wreck, which maybe affect the stability of the ammunition casings; further research is necessary here.

Fig. 6: 3D animation of AUV multibeam echosounder (left) and 2D animation of AUV side scan sonar (right) from the wreck site of the SMS ARIADNE. White circle = perforated hull, green circle = gulper keel on starboard, black circle = propeller shaft, shaft block and shaft hose on starboard, yellow circle = double tube with open hatch, red circle = large hole in the hull (in Side Scan image the hole is visible in the scan shadow) (Scans provided by DLR).

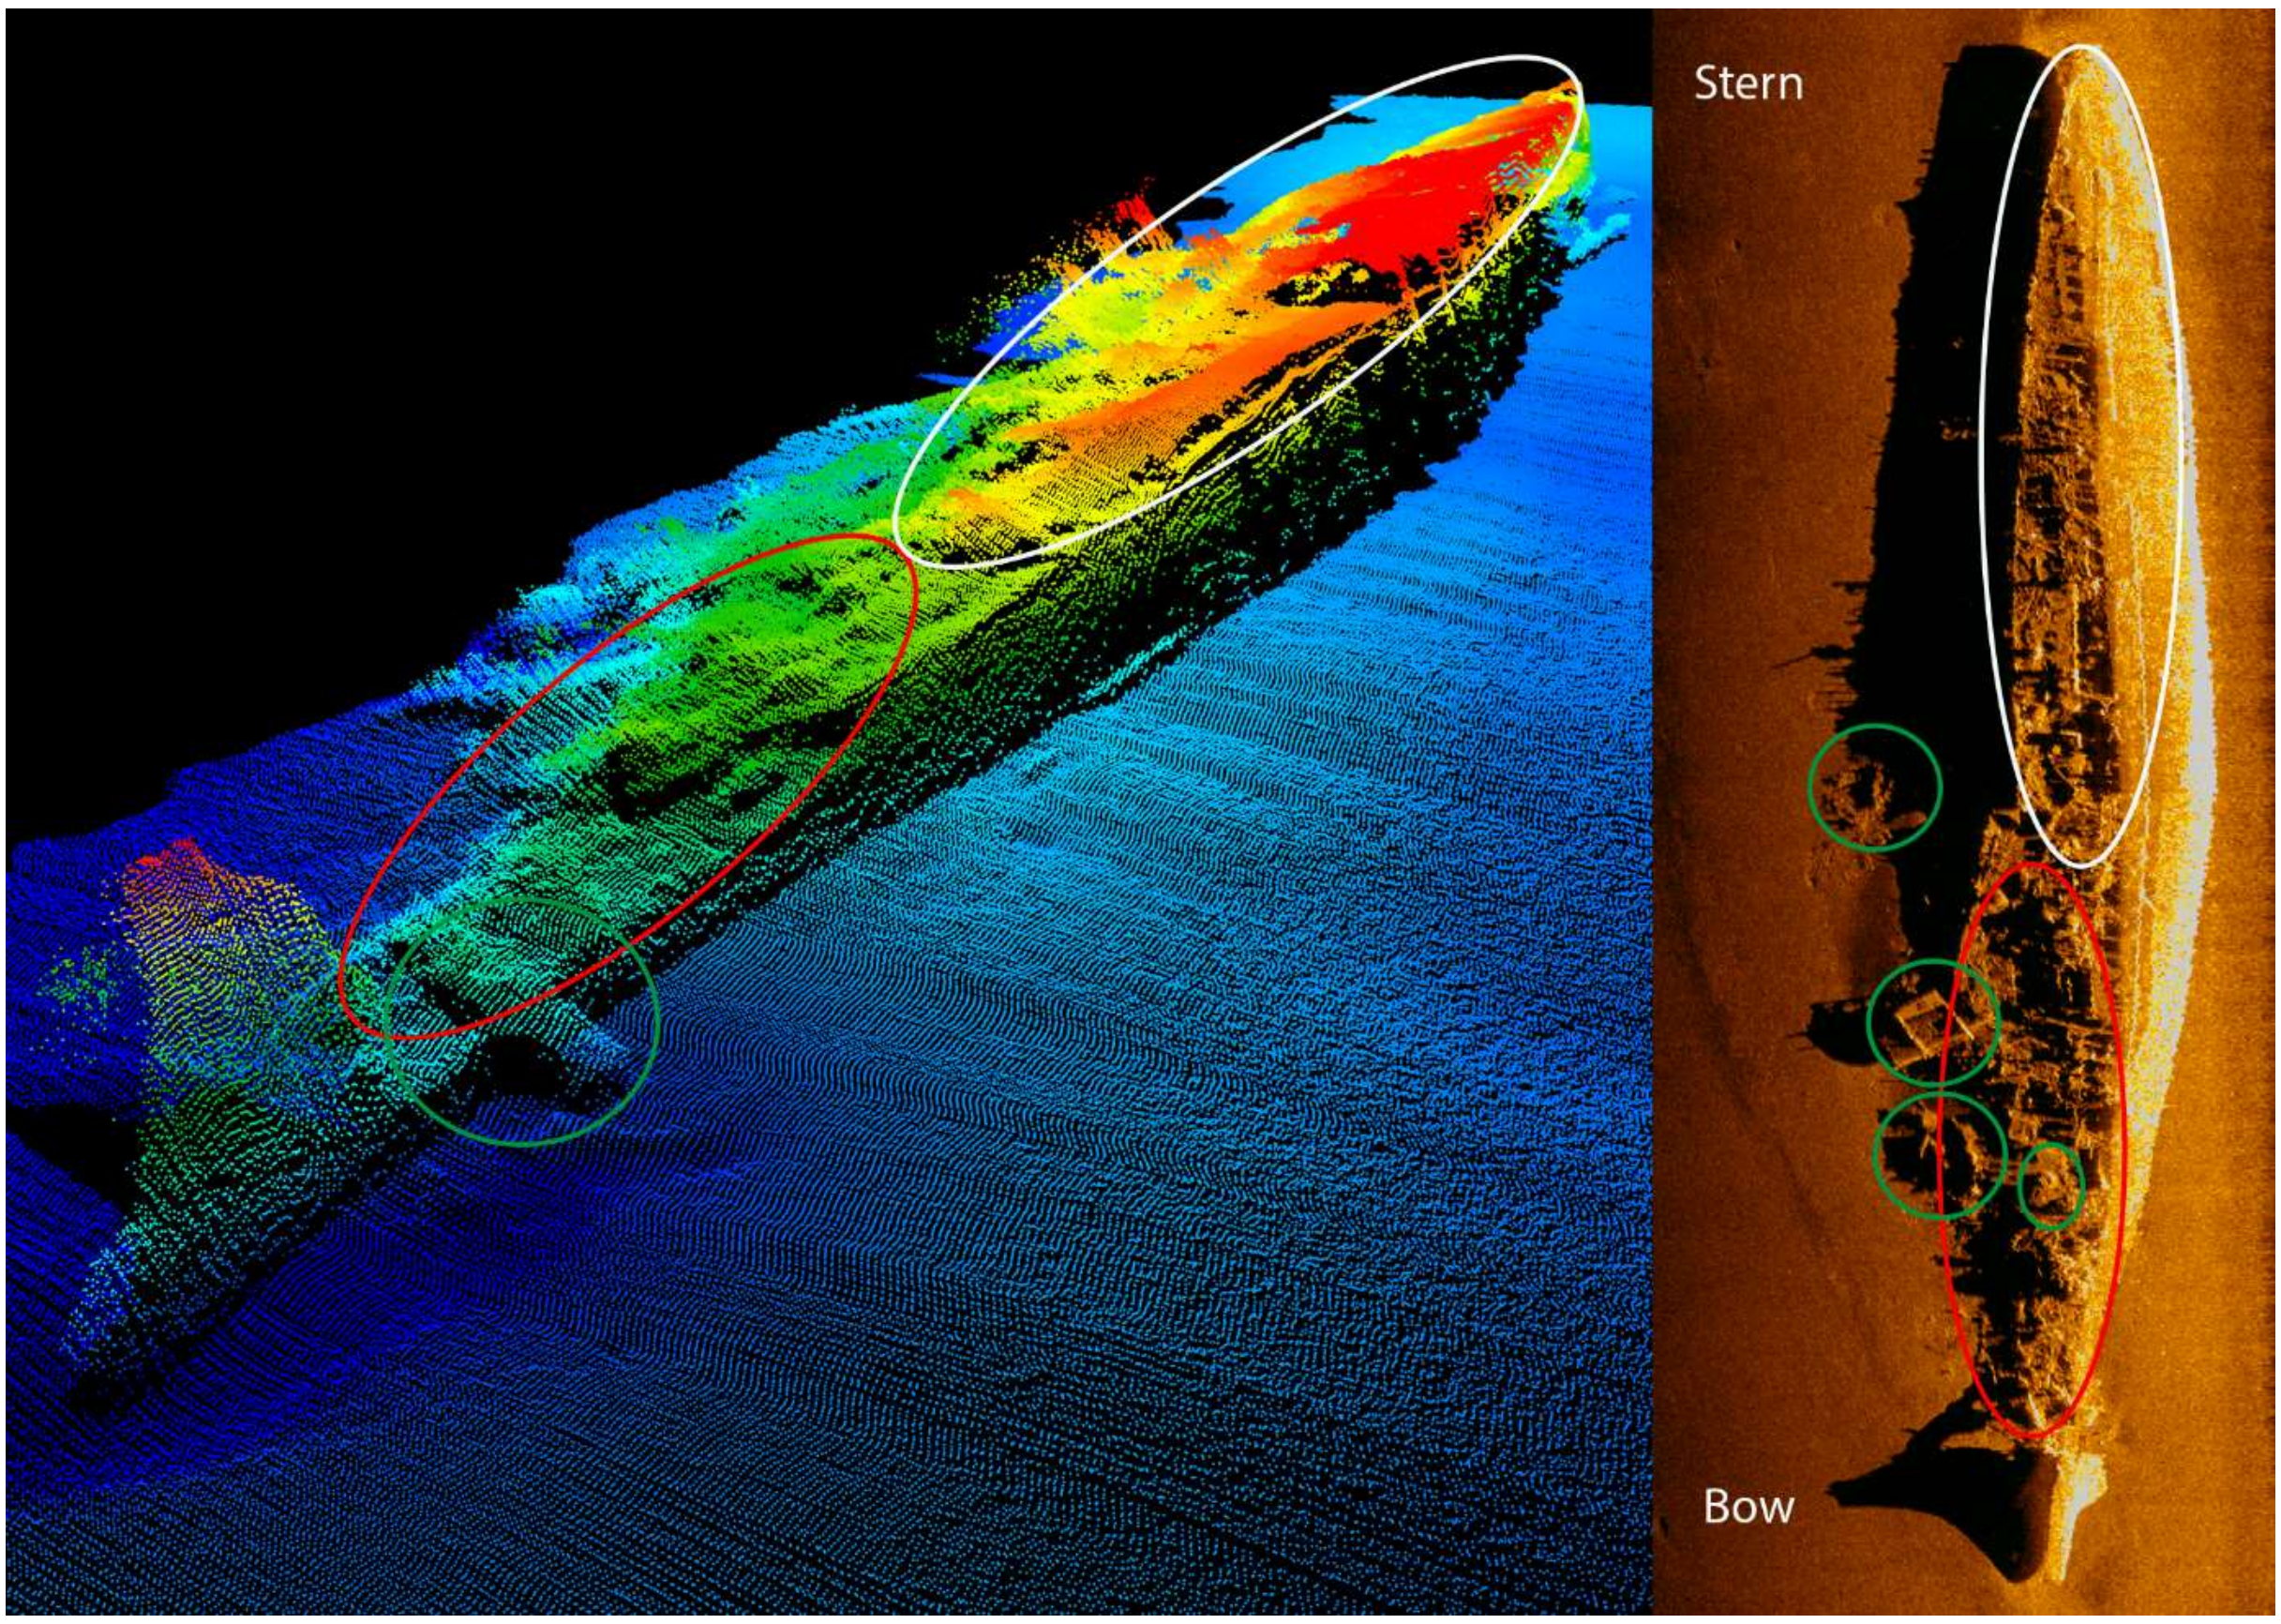
The wreck is situated c. 15 nm north off the island Wangerooge and c. 9 nm south-southeast off Heligoland in nearly 35 m depth. (see Fig. 1) It lies on keel and is slightly inclined to starboard. The wreck seems to be preserved in total length of 105 m and a width of 11 m. It protrudes to a height of c. 7 m at the bow and c. 5 m in the aft from the surrounding sediment. Bow and prow are well preserved, but the fore ship is completely damaged. It seems that the entire fore ship area up to the level of the former waterline and up to the area of the former bridge is affected by this destruction. In this area the ship's front ammunition chamber was situated, as well as the torpedo rooms. The midship area, aft and stern are relatively well preserved. In the stern area, the wreck seems to be preserved possibly up to the level of the former upper deck. The stern itself seem also intact and raised slightly from the sea bottom. Because of this, the portside propeller shaft is visible. The state of preservation of the starboard propeller shaft is not clear. This also applies to the unclear presence of the propellers in general. In the destroyed fore ship area, many larger and smaller fallen objects, which are not identified yet, can be seen.

Regrettably, it was not possible to take underwater images with the ROV from the HELA, as the visibility at the wreck site was very poor. In addition, no clearly identifiable parts of the former armament are visible or be at least recognisable (Fig. 7). Clearance or salvage actions on the wreck are not assignable in the wreck biography so far. However, as especially the fore ship area is conspicuously damaged, blasting actions were probably carried out here in the past. Eyewitnesses of the sinking on the other hand mentioned that it looks like the fore ship would break apart but then sunk very quickly while the aft section was already under water.[6] This could be also a reason for the destruction in the fore ship area. Although no evidences for a break can be seen in the scan-data so far.

Fig. 7: 3D animation of AUV multibeam echosounder (left) and 2D animation of AUV side scan sonar (right) from the wreck site of the SMS HELA. Red circle = damaged fore ship area, white circle = well preserved midship area and aft, green circle = unidentified objects (Scans provided by DLR).

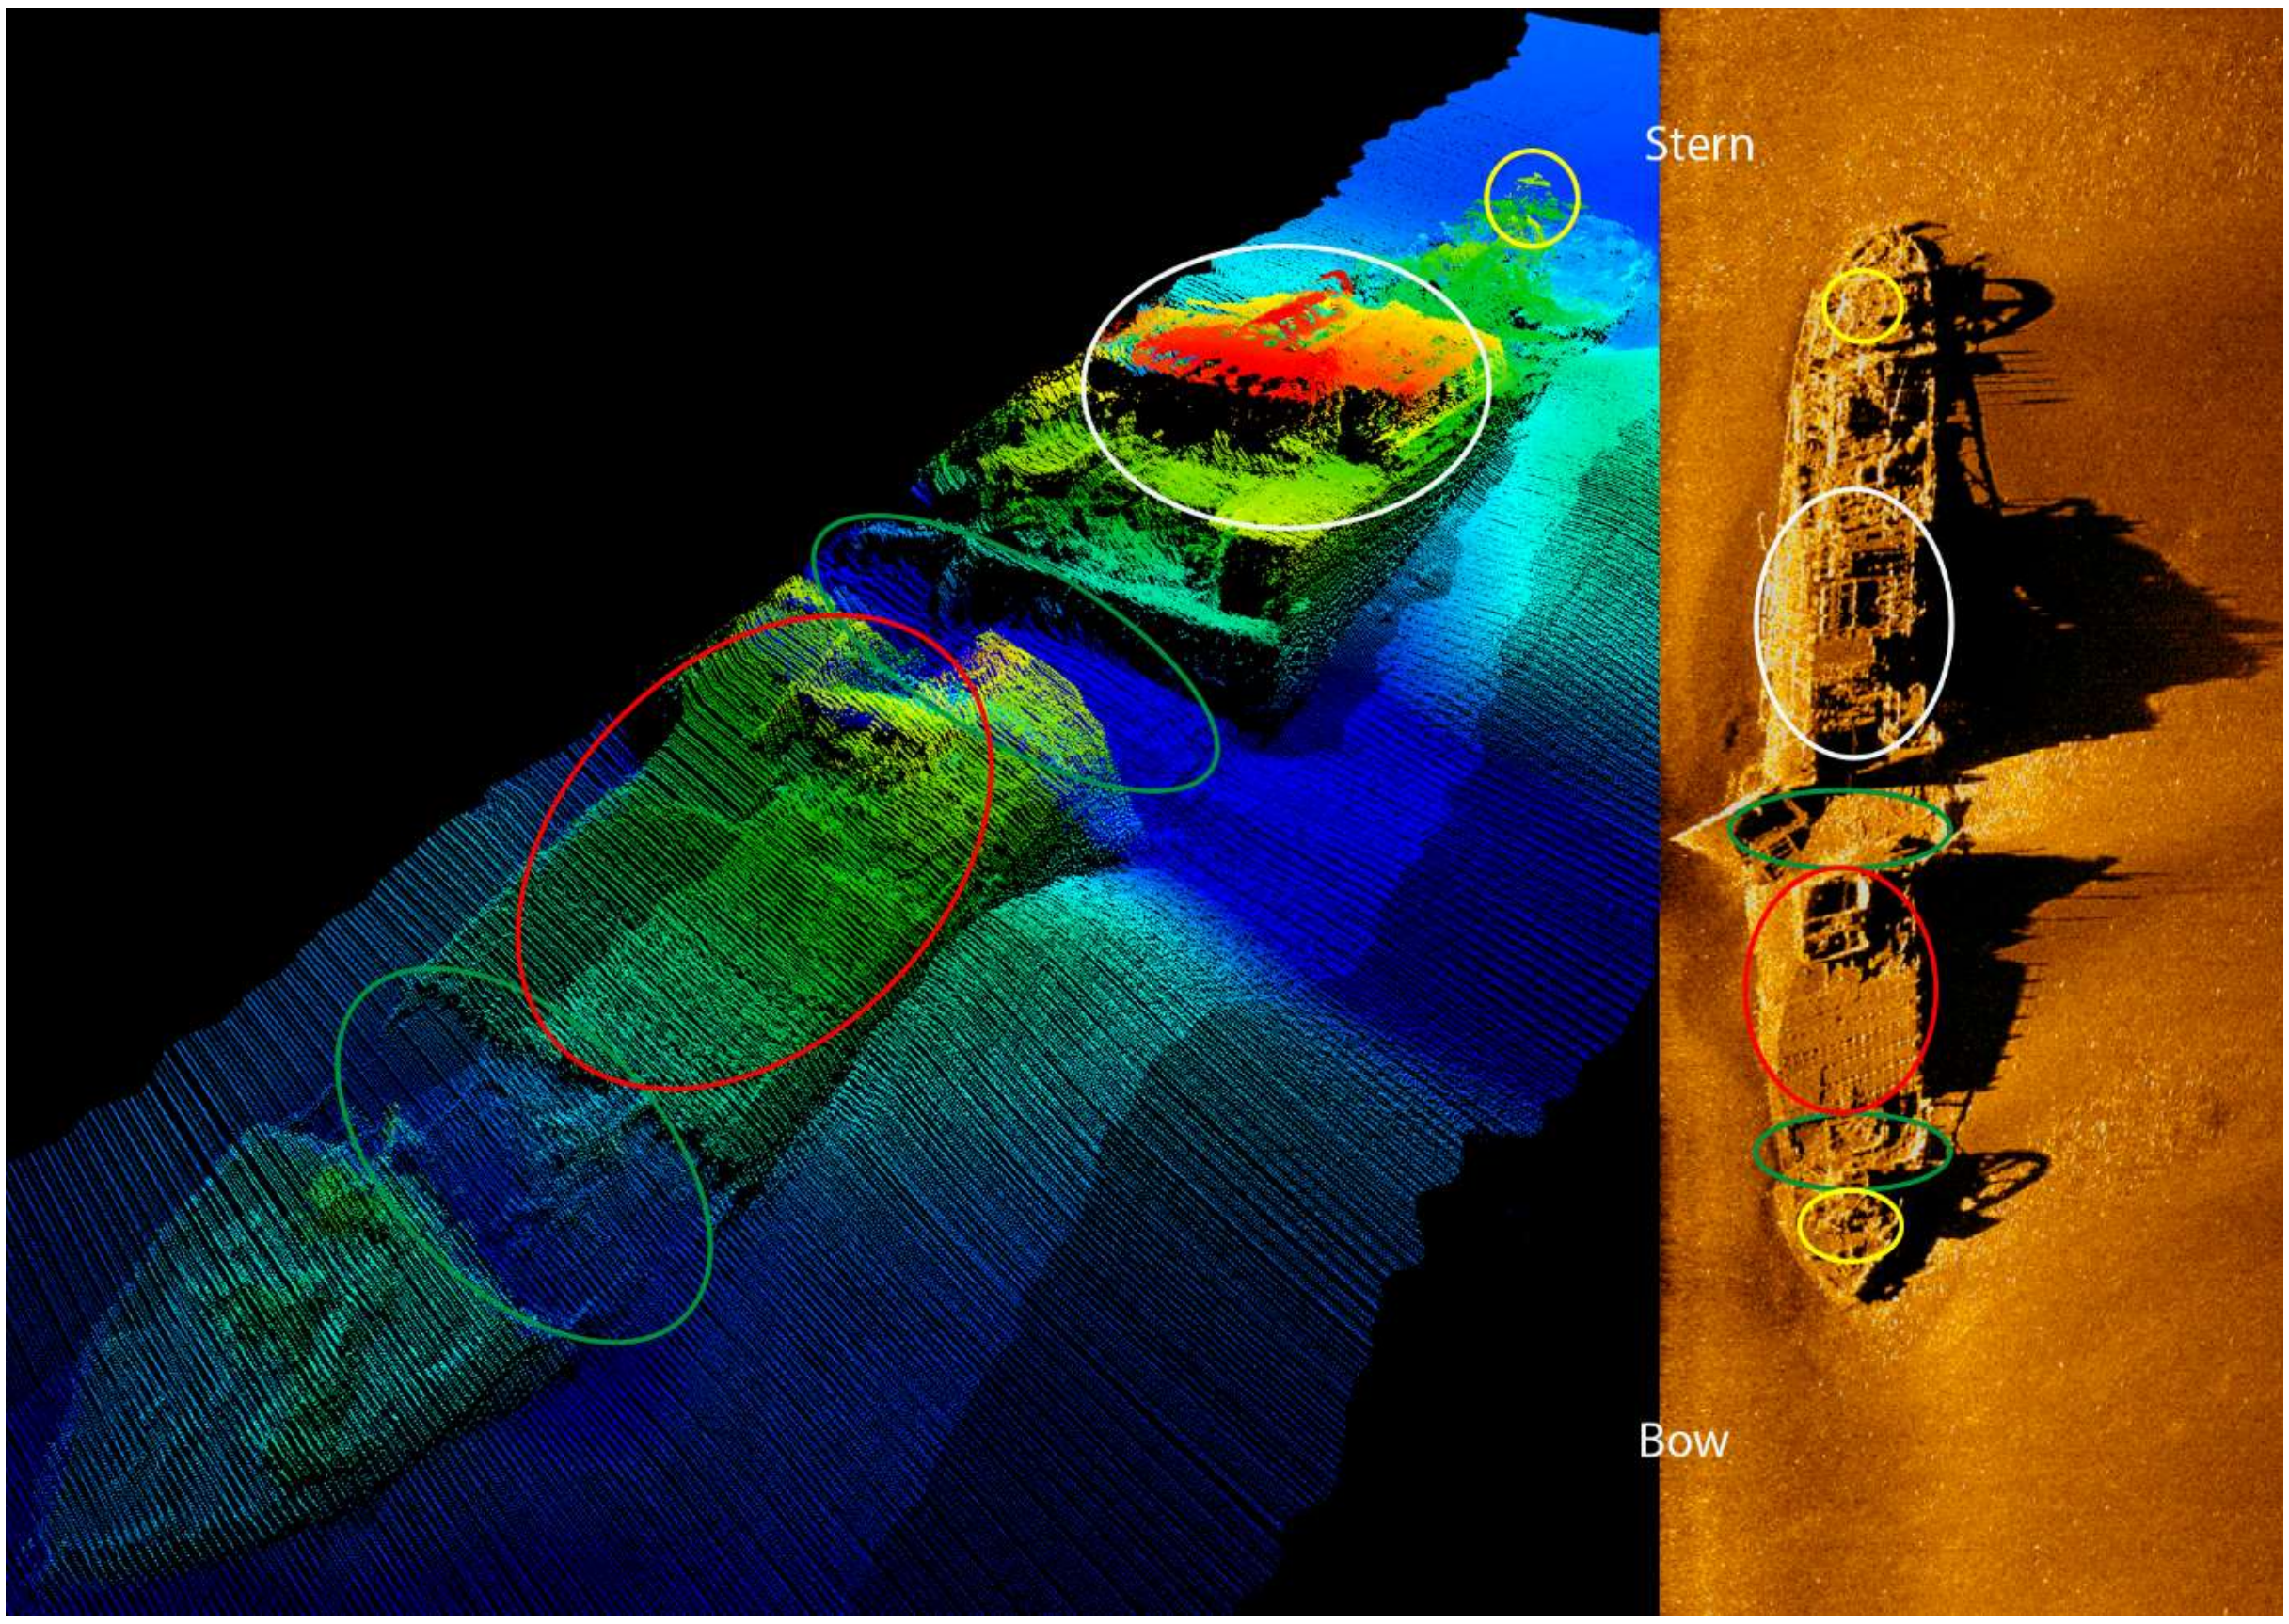
The wreck is situated ca. 11 nm west-northwest off the island of Scharhoern and ca. 14 nm southeast off Heligoland in nearly 25 m depth. (see Fig. 1) It lies on keel and has a large gap in front of the area of the former bridge (Fig. 8). Still the wreck is preserved almost in total length of 70 m and a width of 9 m. It protrudes from the surrounding sediment to a height of about 5 m, mainly in the former bridge area. A slightly smaller gap can be seen in the fore ship area directly in front of the former forecastle. In general, the fore ship, including the bow, and the aft, including the stern, are in good condition. The area of the former bridge is clearly visible with the deck superstructures and protrudes the furthest. In the bow area, the remains of a gun platform are clearly visible.

The same applies to the gun platform in the stern area. In the fore ship, directly in front of what could be a large cargo hatch, the construction remains of the “VES System” are visible. Larger sedimentations can only be seen on the portside area of the wreck next to the fore ship and the aft. Regrettably, due to time reasons and bad visibility, it was not possible to take underwater images with the ROV from the FRIESLAND.

In the 1970s, some blasting actions appears to have been carried out on the wreck. For example, a third gun platform in the midship area was blasted off as it protrudes too much from the wreck. The large central gap could be a result due to this blasting actions. However, this is not clear from the former wreck reports. Furthermore, the gun platforms in the bow and stern area are still visible but it is not clear if the guns are also preserved. Although the wreck is generally quite intact it shows large destruction evidences (two gaps) and further damages at the deck as well as in the bridge area and at the gun platforms. However, ammunition could be still preserved near or beneath the gun platforms and/or below the remaining parts of the deck. Furthermore, remaining mines, which caused the loss of the FRIESLAND could also be preserved in the area.

Fig. 8: 3D animation of AUV multibeam echosounder (left) and 2D animation of AUV side scan sonar (right) from the wreck site of the FRIESLAND. Green circle = gaps near forecastle and before bridge area, white circle = protruding bridge area midship, yellow circle = gun platforms bow and stern, red circle = large cargo hatch and remains of "VES System" (Scans provided by DLR).
