# Quality Assurance for the Manufacturing of Oxide Fiber Reinforced Ceramic Composites for Aerospace Applications

**Abstract.** The processing route of a CMC material comprises several very complex manufacturing procedures which have to be optimized down to the last detail and, if necessary, monitored and controlled continuously. Consequently, non-destructive inspection techniques are important tools to provide the necessary information that is needed to understand the microstructure and to identify the failure-relevant defects that may occur during manufacturing. The examples discussed here are focusing the manufacturing and material properties of the wound highly porous oxide ceramic matrix composite (WHIPOX<sup>TM</sup>) developed by DLR. It is reported about inspection results with air-coupled ultrasound, optically excited lock-in thermography, 3D terahertz imaging and computed tomography ( $\mu$ -CT, nano-CT). Furthermore, mechanical properties of WHIPOX samples which are obtained from tensile and Iosipescu shear tests are correlated with non-destructive inspection results from lock-in thermography and high resolution CT analysis.

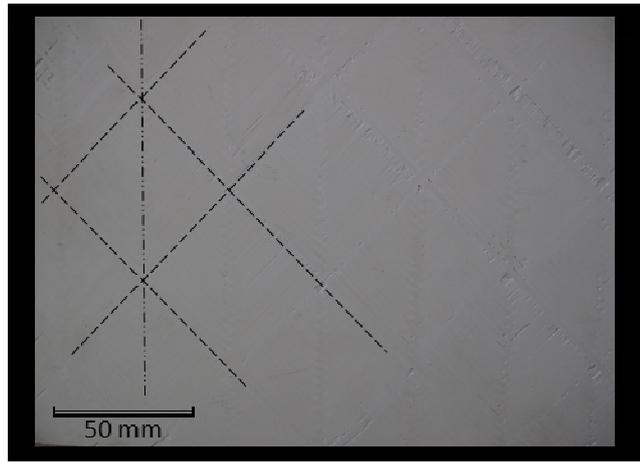
All three plates were inspected by using air-coupled ultrasound (ACU). The C-mode image of plate W1233 shown in Figure 6 was obtained with a through transmission mode technique. The transducer's frequency was about 180 kHz. As the dashed lines indicate, the rhombic fiber bundle structure is slightly visible in the ultrasound image. As the very view dark blue tinted areas confirm, there are no significant defects in this WHIPOX plate. For comparison, Figure 7 shows a photographic image of a part of the plate's surface structure.

**Fig. 7.** Photographic view of a surface segment of WHIPOX plate W1233 (grinded surface)

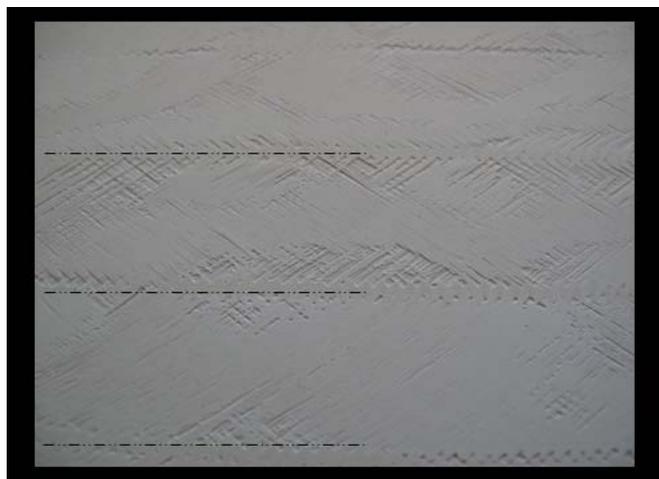
Figure 8 shows an ultrasound image of WHIPOX plate W1289 which is rather thick (approx. 10 mm). The dark blue tinted areas in this scan indicate that there is high ultrasound signal attenuation in these areas. Locally increased porosity or delamination is the most likely explanation for this phenomenon. However, the blue areas are localized along horizontal lines. Regarding the number of lines as well as the distances observed in the C-mode ultrasound scan, it seems that the defective blue areas are in good correlation with the interspaces of the horizontal lines that are visible on the material's surface (cf. Fig. 9). These lines on the photographic image are showing the so called cross-over points of the wound fiber rovings (cf. Fig. 4 & 5). Thus, the defects found by ultrasound inspection are obviously located in between these rows of cross-over points.

**Fig. 9.** Photographic view of a surface segment of WHIPOX plate W1289 (grinded surface)
