Standardizing Accelerated Aging Testing Conditions for Silvered-Glass Reflectors

Johannes Wette, Florian Sutter, Arantxa Fernandez,
Radia Lahlou and Peter Armstrong

SolarPACES 2017 Santiago de Chile

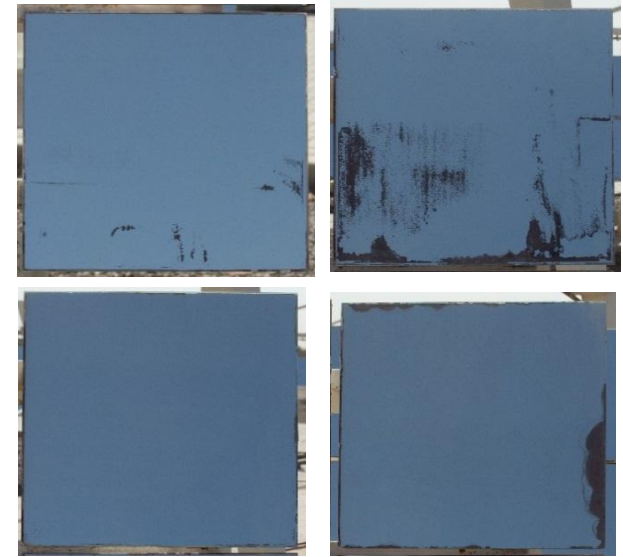
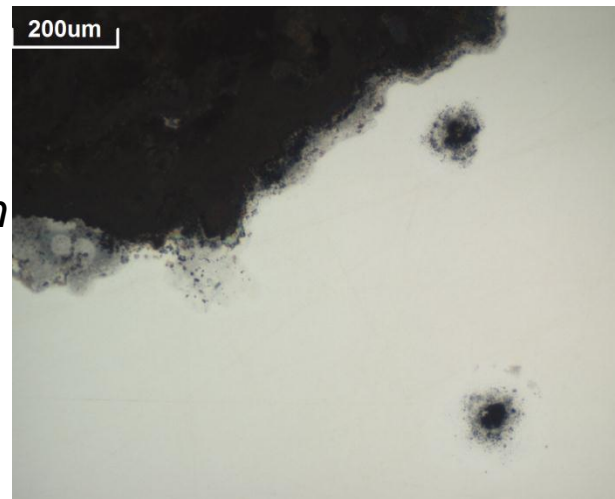
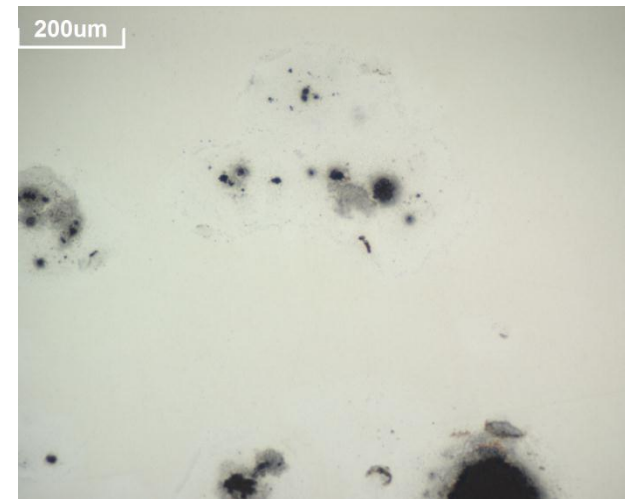
- Degradation on all of the 1419 installed facets
- Ranging from little to very severe degradation
- Microscopic analysis shows similar patterns known from other mirrors where silver layers gets attacked
- For details on the material composition and degradation:
“Study and Comparison of Naturally-Aged and As-Received Silvered-Glass Reflectors”

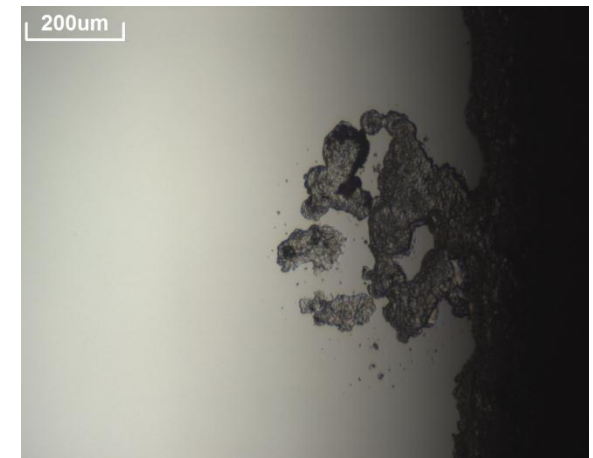
- Strongest reflectance drop of all tests (hemispherical and specular)
- Glass corrosion
 - Known degradation of glass surfaces in high humidity environments
 - Usually not detected outdoors
- Minimal edge corrosion
- Total testing time more than 4x AENOR

Glass surface corrosion

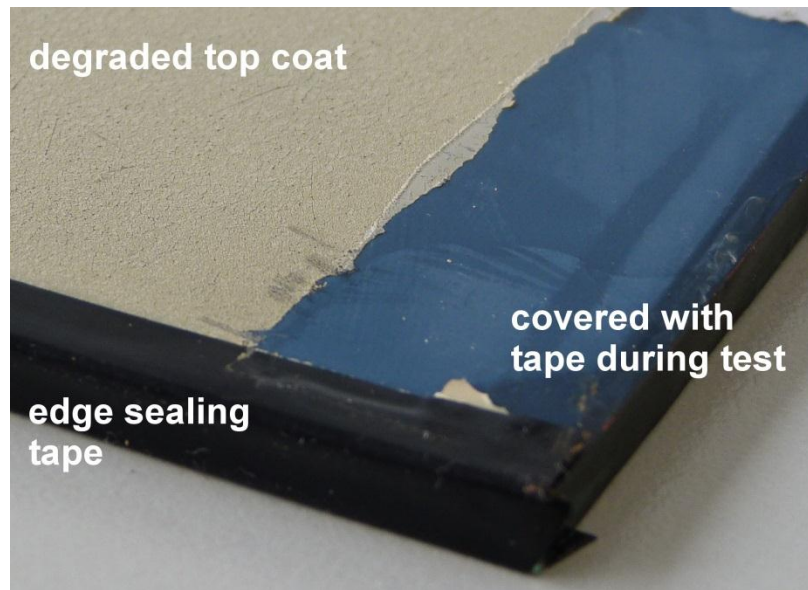
- Severe attack of the backside coating exposed to chamber
- No considerable degradation of the silver layer on both samples
- Minimal edge corrosion

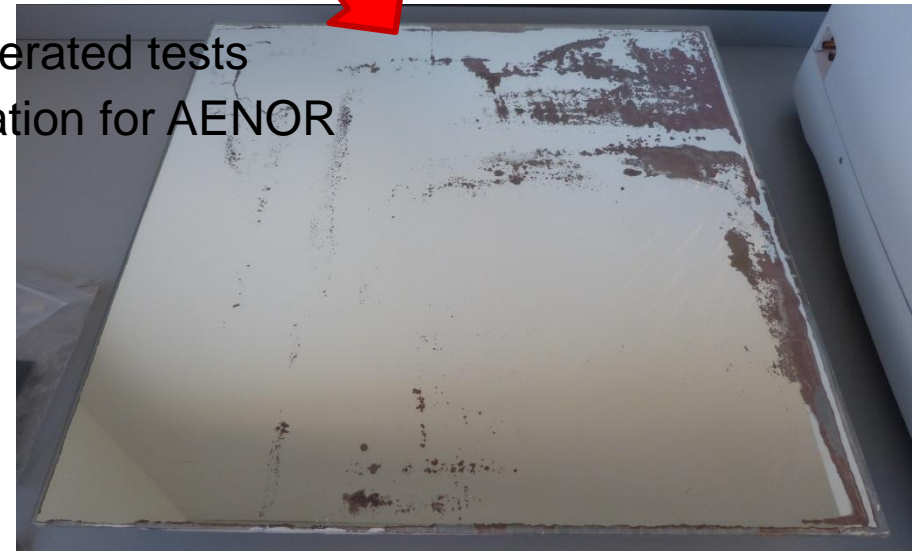
Outdoor facet

- Standardization of testing is a good progress
- Degradation found during exposure is not reproduced by accelerated tests
- Test procedure is unable to identify weak material
- Samples from all 5 accelerated tests
- No macroscopic degradation for AENOR

Testing and parameters have to be optimized
