REXUS 24 FAILURE INVESTIGATION

On Monday, March 12 at 14:30 UTC, 2018, the sounding rocket REXUS 24 was launched from Esrange Space Center. After T+8.9 s, the payload separated unintentionally from the motor. The payload impacted 2 km north east of the launcher. The thrusting motor continued to fly down range. All objects were contained within safe areas, causing no damage on human beings or property.

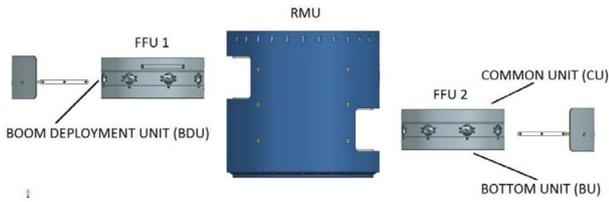
Several findings associated with the FFU retention / ejection mechanism of experiment WOLF have been observed. For a further study, it is important to understand the design of the ejection mechanism. As shown in Fig. 5, two Free Falling Units (FFUs) were planned to be ejected in radial directions. In order to benefit most from the available space, the two FFUs are accommodated on top of each other. The ejection system relies on both, the centrifugal forces of the spinning rocket vehicle and

Figure 5: Side view of WOLF module with FFUs and hatches. From [3].

Upon recovery of the payload, the two hatches and FFUs of the WOLF module were seen to be missing. Marks, scratches and damages around the openings and inside the module suggested a non-nominal ejection with
