FOREIGN OBJECT DAMAGE IMPACT TESTS ON SOUNDING ROCKET FIN STRUCTURES

15 years after Space Shuttle Columbia's disastrous foam strike accident, DLR's Mobile Rocket Base (MORABA) performed high velocity impact tests on two Improved Orion (IO) fin structures thus supporting the failure investigation of the REXUS-24 flight anomaly.

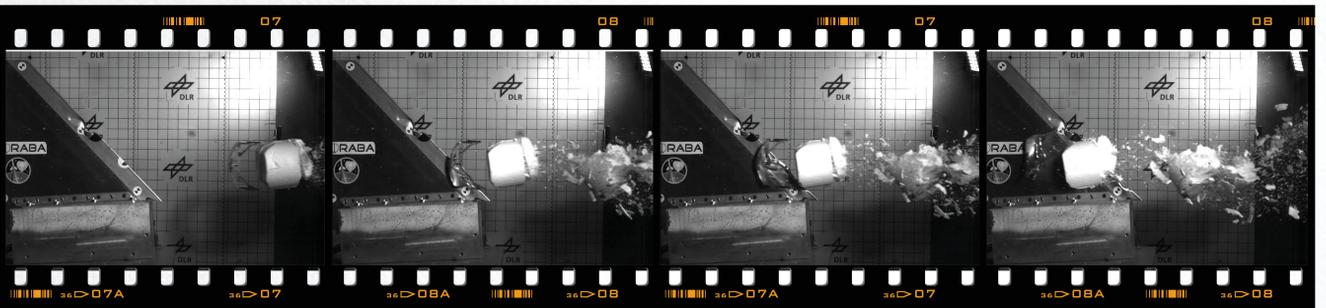
- All impactors showed a stable flight behaviour with an average measured impact velocity of 257m/s.
- After impact all damage patterns showed strong but local destruction from cuts, bents, buckles, scratches and dents. Grazing shots with only marginal damage are possible for some impactor orientations.
- Right after the point of impact none of the impactors showed noticeable deflection or deceleration. All impactors disintegrated in several large pieces which stayed together in close formation on their predefined flight path.
