International Conference on Concentrating Solar Power and Chemical Energy Systems,
SolarPACES 2014

Durability testing of silvered-glass mirrors

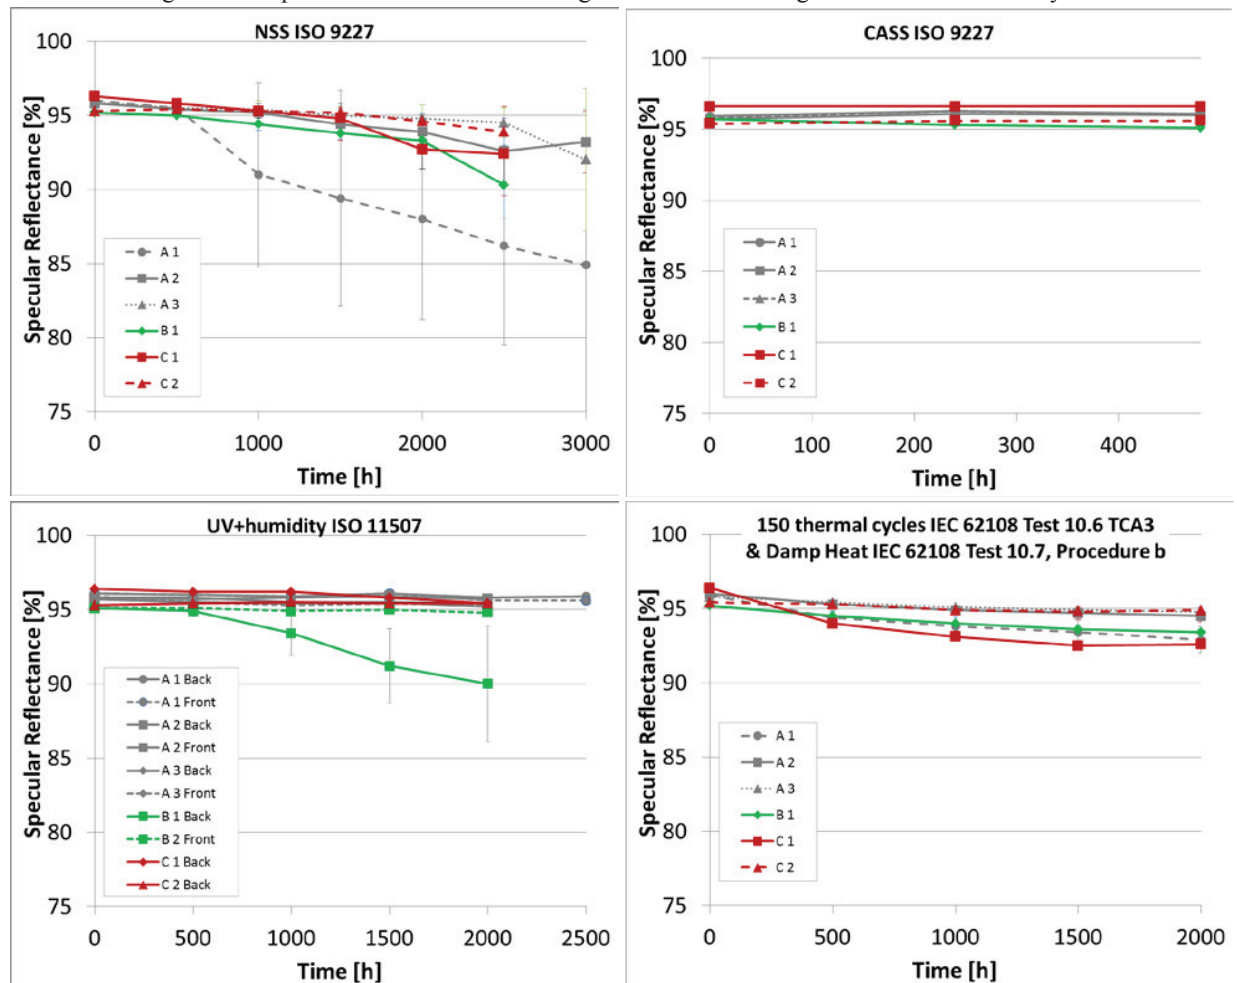
Depicted in Fig. 6 is the evolution of the specular reflectance of the six tested material types under accelerated aging. The highest decays are measured after 3000 hours of NSS testing. Almost no optical degradation was measured after 480 hours of CASS testing and after 2000 hours of UV+humidity testing. Only the 'B 1' samples exposed with the back paint layer towards the UV-lamps showed considerable optical degradation. Microscopically there are many small corrosion spots visible (see Fig. 9 in section B1 and UV+Humidity). After 150 thermal cycles most of the samples showed cracks in the paint layers at unprotected edges which were a starting point for corrosion in the posterior damp heat test. Importantly, no cracks were detected at originally sealed edges.

After 500 hours of damp heat and NSS testing and after 1500 hours of UV+Humidity testing first signs of glass corrosion can be appreciated on samples from different manufacturers. The glass corrosion increments severely with time for some samples, especially for 'A 1' in the NSS test (see Fig. 7), where specular reflectance decay is mainly due to scattering and absorption effects at the corroded glass rather than a degradation of the silver layer.

Fig. 6: Specular reflectance $\rho(660\text{nm}; 15^\circ; 12.5\text{mrad})$ variation as function of time in different accelerated aging tests
