# ADVANCES IN THE BONDLINE CONTROL TECHNOLOGY FOR THE CERTIFICATION OF ADHESIVELY BONDED COMPOSITE REPAIRS

Adhesively bonded composite repairs restoring limit load capacity are not yet certified in civil aviation due to a lack of methods suitable for the substantiation of proper bond quality. In our previous paper, we proposed a novel method for process control to resolve this issue [1]. The core of this bondline control technology is a new type of adhesion test that provides proof of bond quality and simultaneously serves as a robust surface pre-treatment for adhesive bonding.

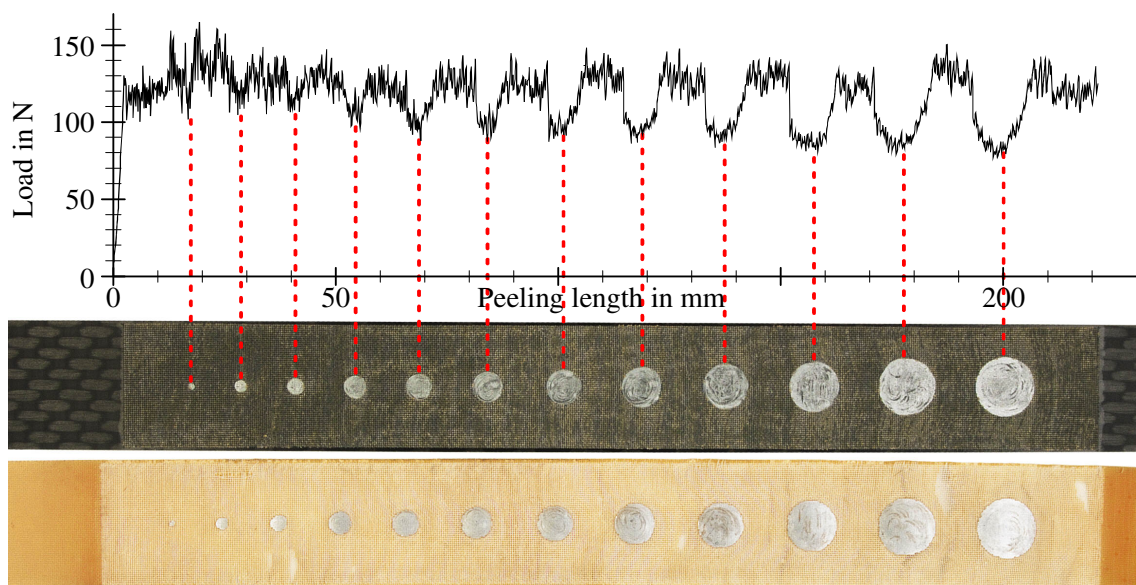
Figure 3: Test result of a defective bond. Bottom: peeled specimen and fabric. Top: peeling diagram.

In order to demonstrate the capability of the method to indicate bonding defects via the fracture pattern and via the peeling diagram, specimens were manufactured with artificial defects. A panel of pre-treated *CFRP C* was contaminated with a paint marker and subsequently a polyester SMF was bonded onto the substrate with *adhesive A*. The test area of each specimen was contaminated with 12 painted circles, starting with a diameter of 1 mm. The diameter of the following circles was increased in increments of 1 mm. After bonding, peel specimens with sealed edges were extracted from the panel.

Fig. 3 shows the test result of one of the contaminated specimens. On the lower part of Fig. 3 the substrate with the tested bond as well as the underside of the fully peeled fabric are shown. All 12 circles can be identified in the test area and on the peeled fabric, which indicates that cohesion failure occurred within the paint. The upper part of Fig. 3 shows the peeling diagram of the specimen. While the load reaches the reference value in the uncontaminated areas, each circle of paint can be allocated to a drop in the peeling force. The width and the magnitude of the drop in load correlates to the size of the respective paint circle.

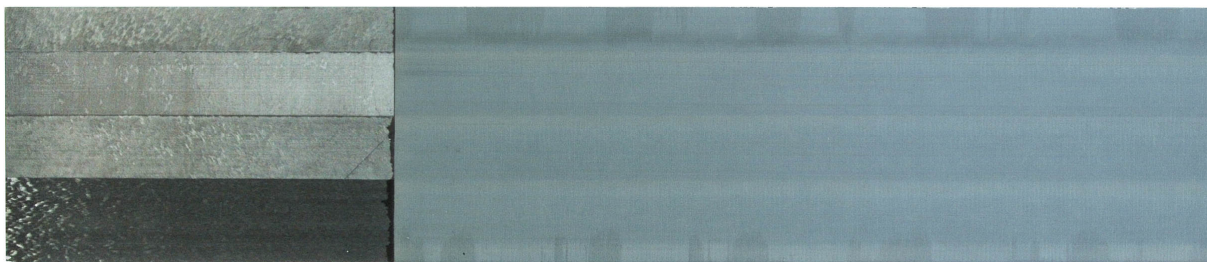
Figure 4: Fracture surface of a peel test performed alongside the steps of a stepped panel.

The result of this series of tests was that independent of the type of fabric and independent of the peeling direction, no substrate damage occurred at the edges of the steps. Fig. 4 shows a peeled specimen representative of the test series. The pictured specimen was produced with a DWF and was peeled along the steps.
