# USE OF IN-PROCESS MONITORING AND ULTRASOUND TO DETECT DEFECTS IN THERMOPLASTIC AFP-PRODUCED PARTS

**Keywords:** Automated Fibre Placement, Thermoplastic Composites, NDT, Ultrasound

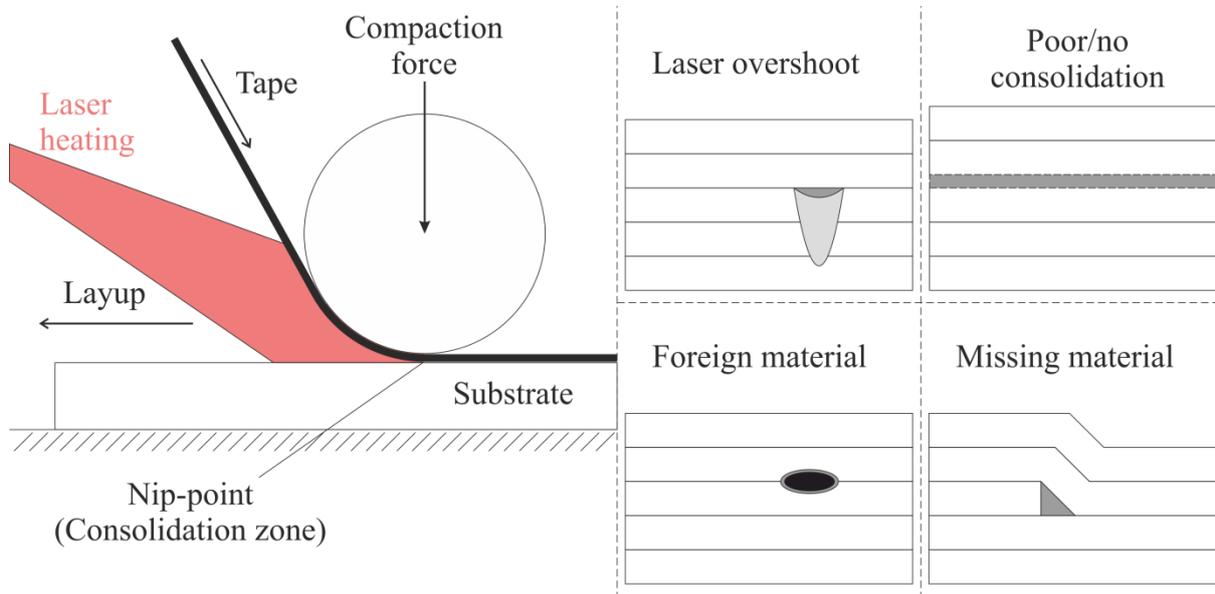
Figure 1: Automated fibre placement principle (left) and common manufacturing defects (right)

Automated Fibre Placement involves the deposition and consolidation of fibre-reinforced thermoset or thermoplastic material to produce parts through additive manufacturing. By using polymer material containing continuous, unidirectional (UD) fibres, components produced using this method are able to further capitalise on the high strength-to-weight ratio of composite materials by aligning the load-bearing fibres with intent rather than distributing them uniformly within the part volume. This allows increased directional strength and hence a lower material demand. A diagram of this manufacturing method is shown in Figure 1.

during manufacturing. Considering these heat source-associated defects, as well as others stemming from incorrectly applied UD tape or the accidental inclusion of foreign material, a list of AFP-inherent defects and their impacts on the laminate structure can be developed. Such a list is given in Table 1, with diagrammatic examples of the defects shown in Figure 1.

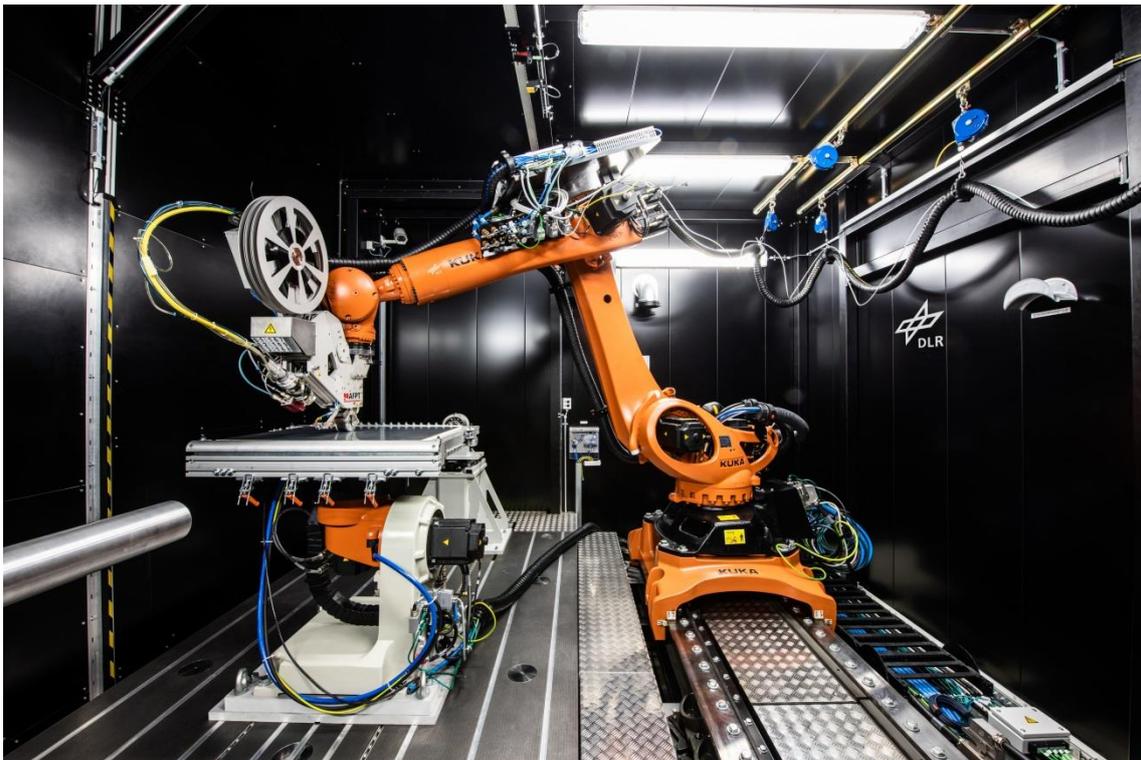
Figure 2: DLR thermoplastic AFP facility in Stuttgart, Germany

The thermoplastic AFP facility of the German Aerospace Center (DLR) is located at the Institute of Structures and Design in Stuttgart, Germany. The facility combines a 6 Degree-of-Freedom (DoF) robotic arm with a 2 DoF planar tooling surface and rotational axis system to facilitate the production of a range of different part geometries and complexities. An image of this facility is shown in Figure 2.

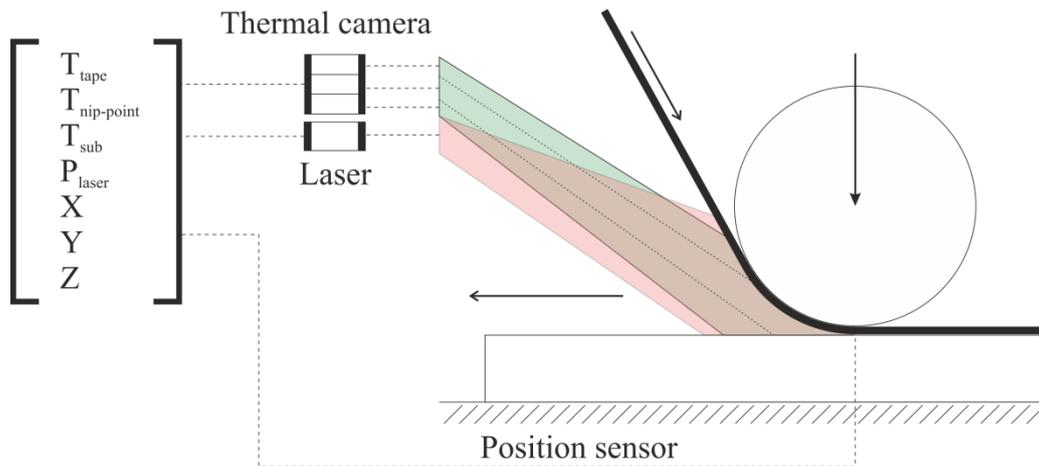
Figure 3: In-process monitoring during AFP manufacturing

During manufacturing, information on the Cartesian position of the consolidation point, as well as the nip-point, substrate, and incoming tape temperatures are recorded using the facility control centre. Temperature values are captured using an Automated Technology IRS128-I thermal camera and used in a feedback loop to regulate laser power and maintain the user-defined process temperature. The detector resolution of this camera is 168 x 128 pixels, with the total capture area being divided in three and each third determining an averaged value for the three temperatures. Values of the laser power incident on the consolidation zone are also recorded. A diagram of this data capturing system is shown in Figure 3.

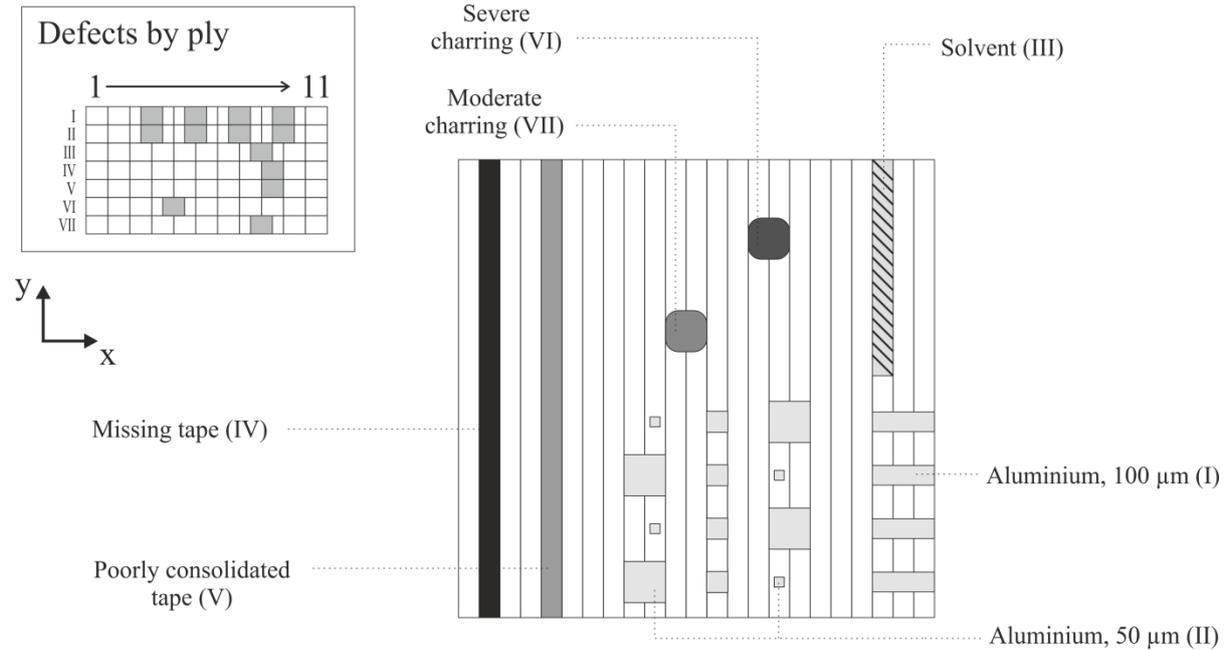
Figure 4: Defect locations within the laminate

The final dimensions of the laminate (x,y,z) were 300, 300, and 2.2 mm, with the positions of various defects visible in Figure 4. Foreign material was placed at different through-thickness (z-direction) locations to assess the quality of visibility as a result of the available scanning surface for a real-world part. Due to spatial constraints of the final laminate, the same variation could not be repeated for the other defects.

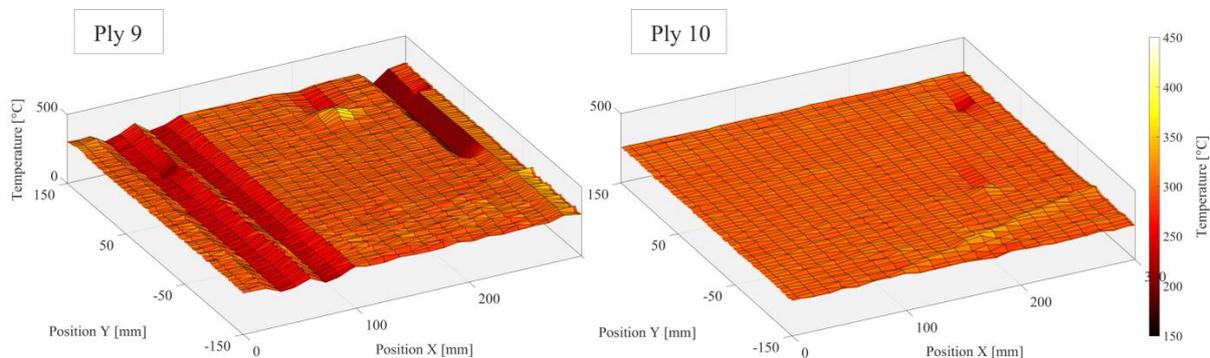
Figure 5: Reconstruction of plies 9 and 10 using in-process monitoring values

Figure 5 shows plies 9 and 10 of the laminate reconstructed using the monitoring software, with a mesh size of 12.7 x 5.0 mm (x,y). These plies contained missing and poorly consolidated tows and the foreign aluminium material, respectively. As can be seen from the figure, the missing and low-power defects are clearly visible as areas of reduced temperature in ply 9. Recorded temperatures in these areas are dependent on the tooling temperature and substrate thickness, though since the tooling temperature is held considerably lower than the polymer melt temperature (in order to ensure substrate stability), such defects can be clearly distinguished from the surrounding standard deposition. It should be noted that the additional low-temperature zone on the right side of the image was also intentional. This was used to apply the release agent to ply 8 without contaminating the roller.

Despite the difference in emissivity and reflectivity from the UD tape, none of the four aluminium material segments produced a significant deviation in the recorded temperature when applying ply 10 to the form. In the reconstruction shown, certain minor deviations from the mean surface temperature are seen, though their magnitude is not sufficient to correlate them with any confidence. Interestingly, the only surface defect registered by the thermal camera was that resulting from the severe charring (simulated power overshoot) from the previous ply (8). This charring, shown in Figure 6, was significantly more aggressive than that applied to ply 4, with the substrate heated to above the polymer

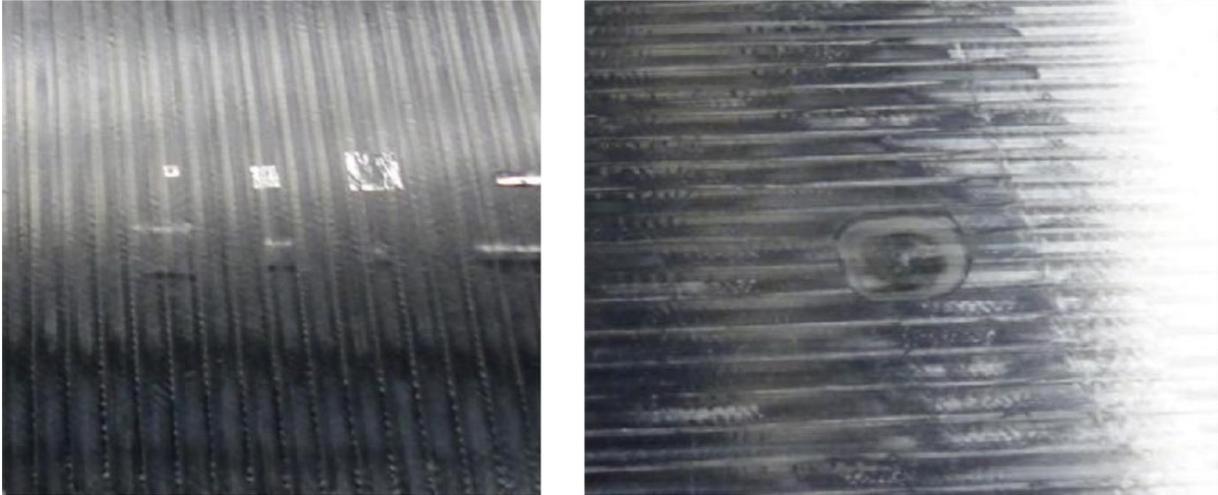
Figure 6: Aluminium foreign material before and after tape deposition (left) and severe substrate charring (right)

flashpoint (500°C [11]). While the homogeneity of the charring is difficult to estimate, it is visible to the naked eye over an area of approximately 40 x 40 mm<sup>2</sup>. The characteristic length of this defect (in the direction of deposition) is hence twice that of the largest aluminium addition. As recorded values for the nip-point temperature are averaged over a reasonably larger number of pixels, it is possible that foreign body inclusions must be larger than those used in this study in order to be registered by the camera in its current configuration. Future investigations will look to quantify the minimum detectable length and improve it through alterations to the temperature averaging function.

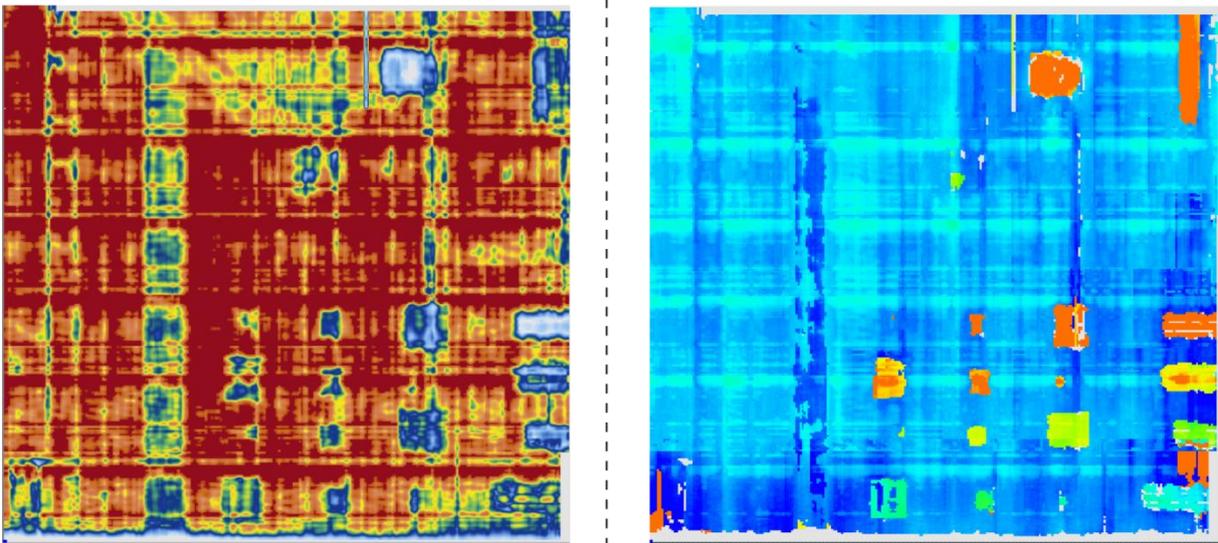
Figure 7: Ultrasound scanning results using the return signal amplitude (left) and time-dely (right)

Figure 7 shows US scans of the laminate using both the amplitude and time-delay of the return signal to identify defects. As can be seen, both methods were able to detect the full list of defects, though with differing degrees of clarity. Aluminium inserts were clearly visible using both methods, though the time-delay scan, with the settings utilised, was not as effective at identifying the smallest inserts (5 x 5 mm). This setback is somewhat compensated by the ability to display the different relative depths at which defects are located. The release agent between plies 8 and 9 was much more visible using the time-delay method, with the unconsolidated area being easily distinguishable against

the laminate background. In contrast, the missing and poorly consolidated tapes were more visible using the amplitude method. Finally, while both methods were able to clearly identify the severely charred area, the time-delay method was able to highlight the moderate charring much more effectively. As for the foreign material inclusions, variations of laser overshoot are of interest for future investigations, including their impact on the mechanical properties of the final part.
