SEARCH AND RESCUE – DEVELOPMENT AND VERIFICATION OF A MODERNIZED PASSIVE FLOATING SYSTEM FOR PAYLOAD SEA RECOVERY

Johannes Göser⁽¹⁾, Oliver Drescher⁽²⁾, Marcus Hörschgen-Eggers⁽³⁾, Ulf Gemeinhardt⁽⁴⁾

ABSTRACT

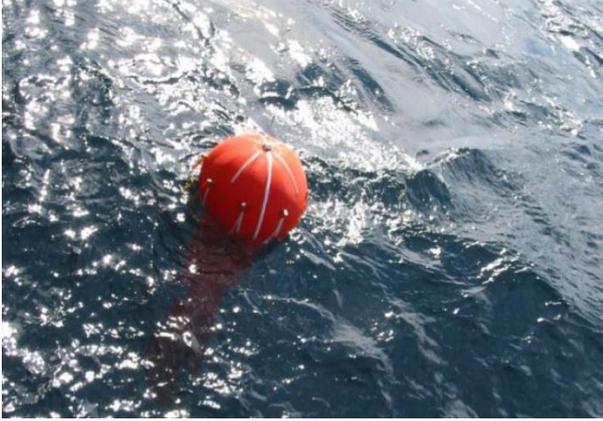
Figure 2 Previous passive floating system

Because of its two chamber design, the floater still generates buoyancy even if there is a rupture on the outer shell. The size of the floater body can vary, depending on the mass of the payload. For localisation a GPS/Iridium transceiver, a VHF radio beacon transmitter and a strobe light for visual detection are installed in a watertight box that is mounted on the floater's apex. After visual detection the floater can be hooked at a salvage line and hoisted off the water together with the parachute and the payload. Those kind of floating recovery systems have been used for multiple missions during the last 50 years.

Most of the recovery operations have been successful whereas several findings and weaknesses could be revealed. For example, the poor tightness of the floater material and the joints increased the probability of a mission failure because of payload sinking. The gained experience combined with modern manufacturing methods showed the potential for the development of an improved and more reliable passive floating system for payload sea recovery.

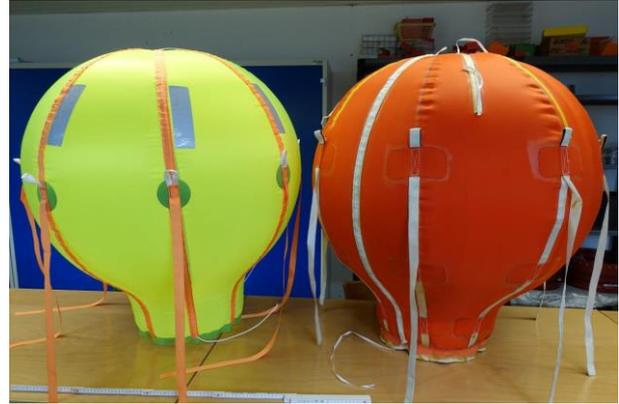
Figure 3 New (left) and previous (right) floater design

The previously used floating system was made of Rivertex 240 material (mass: 240g/m², hydrostatic head: >3000mm) and manufactured by adhesive bonding [2]. Both the material and the joints started leaking over time. The company TEXCON GmbH proposed to use 804 FL Yellow material (mass: 153g/m², hydrostatic head: 155100mm) for the floater body [3]. It is a polyurethane coated polyamide fabric that is commonly used by TEXCON GmbH to design life vests. Besides the lower mass and the higher hydrostatic head the

distinctive and bright colour of the material meets the requirement of a better visibility. Different to the previous design the single strips are not bonded but connected by ultrasonic welding and high frequency welding. This technique provides more reliable, homogenous and tight joints. A first prototype of the redesigned floater was manufactured and completed after one day. In comparison the production of the previous floater took multiple days. The final mass of the floater body prototype is 0.89kg, which results in a mass reduction of 40% compared to the previous design (1.53kg).

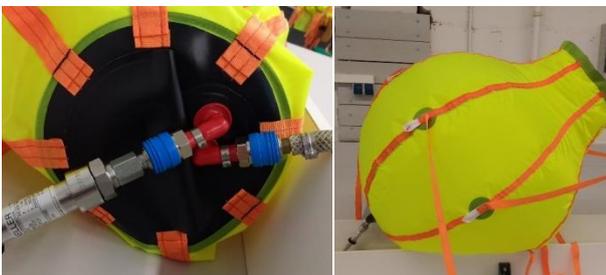
Figure 5 Burst test assembly

For the burst tests the floater was inflated via a pressure port at the apex of the floater body. Additionally, the inner pressure was measured via a second port at the apex.

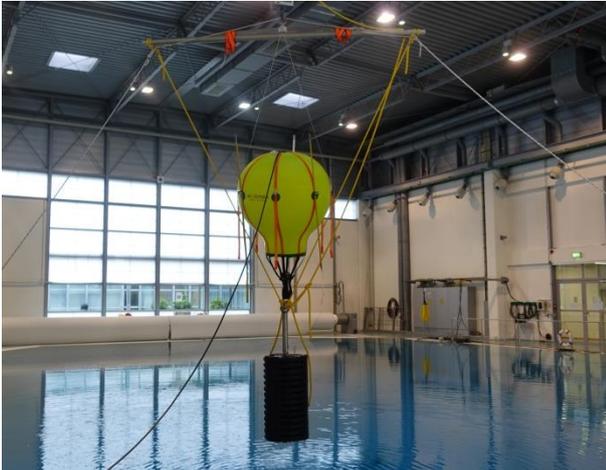
Figure 8 Load beam construction

to a dummy mass carrier (net mass 21kg) that can be equipped with a variable amount of rubber insulated weight plates á 25kg. Furthermore a GoPro camera was mounted to the harness to record the behaviour of the duckbill valve during operation. To keep the floater unloaded while lifting it into the water a load beam construction was developed. It is shown in Figure 8.

When the floater is set down on the water surface the suspension ropes of the load beam are released and the dummy payload mass is finally carried by the floater. Buoyancy tests were performed with three different payload masses (100kg, 200kg and 350kg). For all tests the floaters were inflated with the same initial pressure of 30mbar. The test duration for each test level was 60min. All tests were performed for the new and the old floater. During the buoyancy tests the differential pressure and the temperature was measured. Furthermore draft marks were placed around the payload floater to observe the sinking level of the floater over time.

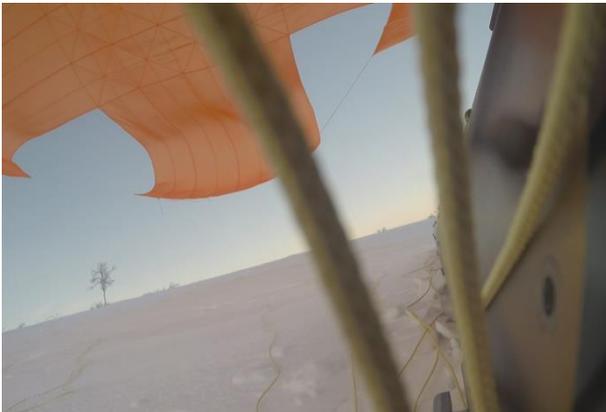
Figure 14 Parachute sinking to the ground

A video analysis showed that the parachute usually hits the ground or water surface with velocities between 1-3m/s [5].

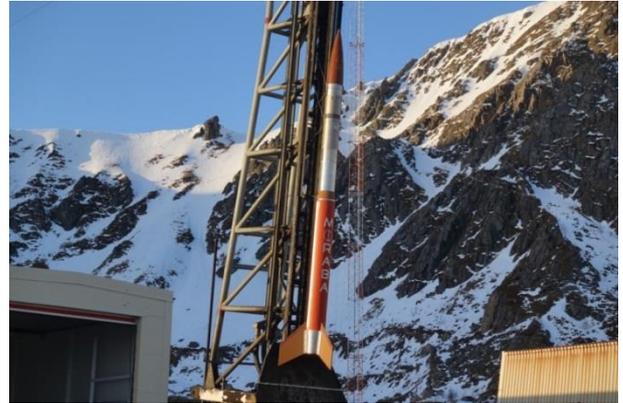
Figure 15 PMWE 2 vehicle at the launcher

Both rockets were boosted by an Improved Malemute motor and were equipped with the modernized passive floating recovery system. The payload masses in recovery configuration were 161.3kg (PMWE 1) and 159.3kg (PMWE 2) [6].

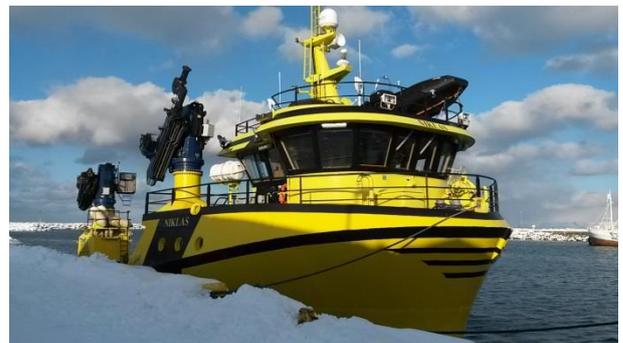
Figure 16 Recovery vessel MS Niklas

For the recovery operation the service and off-shore work boat MS Niklas from FDA (Finnsnes Dykk & Anleggsservice AS) was hired, which is equipped with two 20m cranes that facilitate payload recovery from 10m below the sea surface [7]. Prior to the campaign a VHF direction finder has been installed on board to receive the signal of the radio beacon transmitter. Three crew members of MS Niklas and one member of MORABA finally performed the recovery operation on deck.

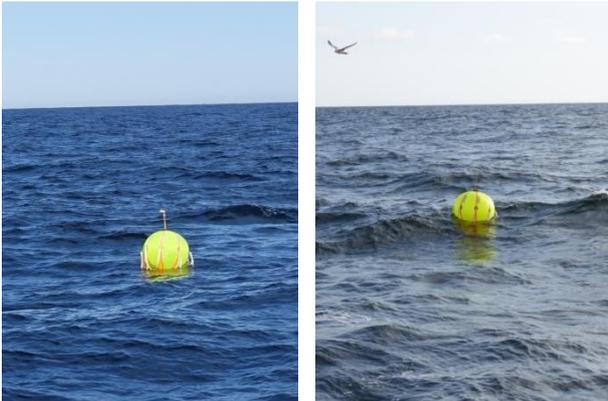
Figure 17 PMWE 1 and PMWE 2 floating in the sea

Both payloads were located within two hours after splashdown. About one hour before visual detection, the beacon signal, transmitted by the floater, was received. The bright yellow colour of the modernised floater created a good contrast to the sea water and therefore the floater was easily localized. Pictures of the PMWE 1 and PMWE 2 floating systems before recovery are shown in Figure 17. The observed draft of the floaters is different. For the PMWE 1 floater 80% of the body volume was above water surface whereas only 60% of the body volume was above water surface for the PMWE 2 floater.

The different amount of water inside the floater explains the different draft of the floaters that was observed before the recoveries (see Figure 17). Considering the short floating time and the moderate sea state level, the amount of water inside the PMWE 2 floater is not satisfactory. During the qualification tests at the ESA NBF such a huge amount of water was never observed inside the modernized floater. Two major differences to the ESA NBF tests are the sea state conditions that could not be simulated in the NBF pool and the stabilization straps connecting the floater to the main parachute. During flotation the main load of the payload is transferred via those straps and not via the floater's base, which is why the less centred floater body could start shaking by the waves. This process is displayed in Figure 20.
