Monitoring coastal erosion in Cyprus: an analysis utilizing Sentinel-1 SAR data

George Melillos, Eleftheria Kalogirou, Diofantos Hadjimitsis, Egbert Schwarz, Stefan Wiehle

> George Melillos, Eleftheria Kalogirou, Diofantos G. Hadjimitsis, Egbert Schwarz, Stefan Wiehle, "Monitoring coastal erosion in Cyprus: an analysis utilizing Sentinel-1 SAR data," Proc. SPIE 12728, Remote Sensing of the Ocean, Sea Ice, Coastal Waters, and Large Water Regions 2023, 127280M (17 October 2023); doi: 10.1117/12.2680258

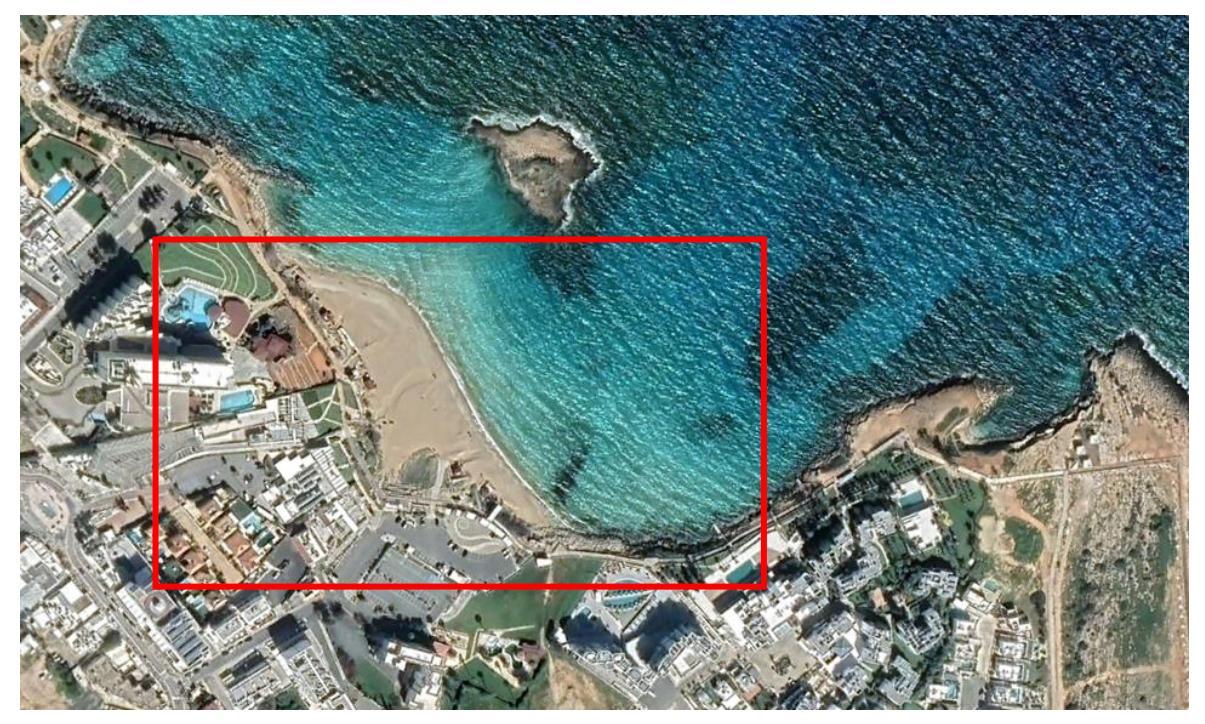
Figure 1: The area of interest (AoI) (red rectangle) used in this study (Satellite View on 03 April 2023).

The study's area of interest (AoI) is the Southeast Cyprus coastlines, Famagusta District. Figure 1 shows the study area. The data includes SAR Sentinel-1A level 1 ground range detected high-resolution (GRDH) data acquired on 03 April 2023 with interferometric wide swath (IW) mode. Level 1 GRD data denotes that the data have been projected using an ellipsoid earth-modelling approach [1]. Table 1 gives a detailed overview of the SAR Sentinel-1 imagery used in this study.

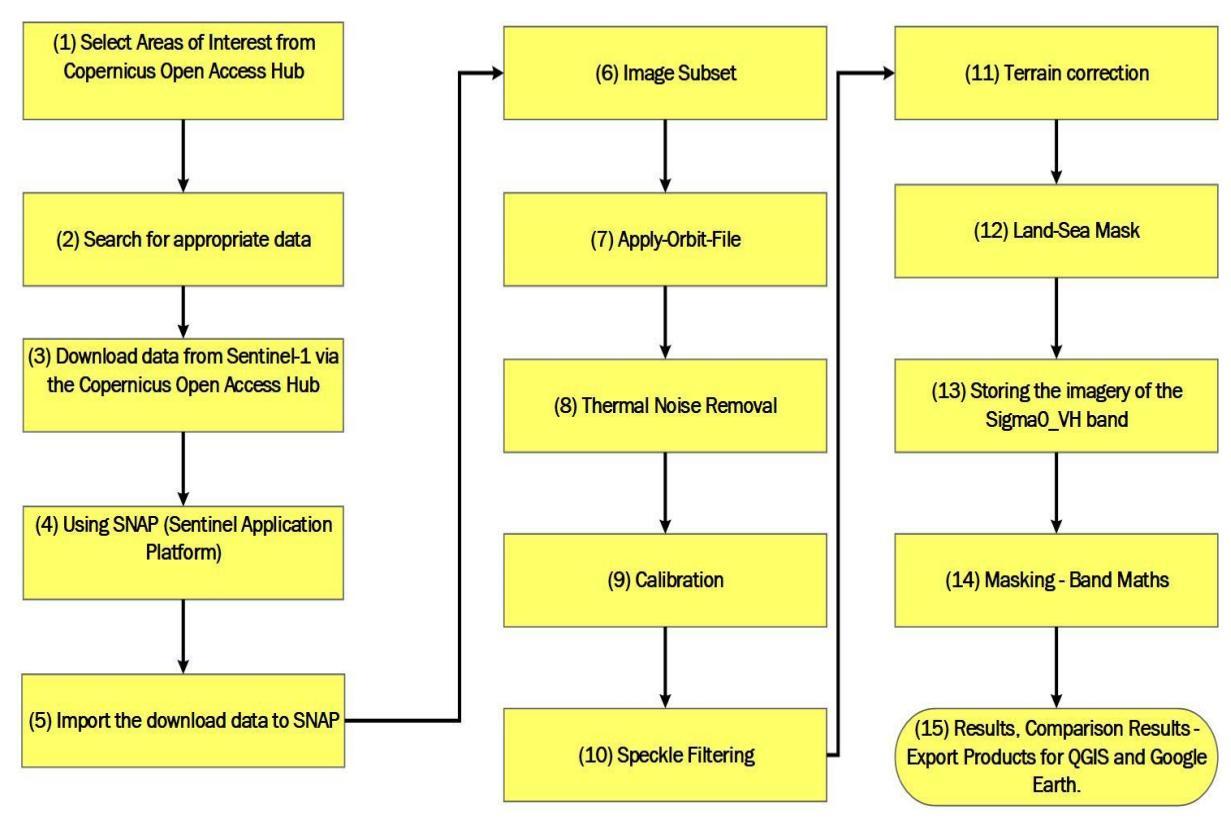
Figure 2: The overall methodology adopted in this study.

The main idea of this study is to present an analysis of erosion patterns in the Southeast Cyprus coastlines, Famagusta District. Data from Sentinel-1 from the Copernicus Open Access Hub was used through the online interface. The methodology was formulated for the Sentinel application platform (SNAP), a typical architecture satellite toolbox [1]. SNAP enables accurate assessment of erosion rates, identification of erosion-prone areas, and understanding of the underlying factors influencing erosional processes in the specific Area of Interest. The overall methodology adopted in this study consists of fifteen (15) processing steps briefly described below (see Figure 2):

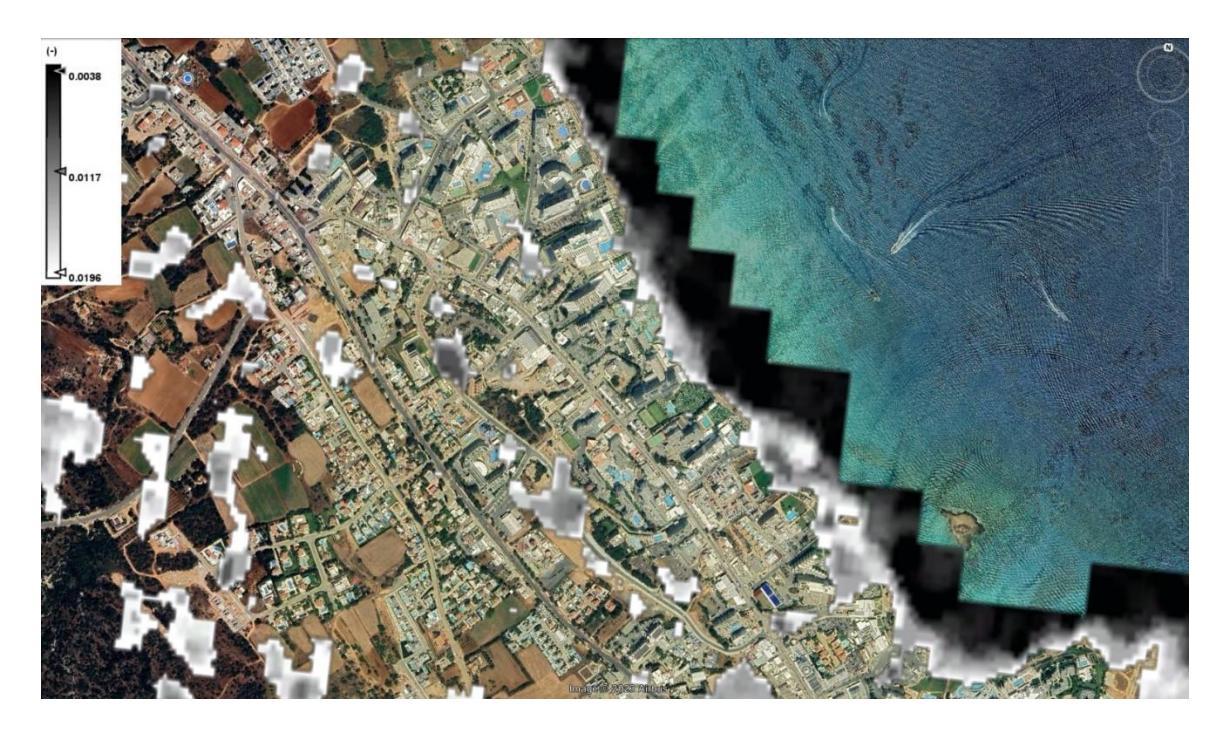
Figure 4. A Google Earth image overlaid with an imported mask (in grey), highlighting the impact and patterns of coastal erosion along the Southeast."

Furthermore, Figure 4 displays the SNAP mask output generated by applying the methodology using Google Earth Image, described above in this paper. This representation comprehensively illustrates the regions susceptible to coastal erosion along the Southeast Cyprus coastlines. Subsequently, Figure 5 presents a Google Earth Image showcasing the imported mask (grey color), enabling a comprehensive analysis of the variations and implications of coastal erosion along the Southeast Cyprus coastlines, explicitly emphasising the renowned Fig Tree Bay in Protaras, Paralimni (Figure 1), one of the most popular beaches on the island as thousands of local and foreign visitors gear up to head to Famagusta district for their summer holidays [14].

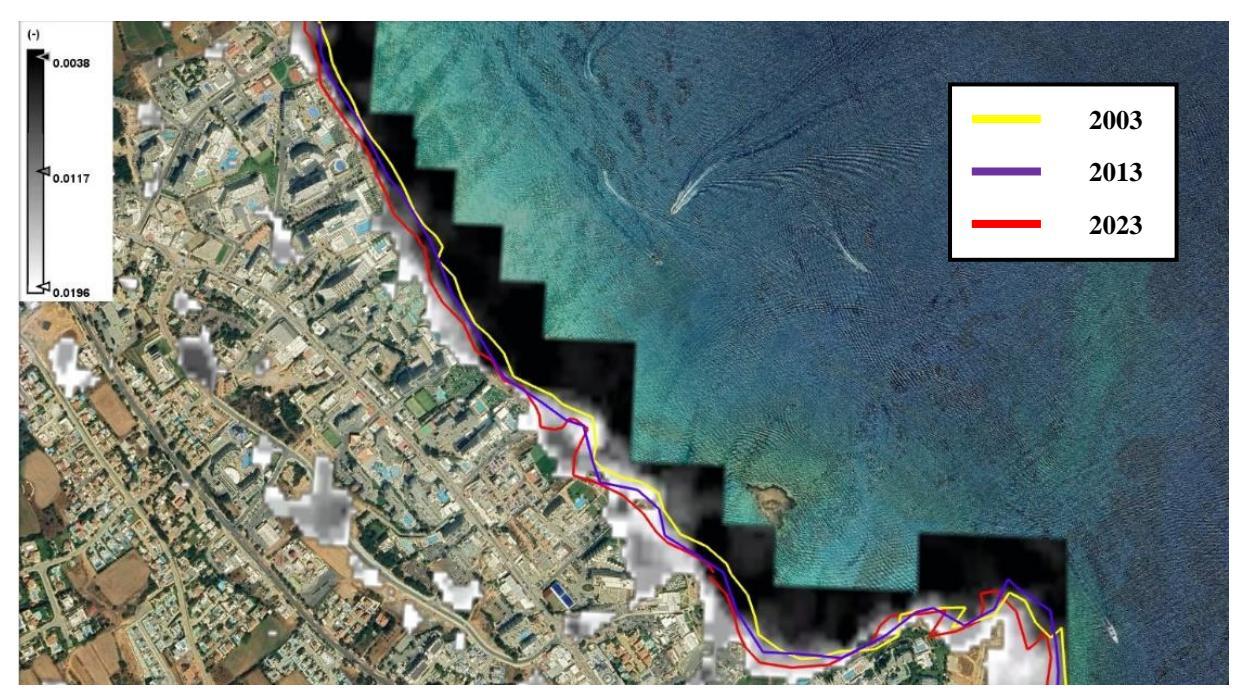
Figure 5: Visualization of decade-wise coastline alterations with mapped shorelines from 2003 (yellow), 2013 (purple), and 2023 (red), highlighting the coastal squeeze and beach profile steepening due to relative sea-level rise and reduced sediment availability. The shorelines were derived using historical Google Earth Satellite Images.

Figure 5 points out the coastline changes between that periods (every ten years) using three (3) shorelines. The shorelines of 2003 (yellow), 2013 (purple) and 2023 (red). The shorelines were derived using historical Google Earth Satellite Images. In this area, the relative sea level is rising, or where sediment availability is reduced, a further coastal squeeze results from a steepening beach profile and foreshortening of the seaward zones [15], as illustrated in Figure 5. The results show an increasing trend of erosion along the Fig tree bay coastline, reaching -1.5 m/year according to the historical Google Earth Satellite Images. Correspondingly, Figures 6 and 7 show images (June 2020) of Fig tree bay beach, where the shoreline has visibly receded. This demonstrates coastal erosion, often worsened by rising sea levels.

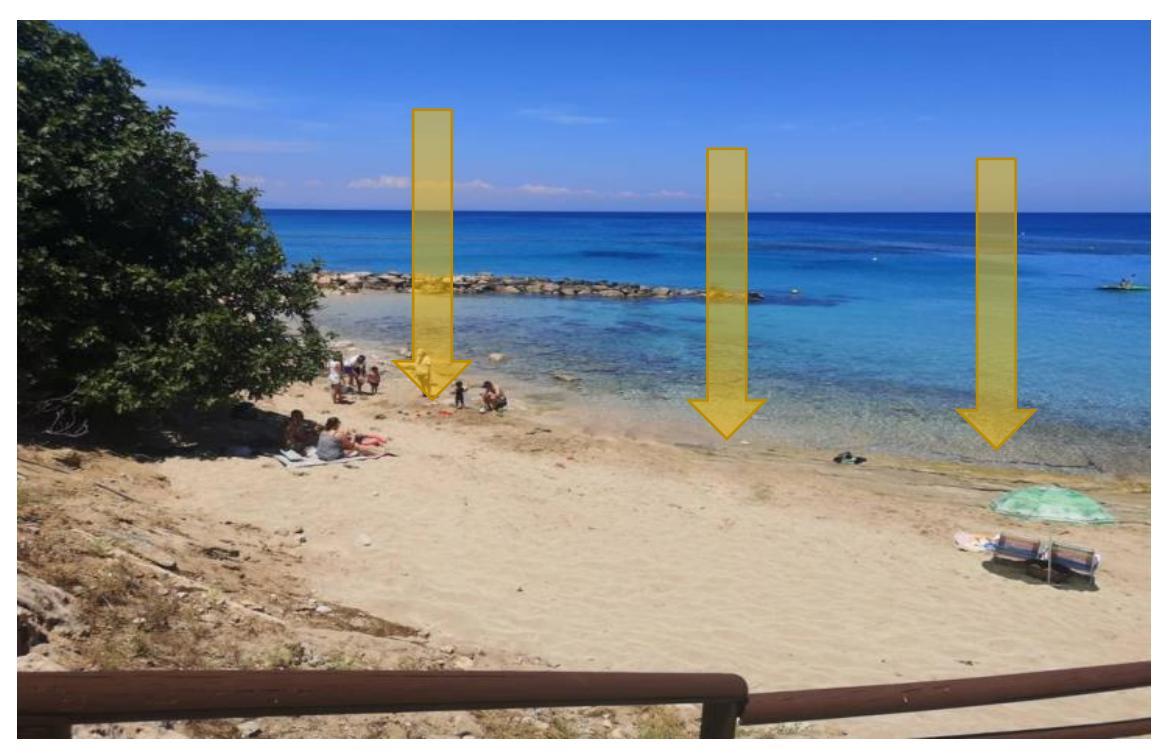
Figure 6: Visual evidence of coastal erosion at a Fig tree bay beach [14], with a marked shoreline recession indicative of the heightened effects of rising sea levels.

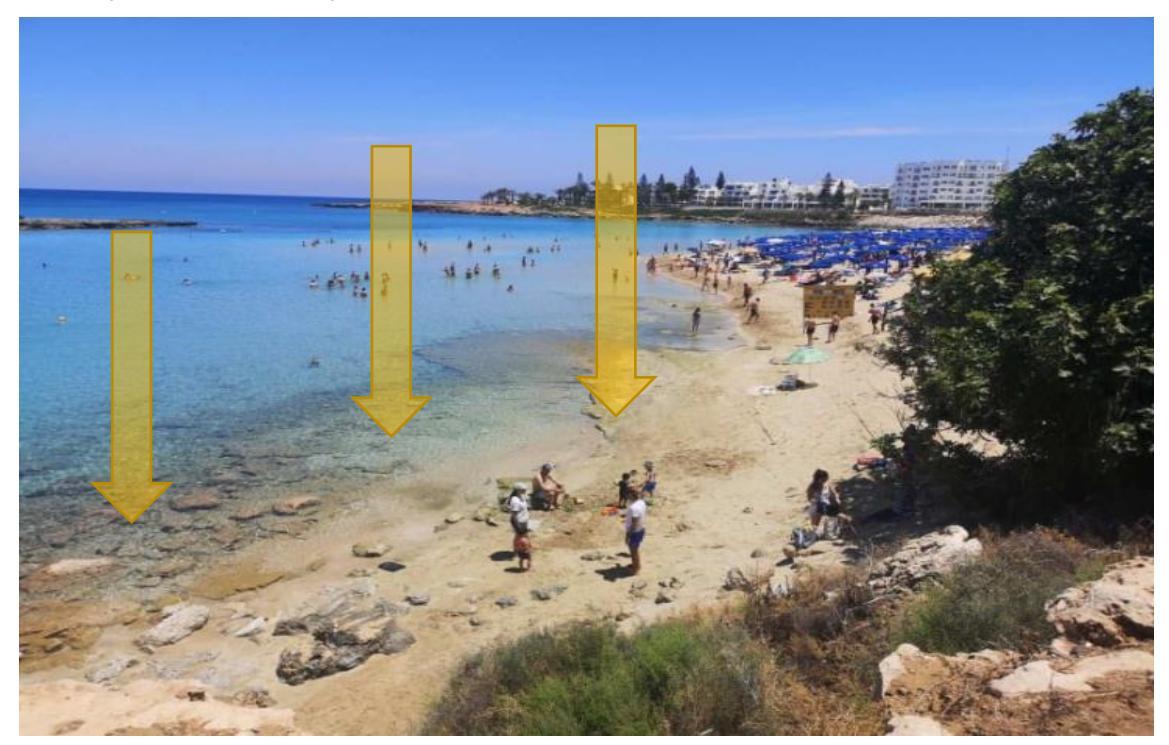
Figure 7: Image depicting a distinct shoreline recession indicates the escalating coastal erosion at fig tree bay [14], often exacerbated by the rising sea levels.
