Friedrich-Alexander University Erlangen-Nuremberg
Faculty of Engineering
M.Sc. International Production Management and Engineering (IP)
Specialization in Photonic Technologies

Master's Thesis

**“Feasibility study on the automatic detection of faults in
photovoltaic plants with unmanned aerial vehicles using low
resolution thermographic cameras”**

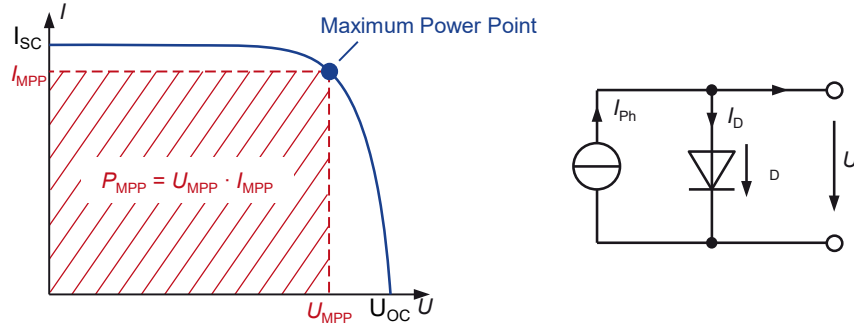
Figure 2.2: Solar cells characteristic curve (left) and simplified electrical circuit model (right) [11]

The solar cell can be analyzed using a simplified electrical circuit model with well-defined parameters (fig. 2.2). Using this model, a characteristic equation can be derived equ. (2.4). An ideal factor m was added to the exponent to better simulate the real solar cell curves. The ideality factor is typically in the range between 1 and 2 [11].

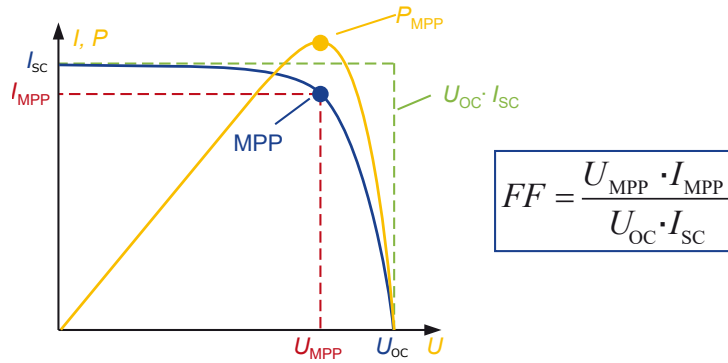
Figure 2.3: Solar cells characteristic curve with MPP (maximum power point) and FF. [11]

MPP is calculated by multiplying the current and voltage values I_{MPP} and U_{MPP} with each other. In addition, fig. 2.3 shows the power curve $P = f(U)$, which reaches its maximum at MPP.

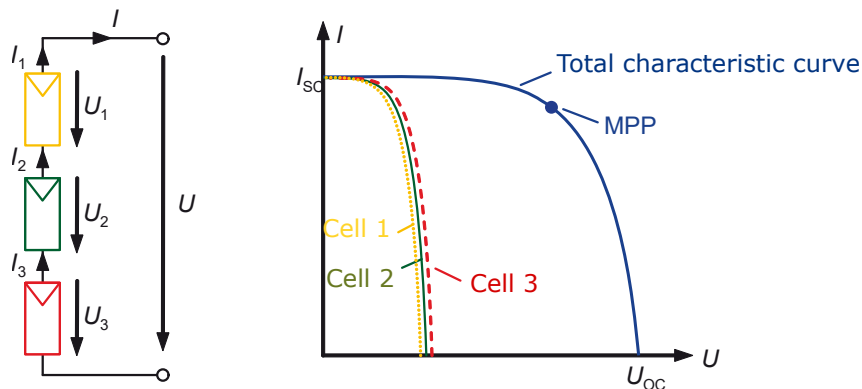
Figure 2.4: Series connection of solar cells: The voltages of the individual cells add up [11]

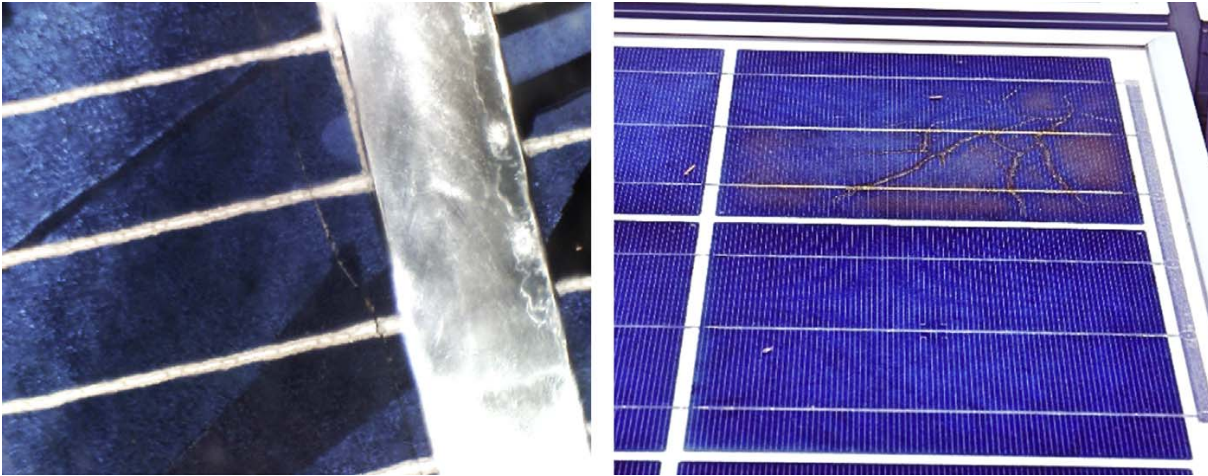
Figure 2.8: Cases of cell cracks (left) and consequent snail trails effect (right) in two different PV modules. [4]

Discoloration effect (grey/black) of silver grid lines on the surface of crystalline silicon cells are often called snail trails (fig. 2.8, right). Snail traces usually occur at micro-cracks and/or along the cell edges [28]. Snail trails can easily be identified by vision. They typically occur three months to one year after the installation of the PV modules and spread depending on the environmental conditions [26]. Experimental tests showed a decrease in electrical PV power of

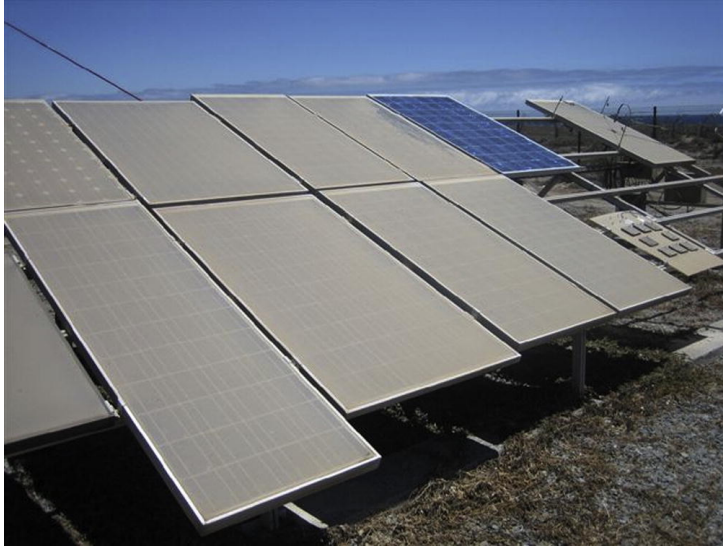
Figure 2.13: Heavily soiled modules on the Gran Canaria Island. A manually cleaned module is visible at the top right corner. [38]

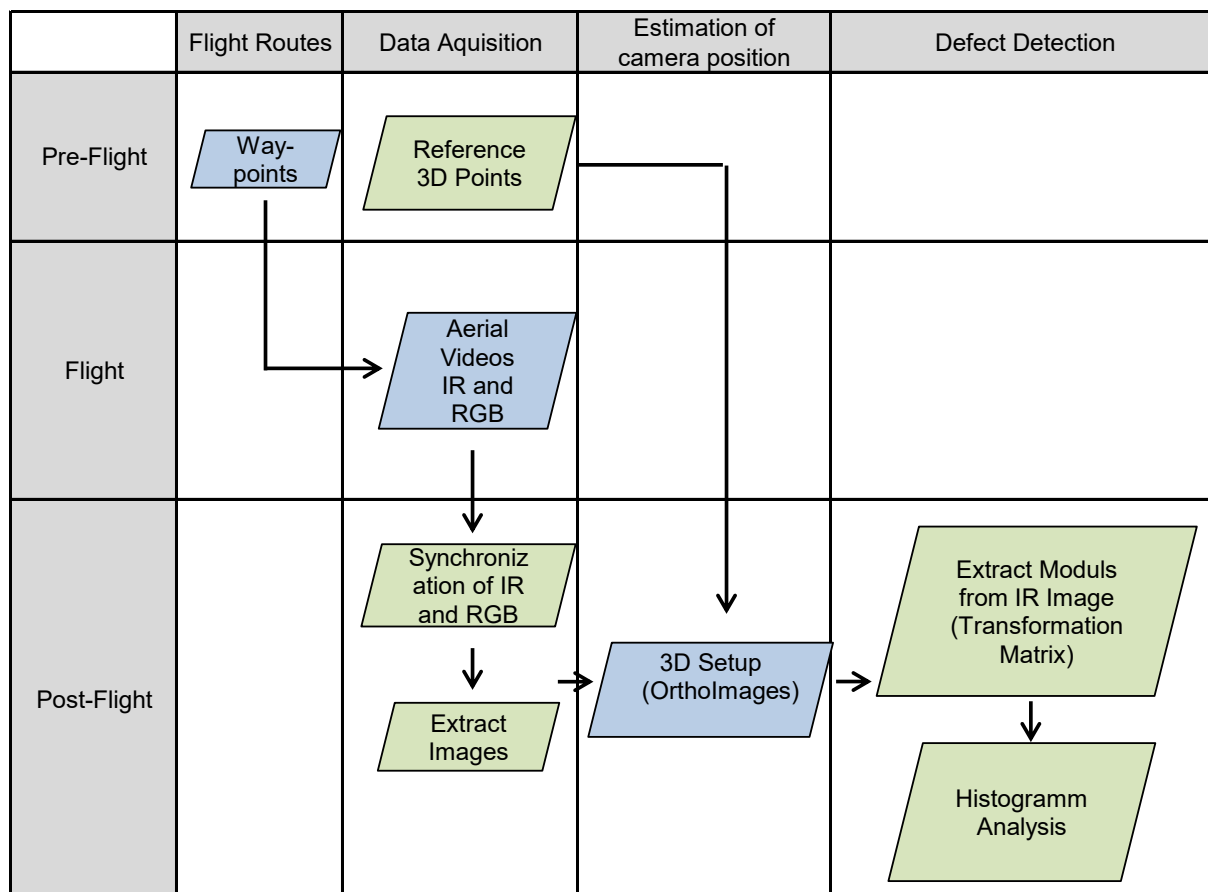
Figure 2.17: QFly Workflow on a vertical level consists of three steps: pre-flight, during the flight and post-flight. On a horizontal scale the process can be divided into determination of flight routes, data acquisition, estimation of camera position and defect detection

In the following graphic the basic QFly workflow is presented fig. 2.17.

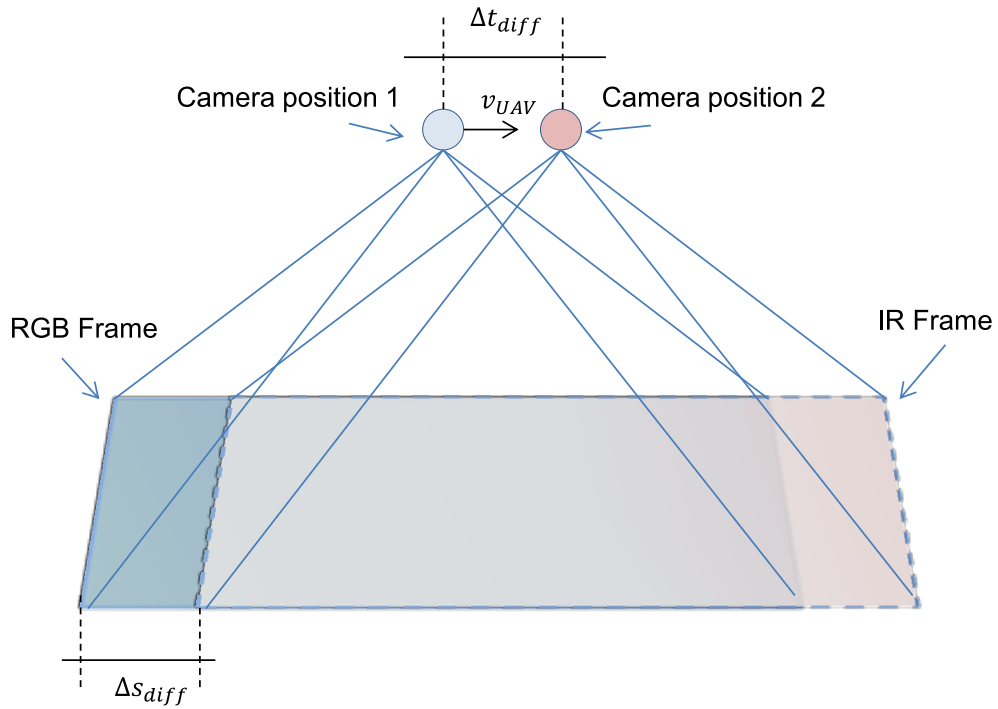
Figure 3.5: Dependency of Δt_{diff} , Δs_{diff} and flight speed of the drone v_{UAV} .

For this reason, Δt_{diff} must remain as minimal as possible so that a correct superimposition of

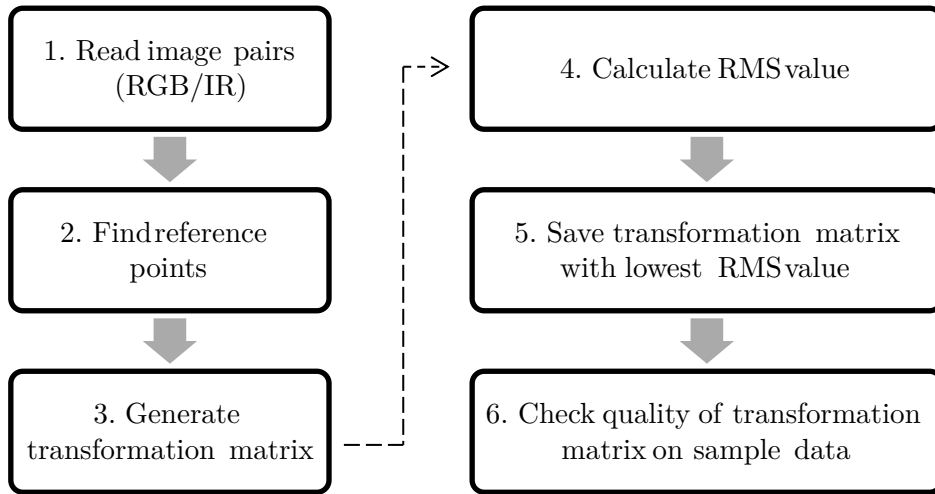
Figure 3.8: Program structure of transformation matrix tool

In the context of this research, a tool (TransMatrixTool) was developed, which allows us to generate a suitable transformation matrix independently from the QFly workflow, which is subsequently integrated into the QFly workflow to transform RGB orthoimages into IR orthoimages. In fig. 3.8 the program structure is illustrated.

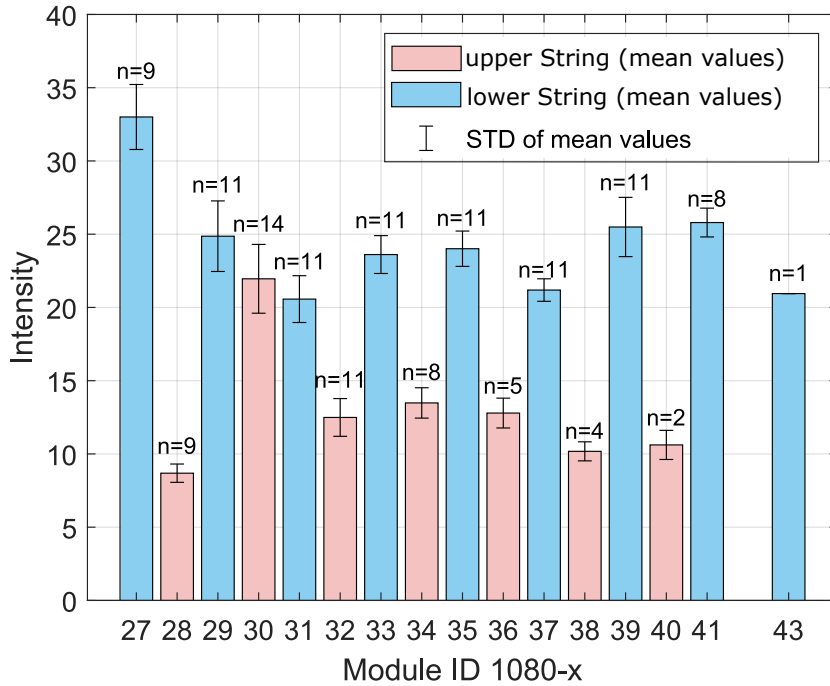
Figure 5.14: Average mean intensities of the individual multiperspective IR orthoimages, upper module-string illustrated by red bars and lower module-string illustrated by blue bars. The calculated STD_{mean} value is derived from the mean values of the individual orthoimages.
